ULTRA WIDE GAP BRAZING OF HIGH TEMPERATURE
CAST STEEL BOILER VALVES

A thesis submitted to the Faculty and the Board of Trustees of the Colorado School of Mines in partial fulfillment of the requirements for the degree of Master of Science (Metallurgical and Materials Engineering).

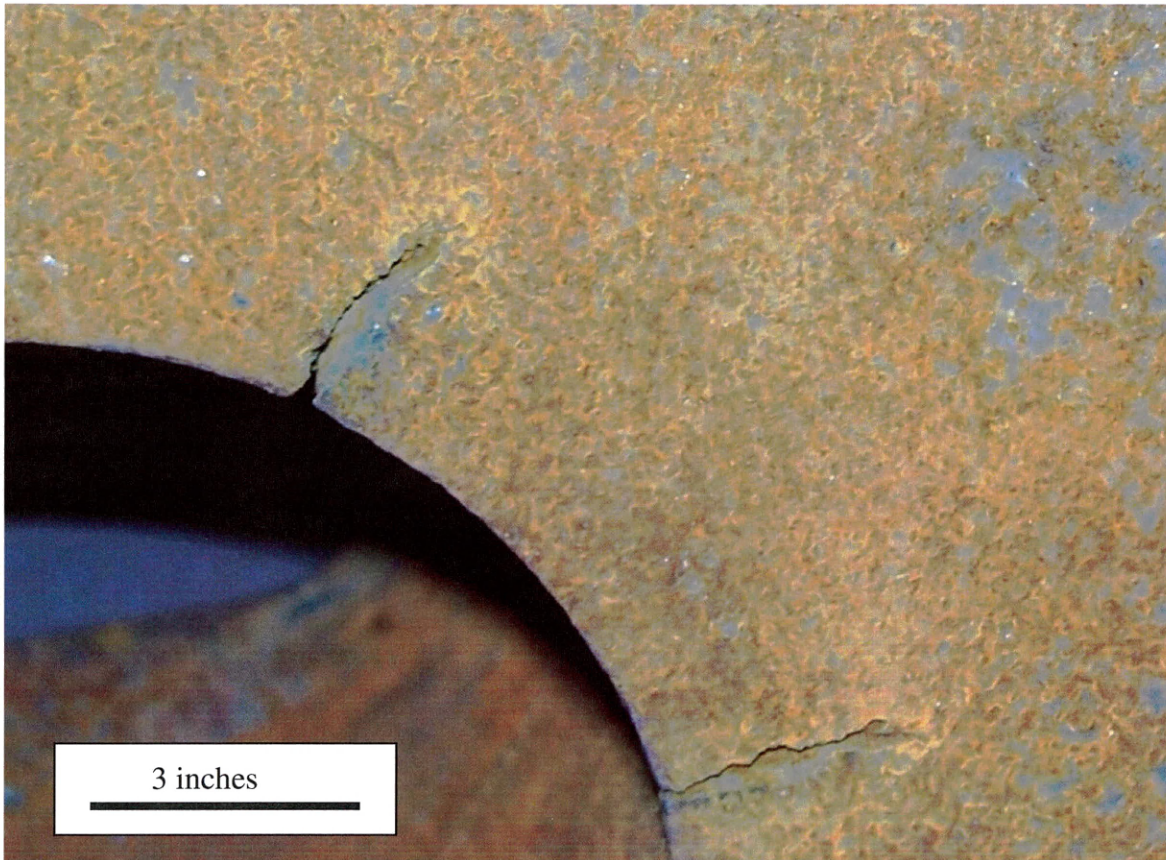
In the electric power industry, coal-fired power plants contain numerous parts in the boiler loop that experience high temperatures. Many points on the boiler loop are exposed to elevated temperatures as well as water or steam. In either case the combination of heat and moisture creates substantial oxidation on the interior surfaces of these components. Of interest in this study are boiler isolation valves, referred to here as boiler valves. These components are typically made of low alloy cast steels with wall thicknesses ranging from three to twelve inches. Each valve weighs several tons and consists of a large cast steel valve body and a valve insert. Repair of the valve body itself is of specific interest within this investigation. As earlier indicated, within the boiler assembly, boiler valves are exposed to both elevated temperatures and oxidizing environments, as well as mechanical stresses. As a result of the heat and aggressive environment, the interior surfaces of boiler valves quickly become oxidized. In addition to normal oxidation, the added stresses created by the elevated operating pressures can create stress corrosion cracking on the interior surface as shown in Figure 1.1.

Figure 1.1 – Cracked boiler valve specimen showing major cracks radiating from the interior surface of the valve [2]

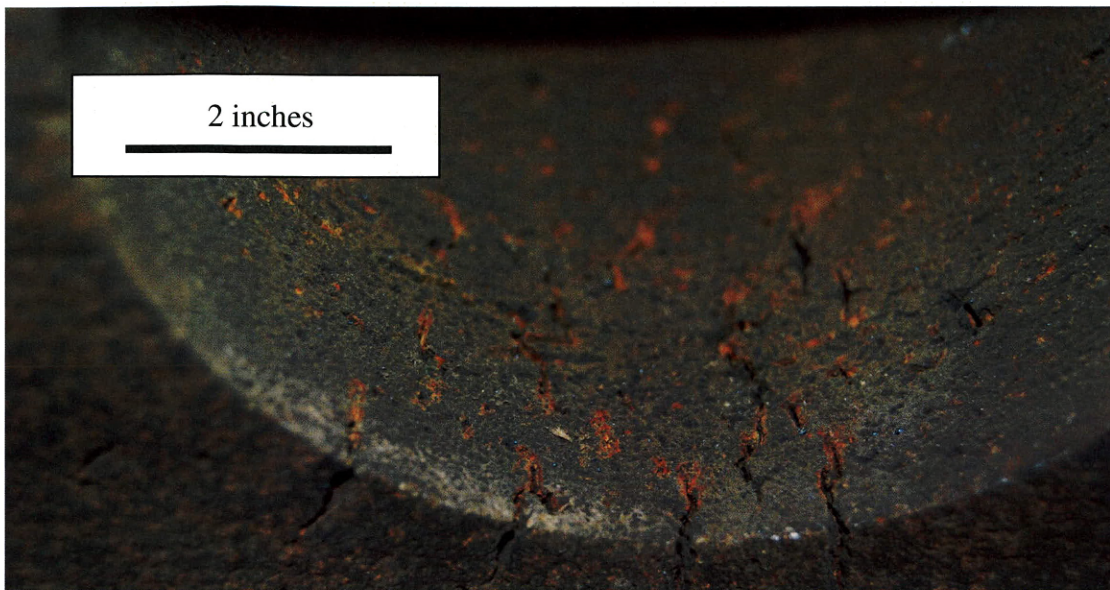
stress corrosion cracks such as those shown in Figure 1.2, which are not considered to be detrimental to the long-term life of the part. However, some of these cracks may continue to extend into the valve body turning into significant defects that must be repaired. Currently repairs are conducted using a welding process that requires the removal of the entire crack, filling the resulting cavity with weld metal, and stress relieving the entire valve. This repair procedure is highly costly due to the size of the parts involved and the complexity of the weld repair. In addition, the welding process can result in deformation in the boiler valve, which can be detrimental to proper function.

Figure 1.2 – Interior valve surface showing network of shallow cracks covering entire interior surface [2]

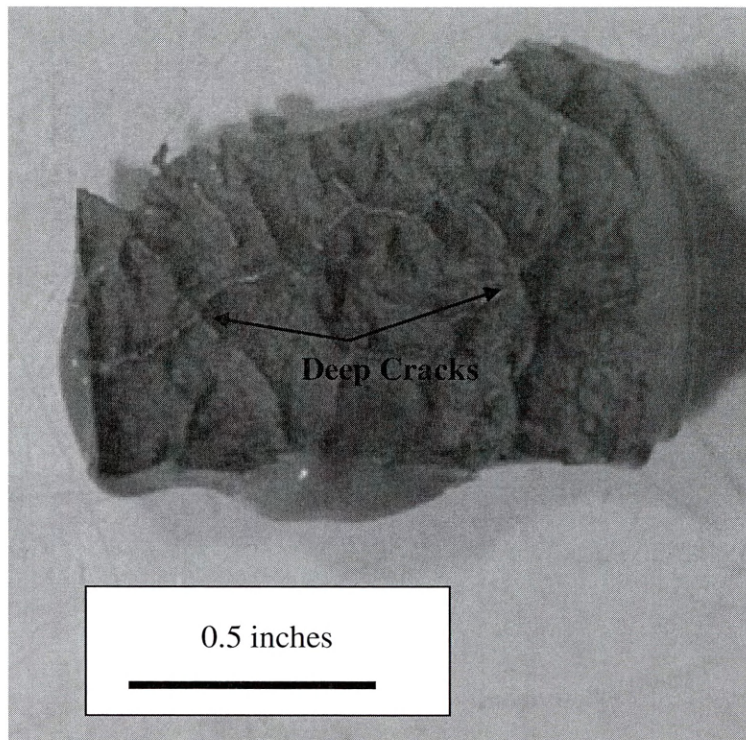
Figure 3.1 – Mikrosil™ cast of cracked surface photographed using oblique lighting. Cast shows complete flow to crack root over the extent of the sample. A number of deep cracks are also shown.

It became obvious that the network of cracks present on the valve surface was far more complex than was evident from surface examination. Even though it was not possible to conclusively determine the mechanism for crack formation from examination of the resulting cracks, some hypotheses regarding crack propagation patterns were established. Figures 3.3 and 3.4 show the interface between two adjacent cracks. The

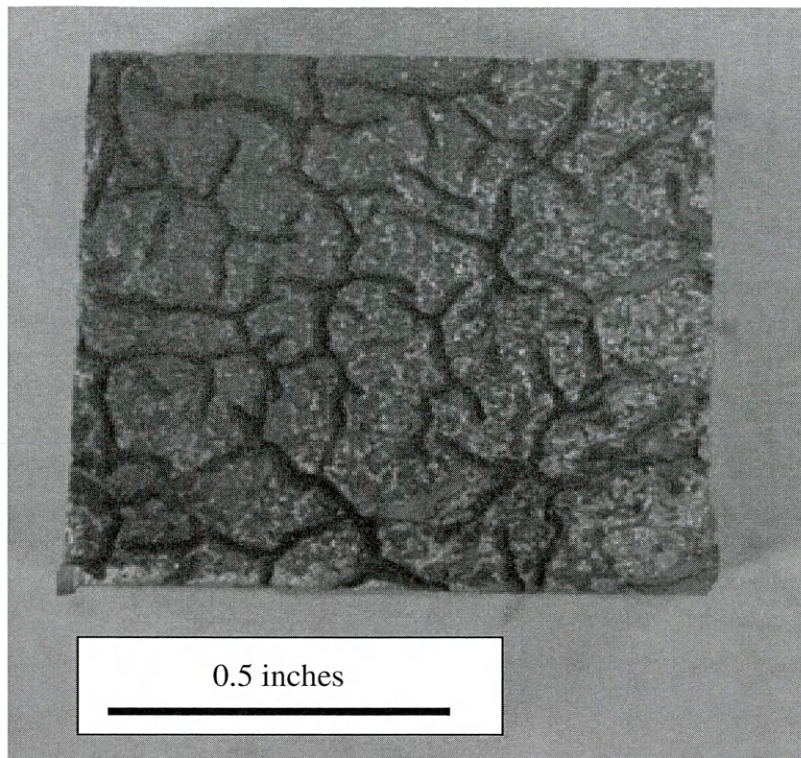
Figure 3.2 – Cracked boiler valve sample which corresponds to the Mikrosil™ cast shown in Figure 3.1.

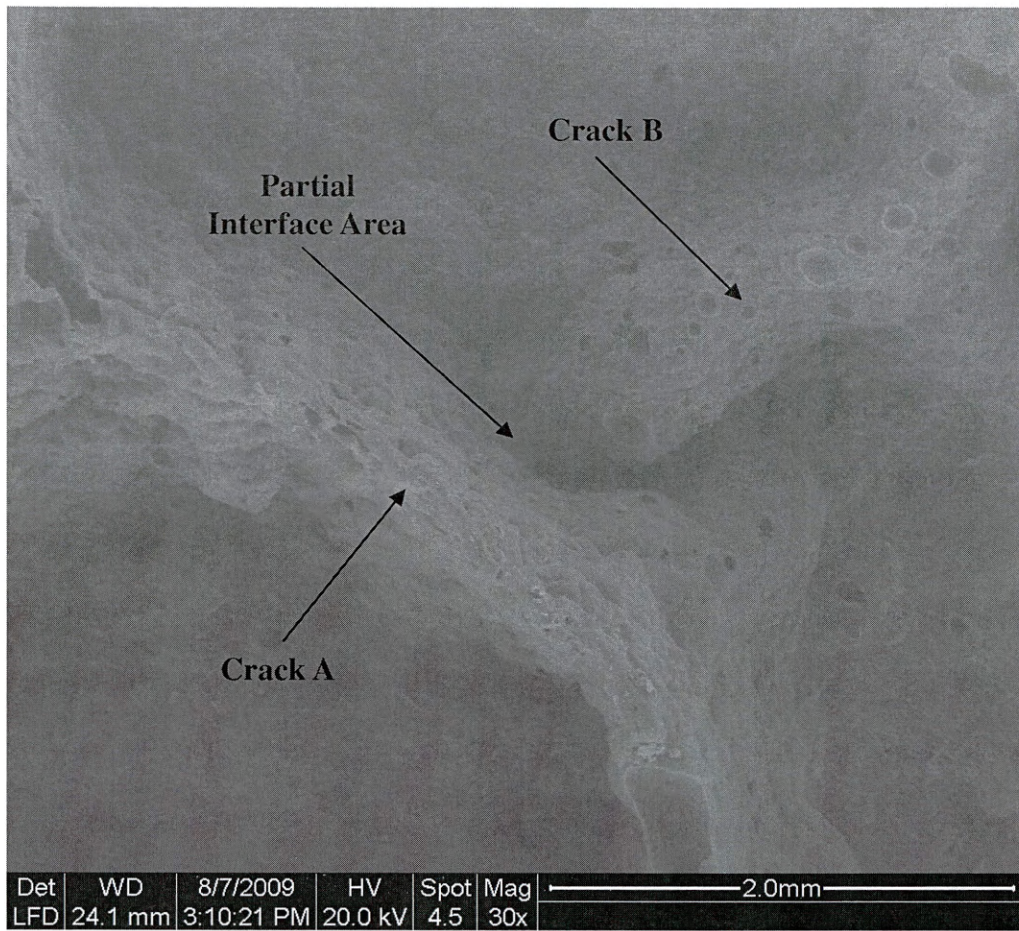
Figure 3.3 – SEM image of a Mikrosil™ crack cast. Two cracks are shown with a partial interface existing between the cracks.

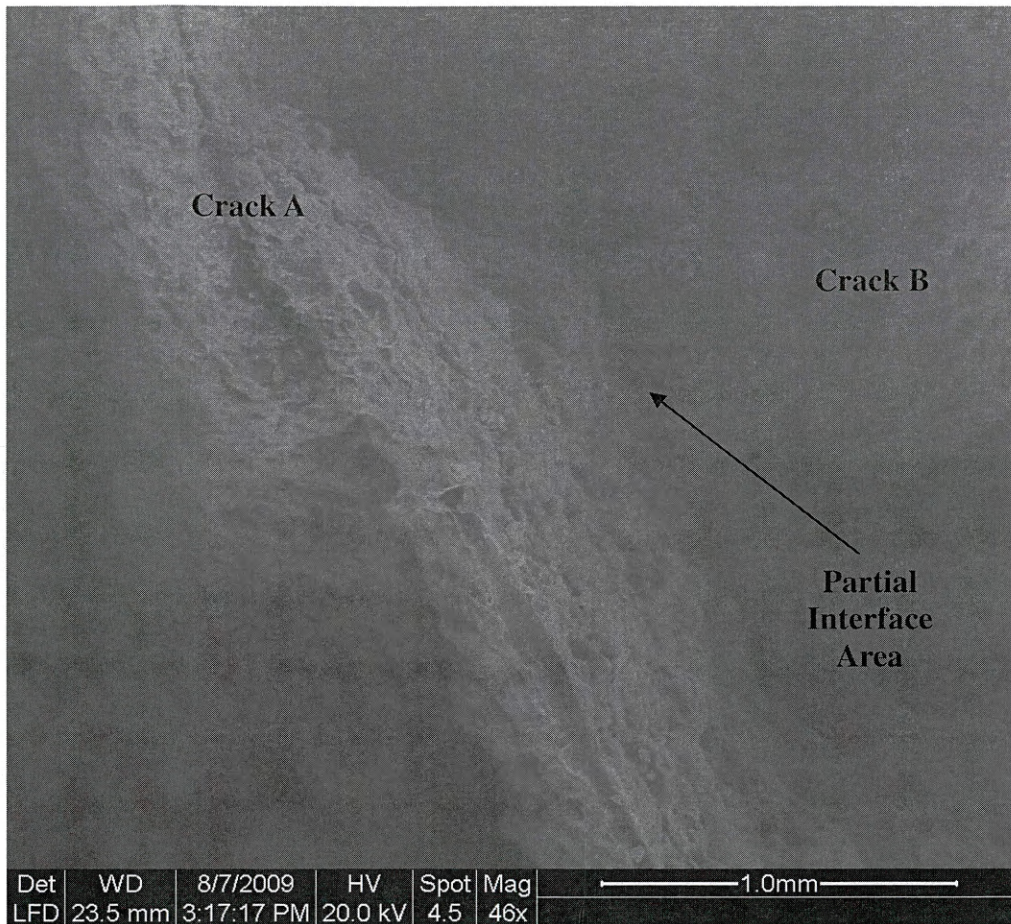
Figure 3.4 – SEM image of a Mikrosil™ crack cast. The cracks shown are the same cracks shown in Figure 3.3 at increased magnification and rotated slightly clockwise. Rough surfaces are those of resulting crack surfaces after cleaning and are not due to residual corrosion products within the cracks.

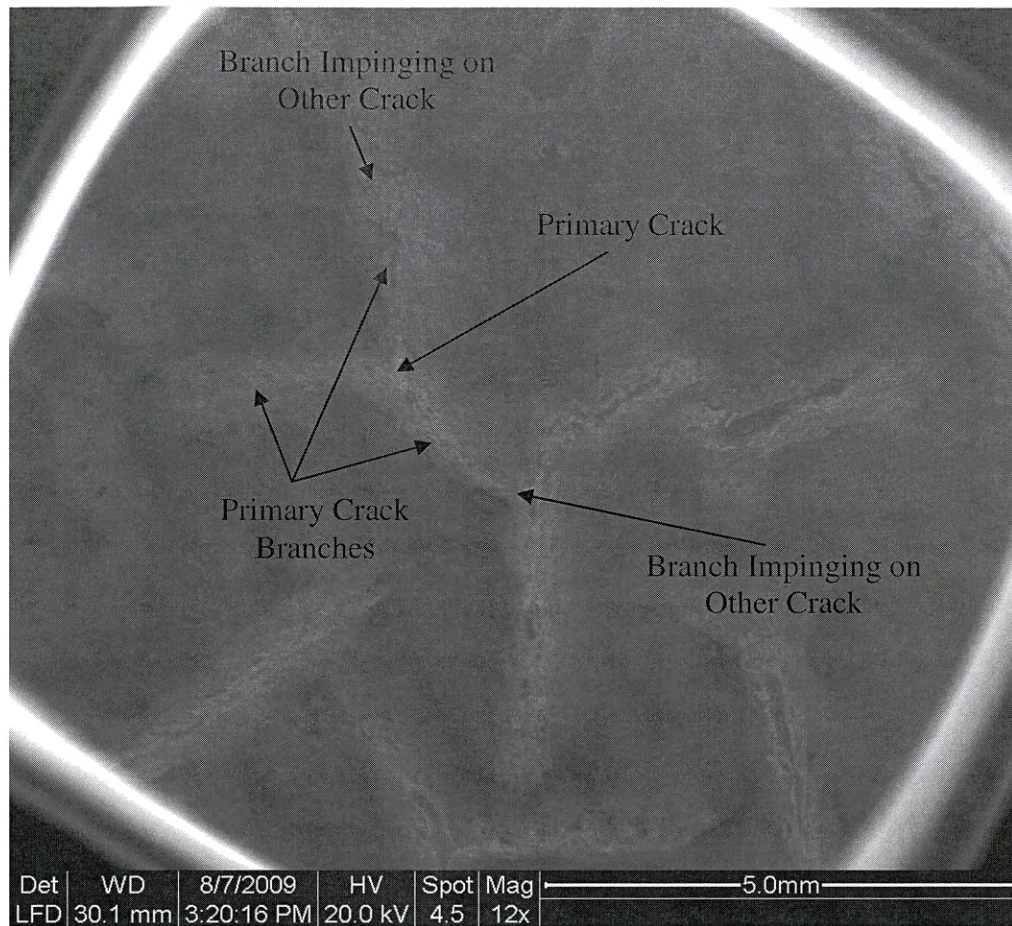
In addition to a network of independent singular cracks, some cracks have multiple branches. One such crack is shown in Figure 3.5. In these cases the areas where the cracks branch become wider and somewhat deeper than the crack segments that are strictly independent. Overall examination of the casts indicates that the majority of cracks intersect at the sample surface, however a relatively small fraction of them intersect at the crack root. The cracks do not appear to have a preferred orientation, which suggests that the flow of liquids or gases within the valve do not have a significant

Figure 3.5 – SEM image of a Mikrosil™ crack cast. The primary crack system shown has three branches which all join together at a single point. In addition two of the branches impinge on other cracks in the same way as illustrated in Figures 3.3 and 3.4.

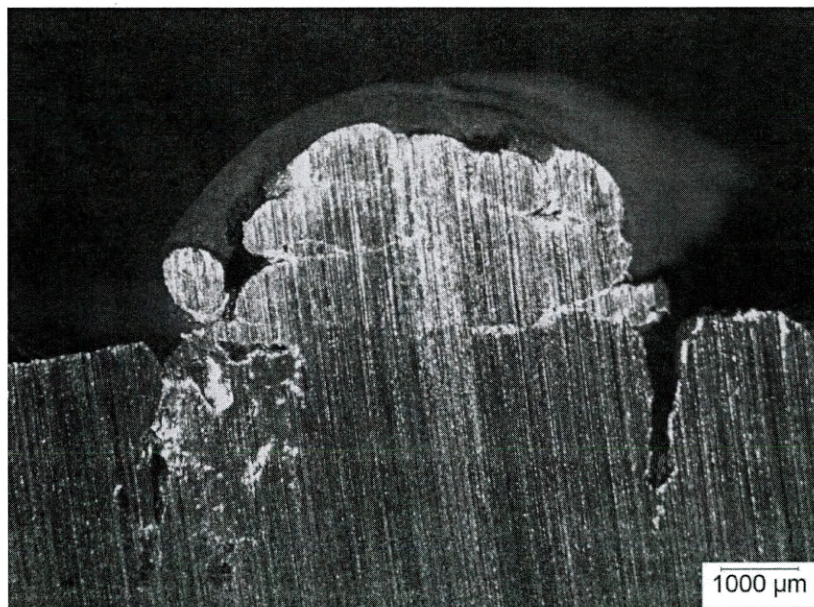
Figure 3.18 – Cross section of initial braze test using silver-based filler metal. Filler metal remains confined to its initial morphology on the surface of the sample.

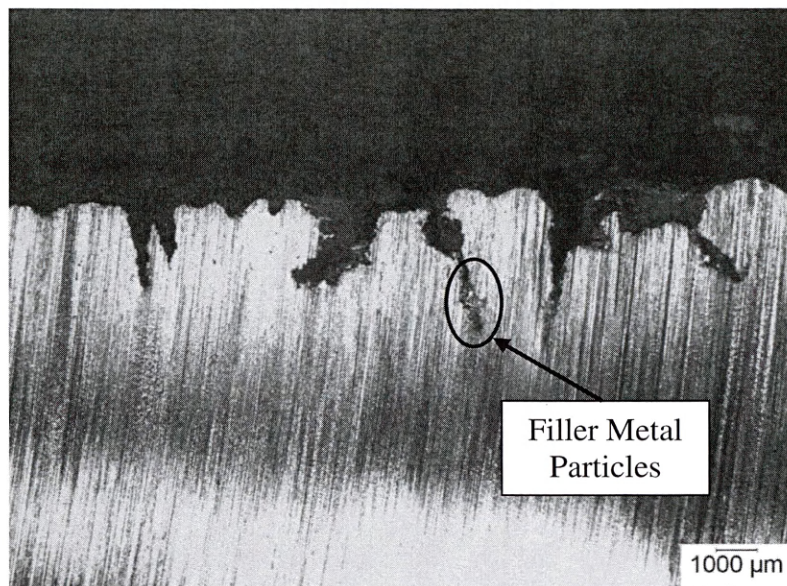
However, these particles did not consolidate into a solid filler metal. Some sintering was present which allowed for the filler metal particles to adhere to each other as well as to the cracked surface. The adhesion was significant enough to prevent easy manual separation of the particles. However the interaction was insufficient to provide consolidation between the particles.

Figure 3.19 – Initial brazing test using nickel-based filler metal. Particles of filler metal are present within cracks but are not consolidated.

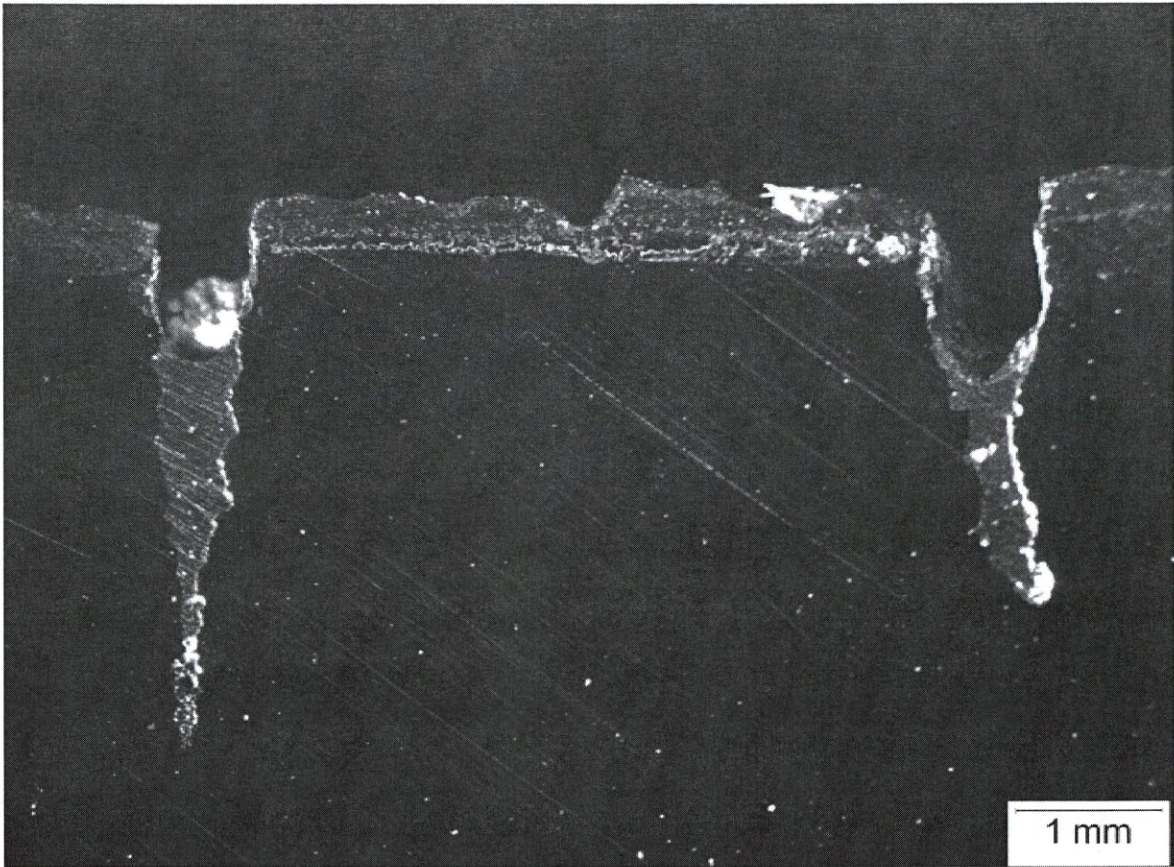
While the filler metal did flow deep within the cracks, in some cases it did not reach all of the way to the crack root. In all cases where the root was not filled a dark colored granular substance was observed filling the remainder of the crack root as

Figure 3.20 – Stereo optical image of brazed crack showing extent of flow as well as emptying at crack mouth.

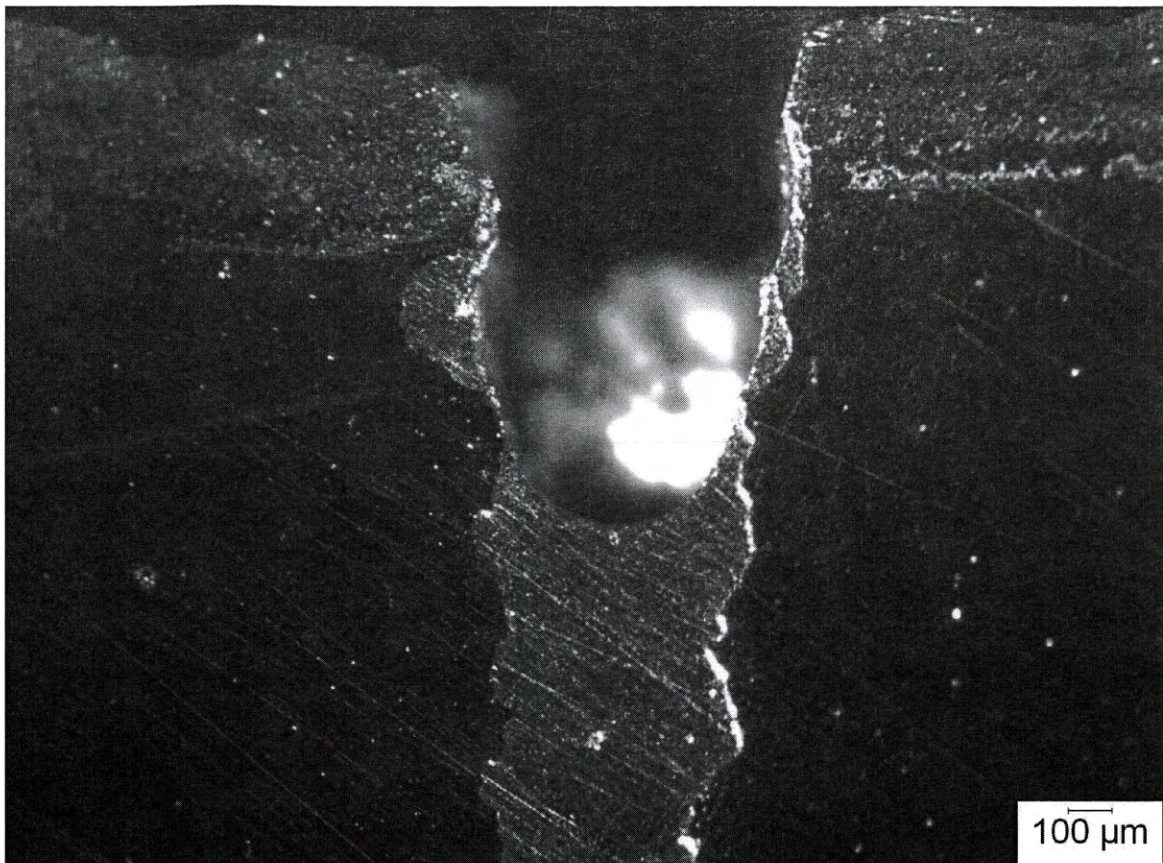
Figure 3.21 – Stereo optical image of brazed crack mouth. Filler metal layer is evident along crack edge illustrating the existence of filling and subsequent partial emptying of the crack.

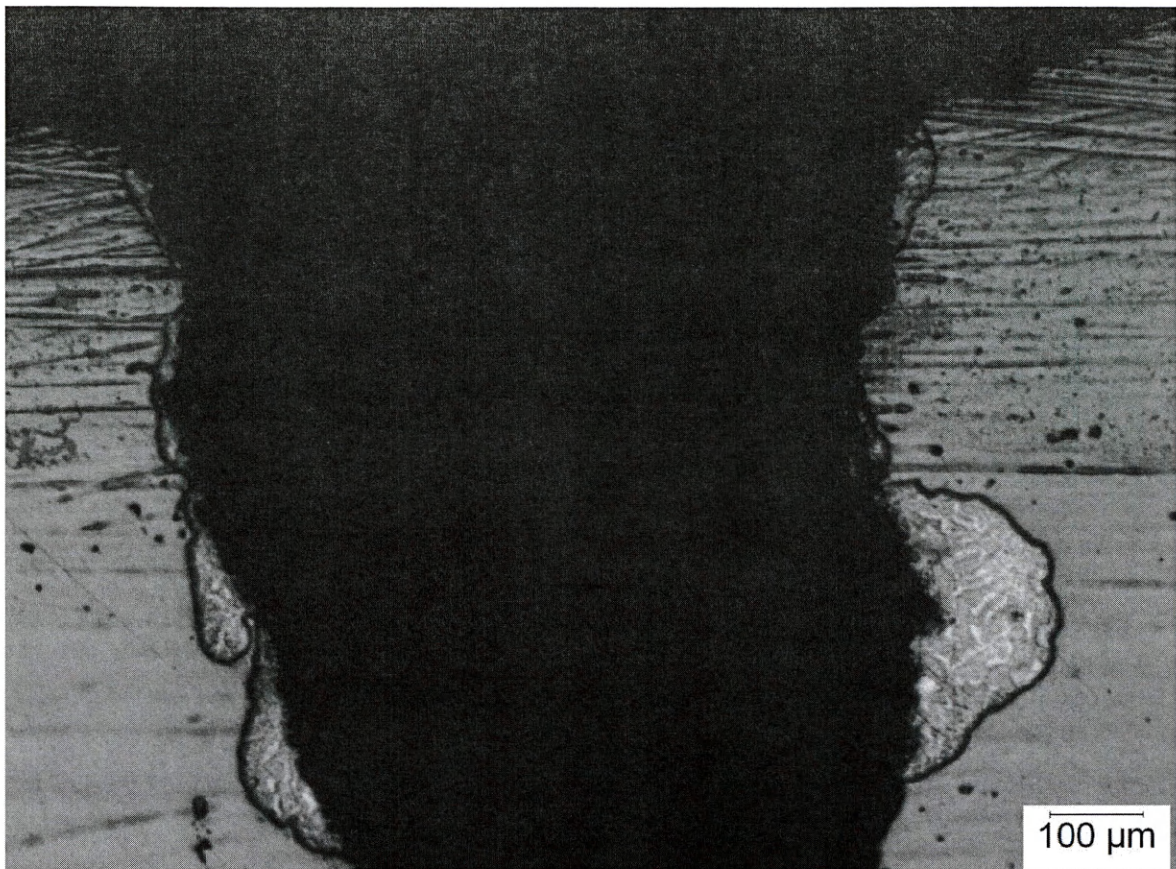
Figure 3.22 – Micrograph of brazed crack mouth. Remaining filler metal after partial emptying is evident in surface roughness on the crack surface.

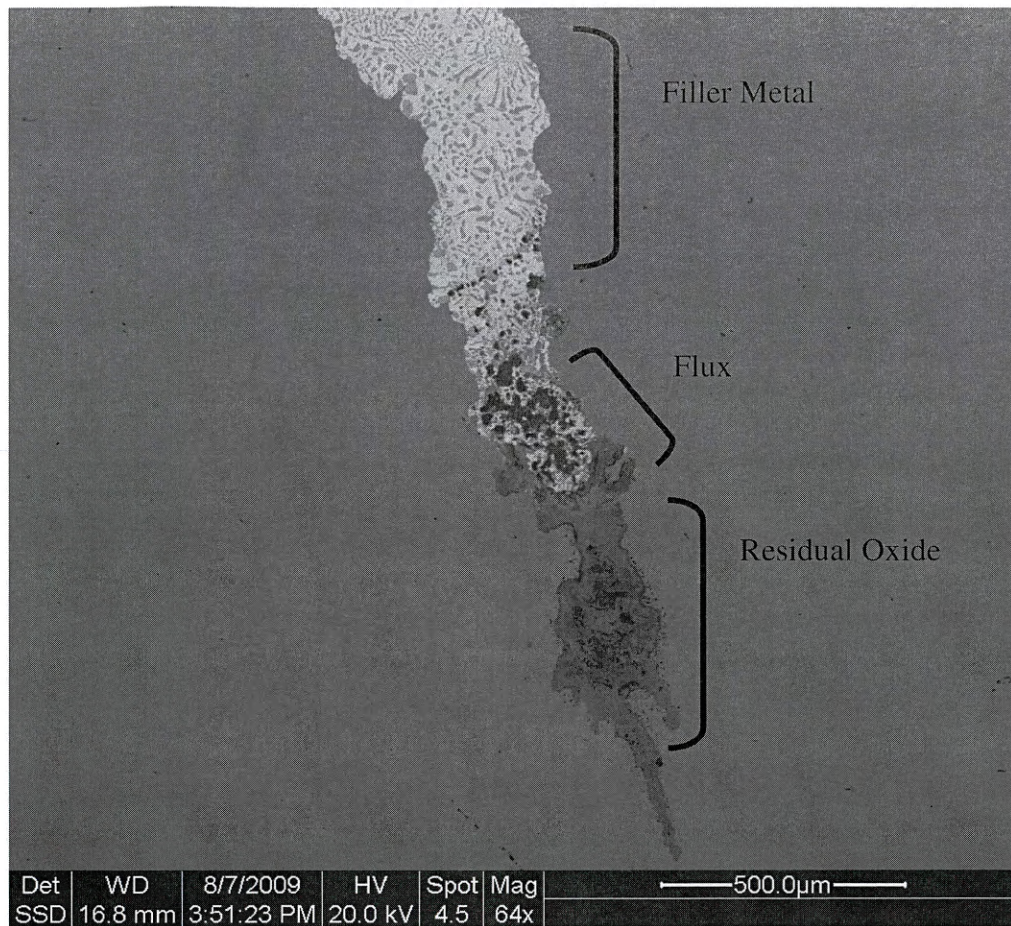
illustrated in Figure 3.23. SEM analysis identified this substance as a mix of iron oxides as well as a layer of brazing flux separating the filler metal and the iron oxides. The layer of flux was crystalline in surface appearance and exhibited some voids that had a crystalline appearance which can be seen in Figure 3.24. From the presence of these deposits it was determined that the cleaning procedure, while effective, was not able to remove 100 percent of the oxides from the cracks, particularly in the crack roots. The deepest cracks were more likely to exhibit this incomplete filling suggesting that the cleaning effectiveness is linked to crack depth and morphology.

Figure 3.23 – Backscatter SEM image of crack root showing residual flux layer and oxide deposits.

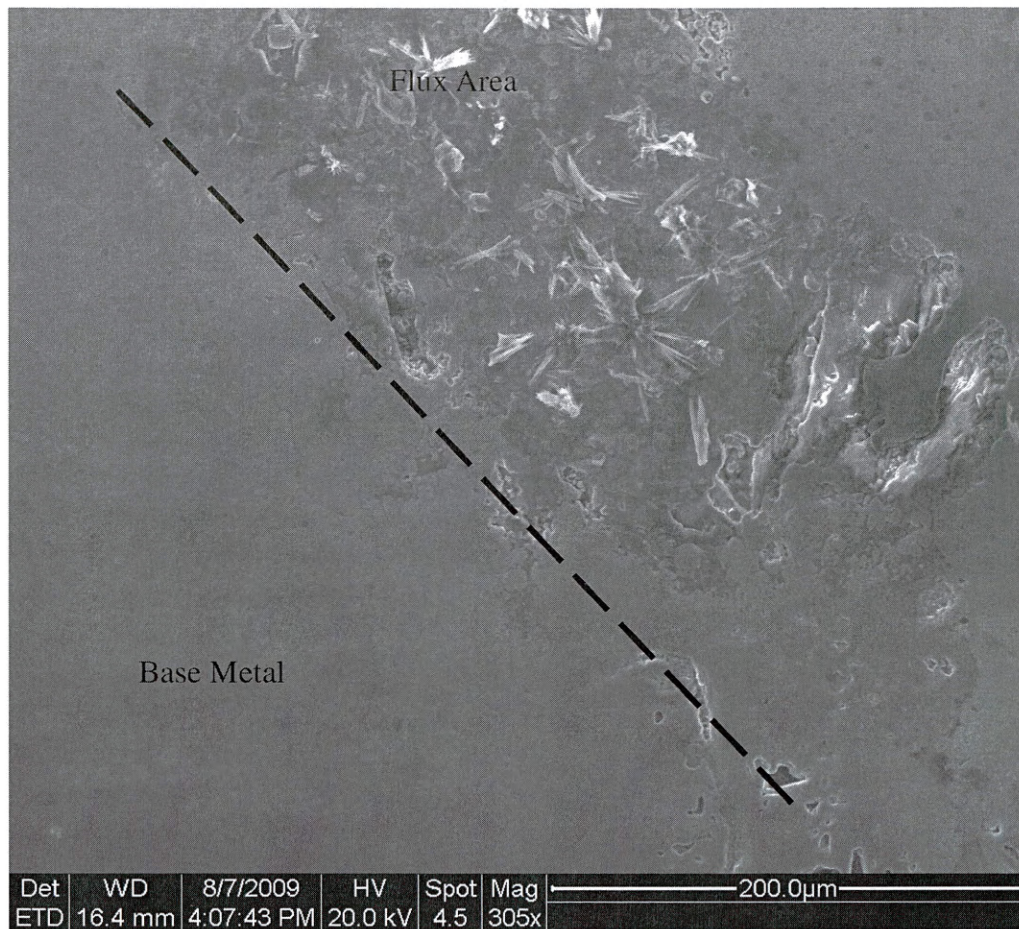
Figure 3.24 – Secondary electron SEM image showing the physical morphology of the residual flux in crack root.

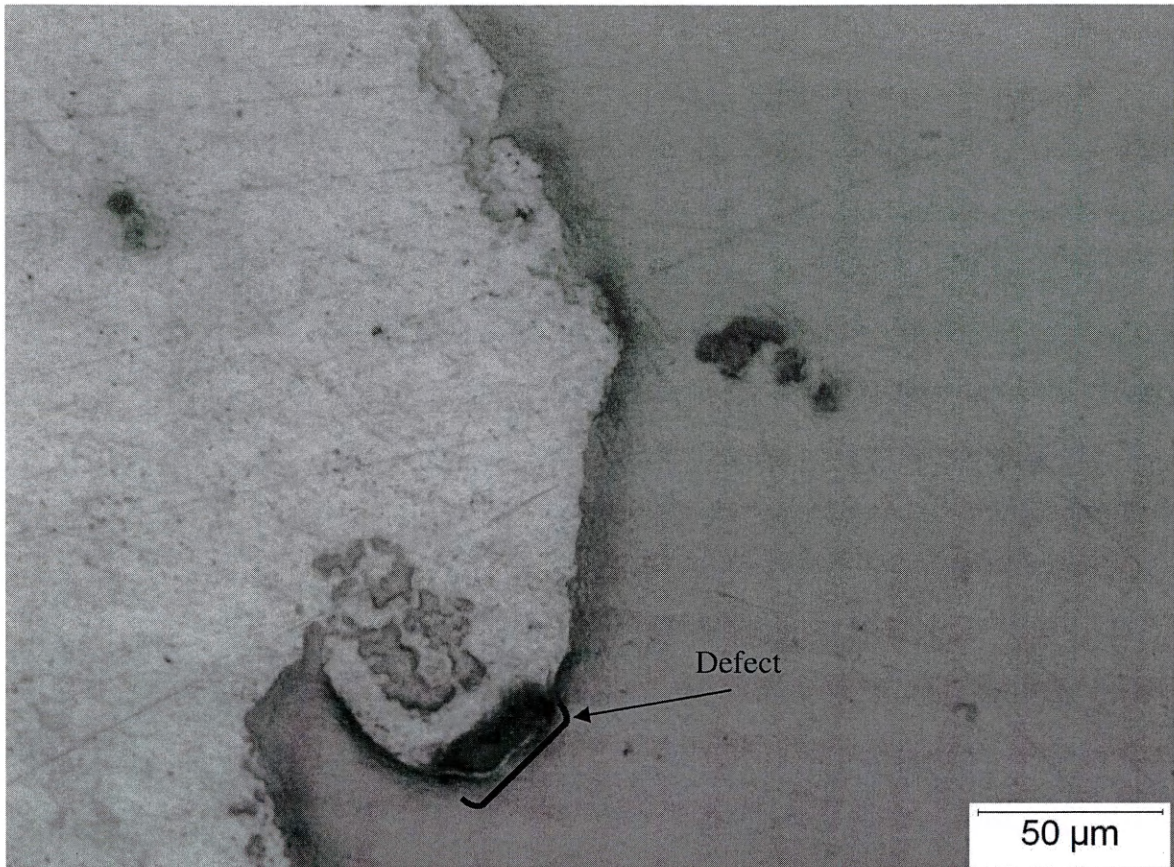
In cracks which had residual oxide deposits at the root, a greater concentration of defects was observed. These defects were limited to the areas of the crack near the residual oxide deposit. All discontinuities were observed in these areas and consisted of inclusions of oxide or flux trapped within the filler metal.

Figure 3.25 – Micrograph of brazed crack with discontinuity present. Discontinuity appears to be residual oxide trapped at the crack surface.
