ENGINEERING GEOLOGY OF THE BATTLE MOUNTAIN LANDSLIDE
SOUTH OF MINTURN, COLORADO

by
Brendan F. Shine

An engineering report submitted to the Faculty and the Board of Trustees of the Colorado School of Mines in partial fulfillment of the requirements for the degree of Master of Engineering (Geological Engineer)

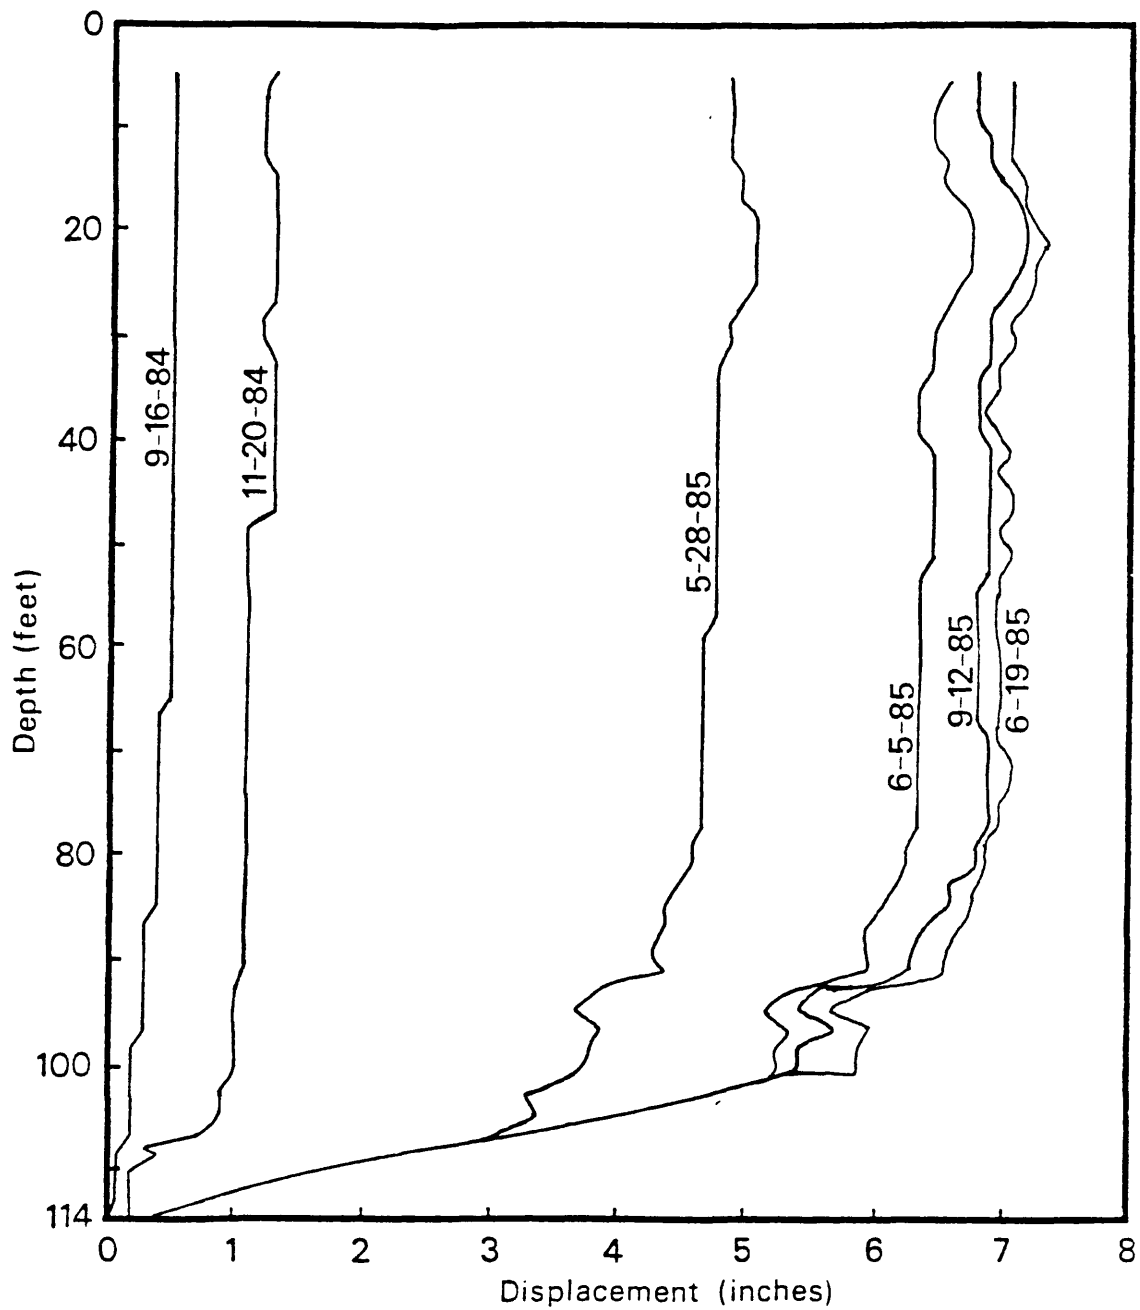
The inclinometer provided useful data concerning the location of failure surfaces at one location in the slide. The inclinometer data were processed using standard techniques and the results are shown in Figure . Several surfaces are evident at this location. The major failure surface is at a depth of 108 feet, but there are several other zones at depths of 95, 55, 38, and 20 feet. Near the surface, some rotational movement is indicated by the progressively decreasing displacements from about 20 feet of depth to the surface. In general, however, the movements at this location are largely translational. This is not unusual in the center of a large complex slide of this type.

Figure 8. Plot of movement from inclinometer data. Original readings were taken 9-9-84. Inclinometer casing sheared after 5-28-85; subsequent readings use the 5-28 data as a baseline.

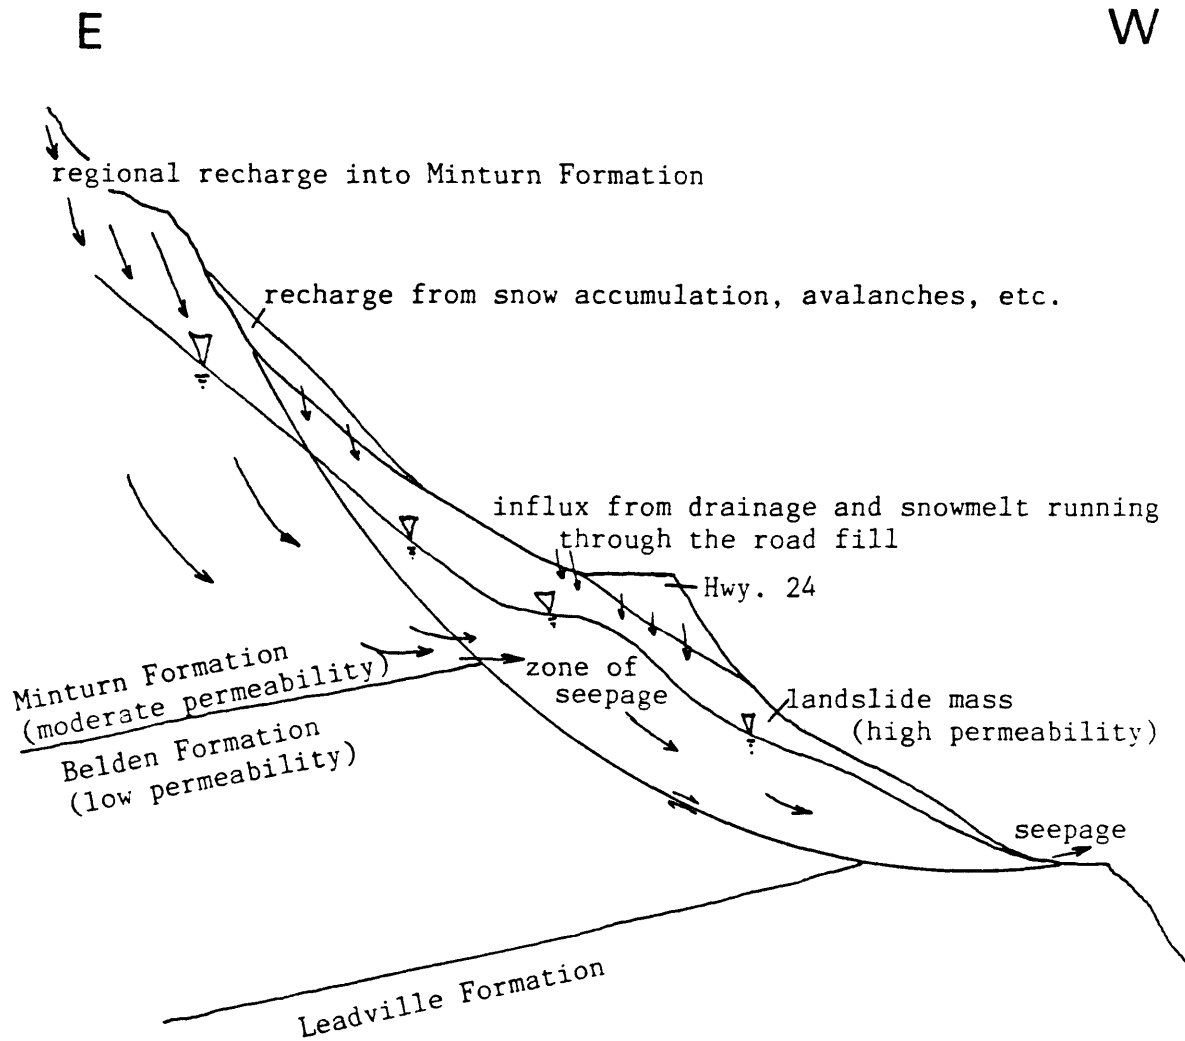
Figure 11. South-looking section of suspected hydrologic conditions existing in the slide.

Minturn, and the infiltration of large volumes of water from avalanche deposits on the upper portions of the slide, this subsurface seepage seems to cause a "mounding" of groundwater within the slide mass which can only drain by moving through the lower portion of the slide materials. Because the slide materials are more permeable than the Belden, the net result is a high level of saturation throughout the slide mass.

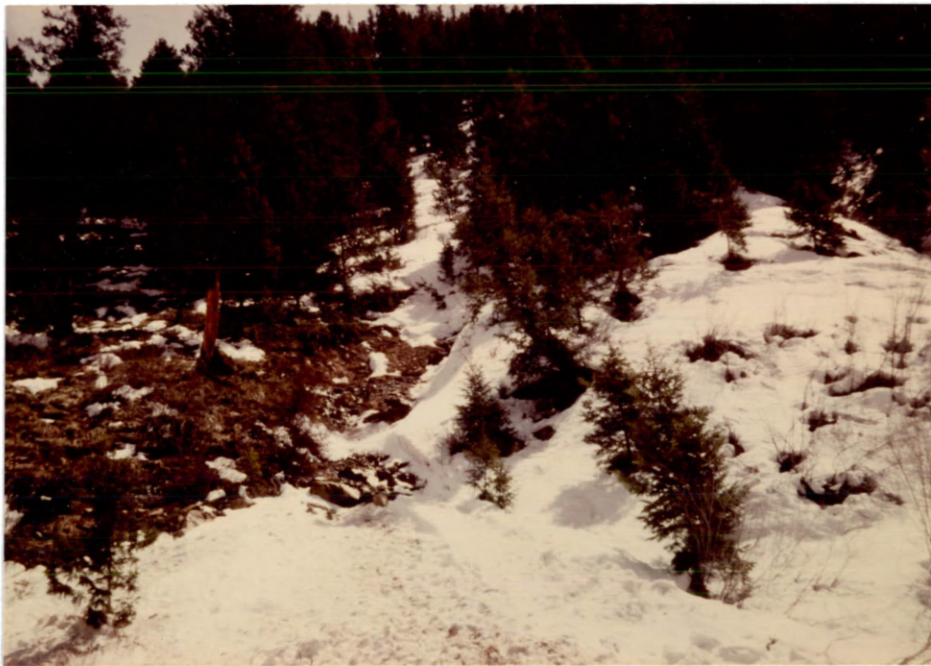
Figure 14. Drainage above TH-9 running directly into the slide. Note snow avalanche debris in the foreground.

per minute. Water flows down the channels above the left flank, then disappears into the slide mass when it reaches the left flank scarp. The location of these channels is shown in Plate 1. Flow into the slide was not measured because of unstable snow and difficulty in reaching the channels. Flow in these channels ceased as soon as all of the snow on the hillside had melted.

These channels also acted as snow avalanche chutes in the winter and early spring months. This avalanched snow is believed to be a major source of water infiltrating into the slide mass. The avalanche shown in figure 15 ran down the slide, crossed Highway 24, and ran out over the bank of the highway. Snow deposited along the uphill gravel shoulder of the highway also percolated into the slide. At TH-1, the sound of underground flowing water could be heard during spring thaw.

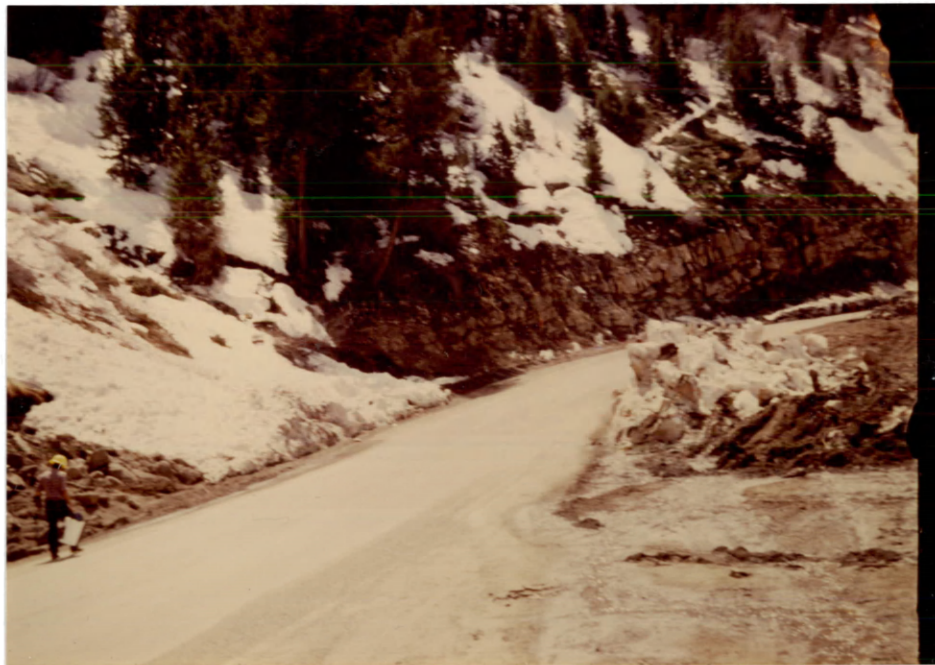
Figure 15. Remains of a snow avalanche that ran across Highway 24 near the south flank. Photograph taken April 16, 1985.

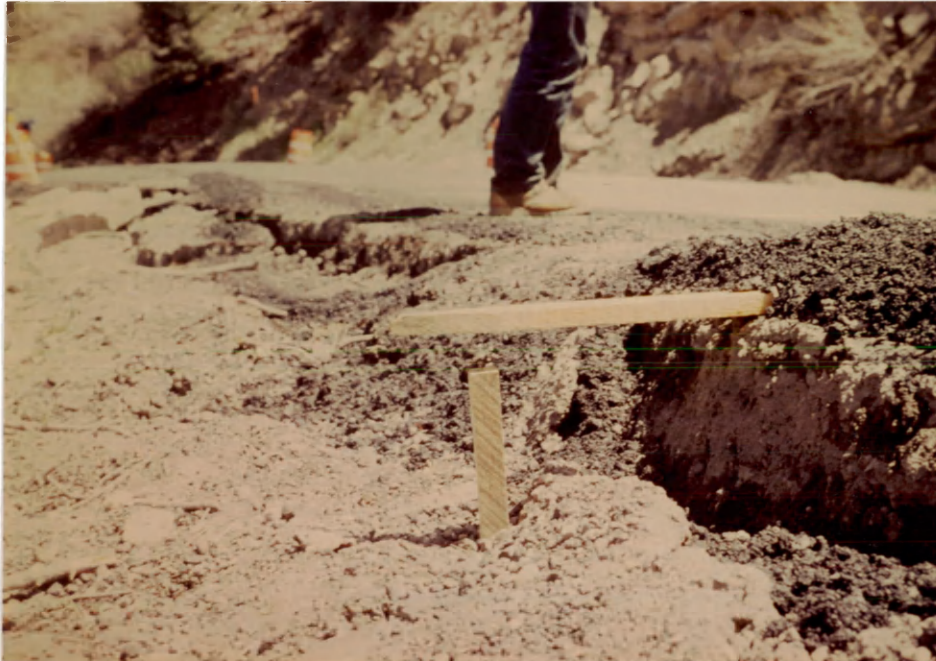
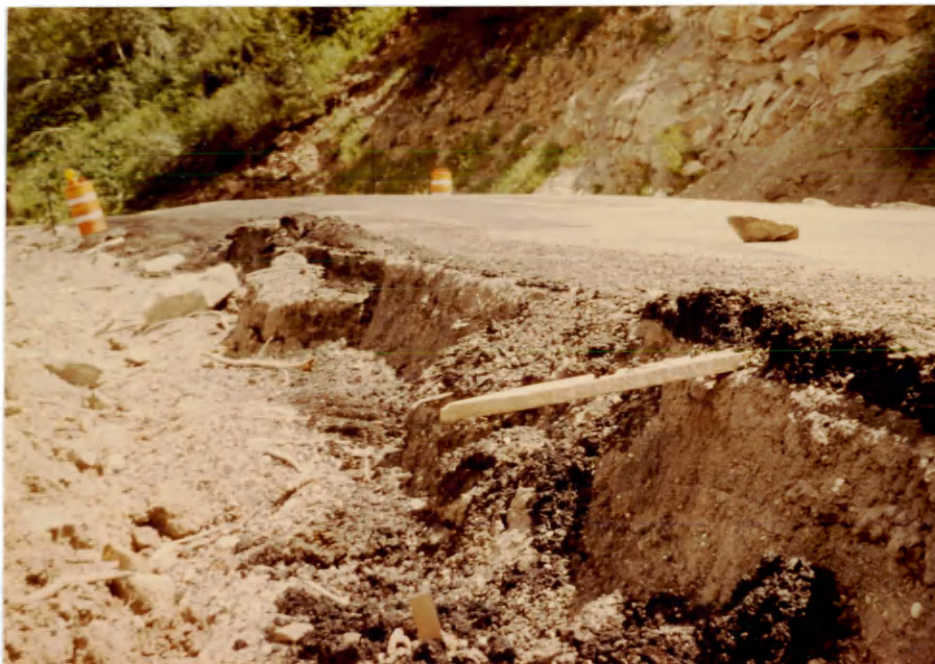
Figure 16. Before and after shots of a measurement point along the south lateral scarp on the highway. The top photo was taken May 14, 1985, and the bottom photo was taken July 31, 1985.

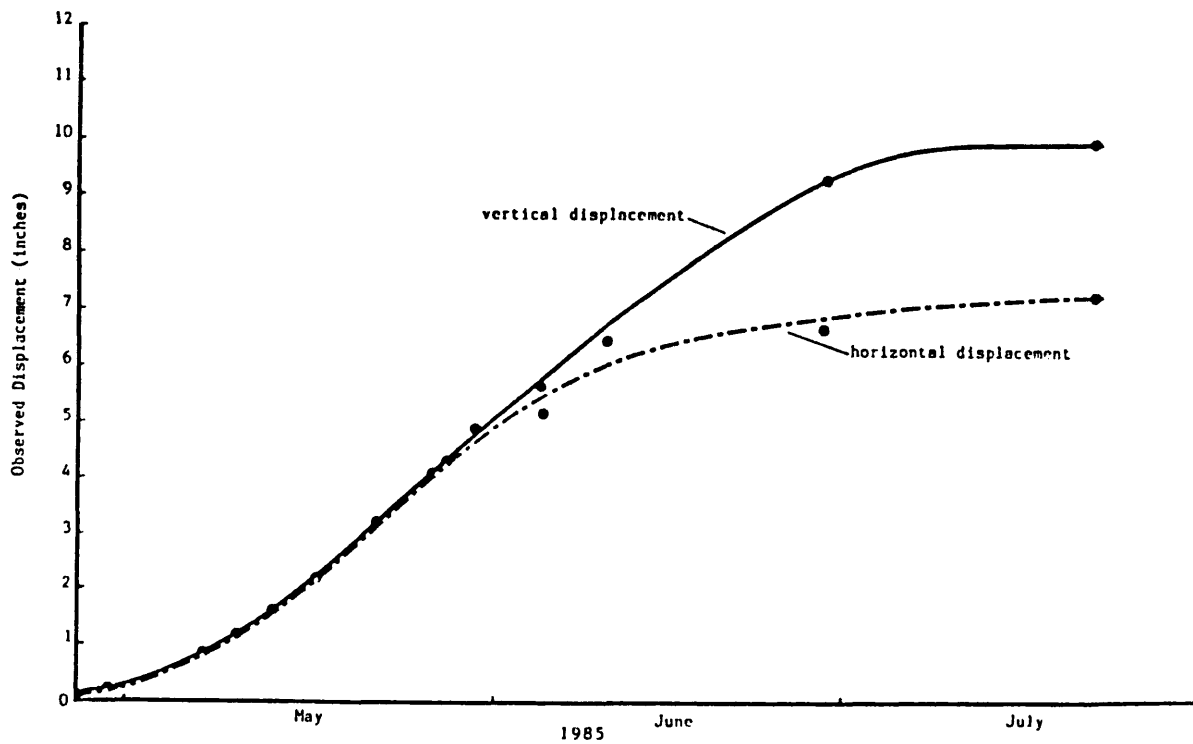
Figure 17. Observed displacement as a function of time at station located across the south lateral scarp, where it crosses Highway 24. Station was paved over and replaced on 5-13, 5-21, and 6-6

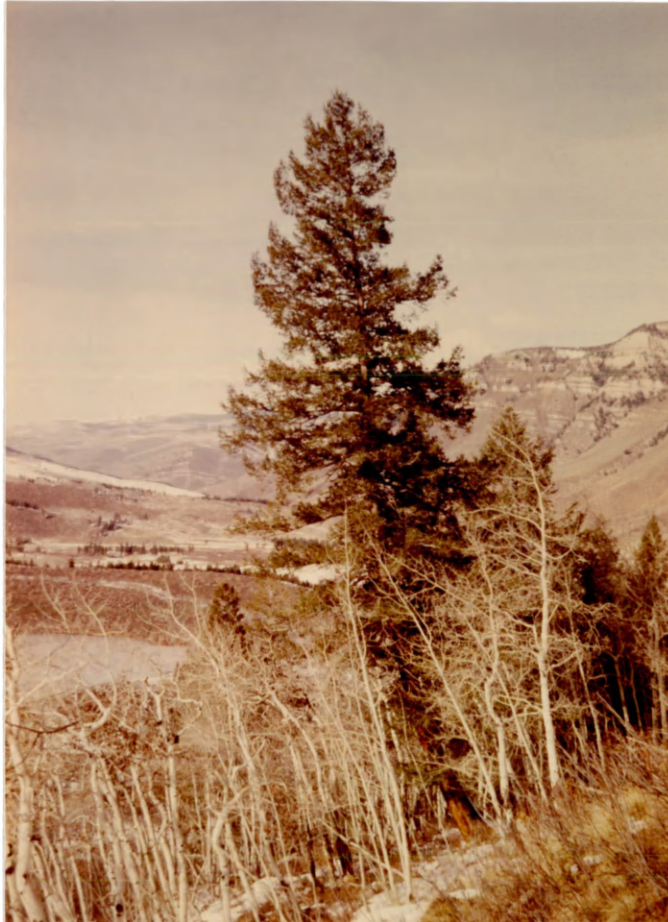
Numerous mature conifer trees are found in the slide area. Many are leaning or have curved trunks indicating direction and degree of movement (figure 18). Such trees were located on the base map and the directions of movement for each tree were recorded. These data were also

Figure 18. Looking north from the upper drill road at a distressed conifer, typical of the older trees found on the slide.

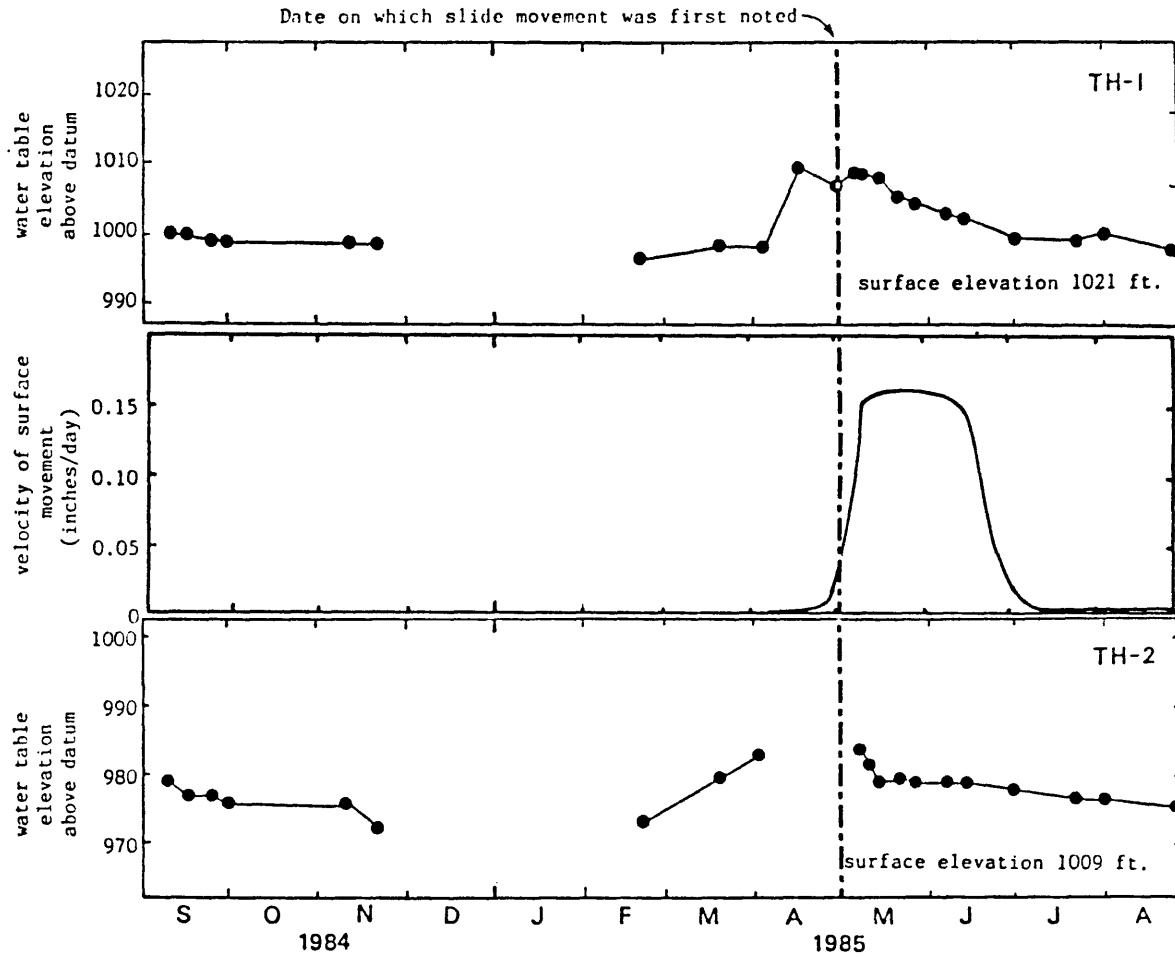
Figure 19 was constructed to demonstrate the effect that increases in the water table elevation have on slide movement. Movement data were taken from measurement points across the crack in Highway 24, near TH-1 (see figure 15 for photographs of the crack). No movement was observed on this crack until late April. From that time until August, movement was regularly monitored. Movement was converted into inches per day and compared with water levels in the adjacent observation wells, TH-1 and TH-2.

Figure 18 shows that movement lags behind rises in the water table. This suggests that once a threshold water level is reached, movement is initiated. After the water level

Figure 19. Comparison of water table elevations vs. slide movement. Slide velocity data taken from south lateral scarp movement, across crack in Highway 24, immediately adjacent to TH-1.

drops, loss in soil strength and internal structural changes allow the slide to continue to fail. Finally, when water levels drop sufficiently to stabilize the slide, movement abruptly decreases.

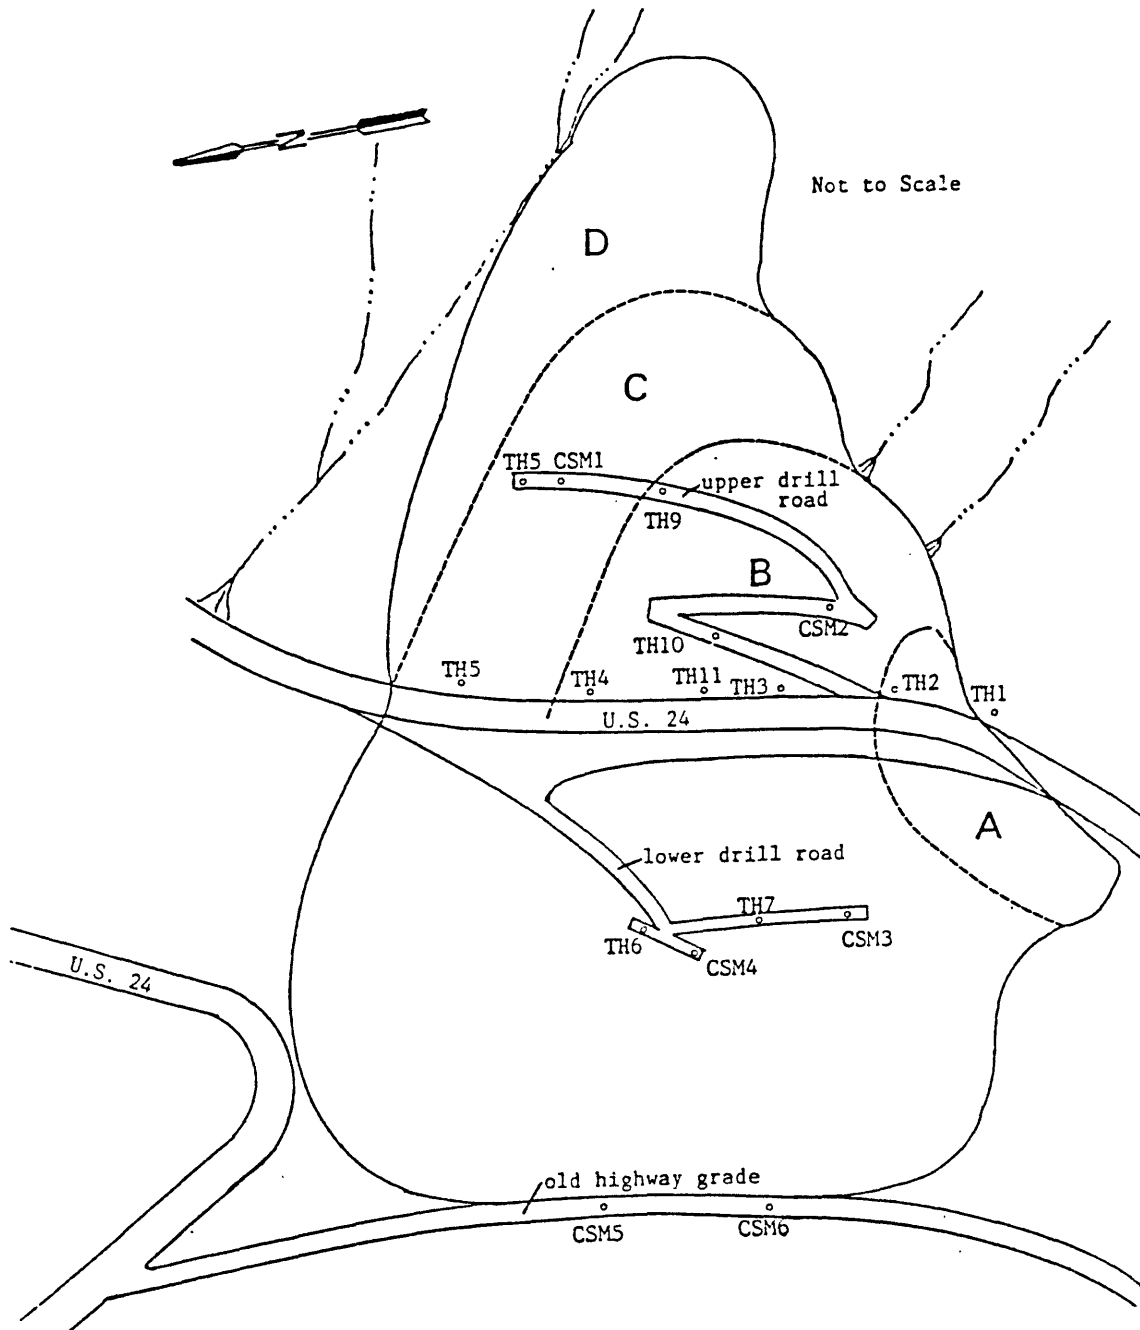
Figure 20. Major zones of movement.

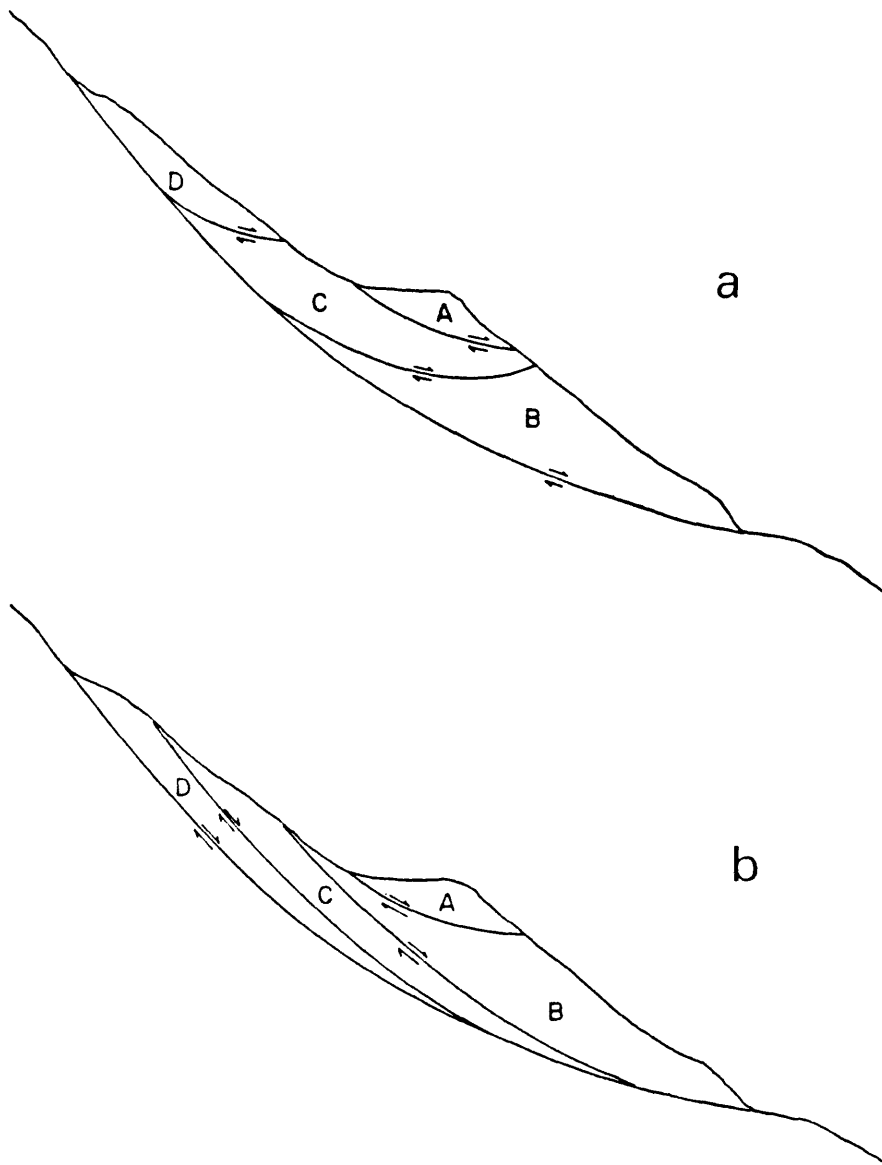
Two possible alternatives for such superimposed failure zones are shown in figure 21a and b. In the situation represented by figure 21a, movement first occurs at the head of the slide with failure occurring in the upper zone. This loads the next lower zone which fails in turn. Thus, the movement progresses down the slide in an incremental fashion.

The situation shown in figure 21b fails in a different manner. Failure begins in the lower portion of the slide,

Figure 21. Cross section showing two possible modes of failure.

not necessarily right at the toe, but perhaps as a more generalized remobilization of the lower part of the slide mass. This could be caused by saturation. As this lower portion moves, the upper portions become unsupported and fail in turn. In this situation the failure retrogresses up the slide.

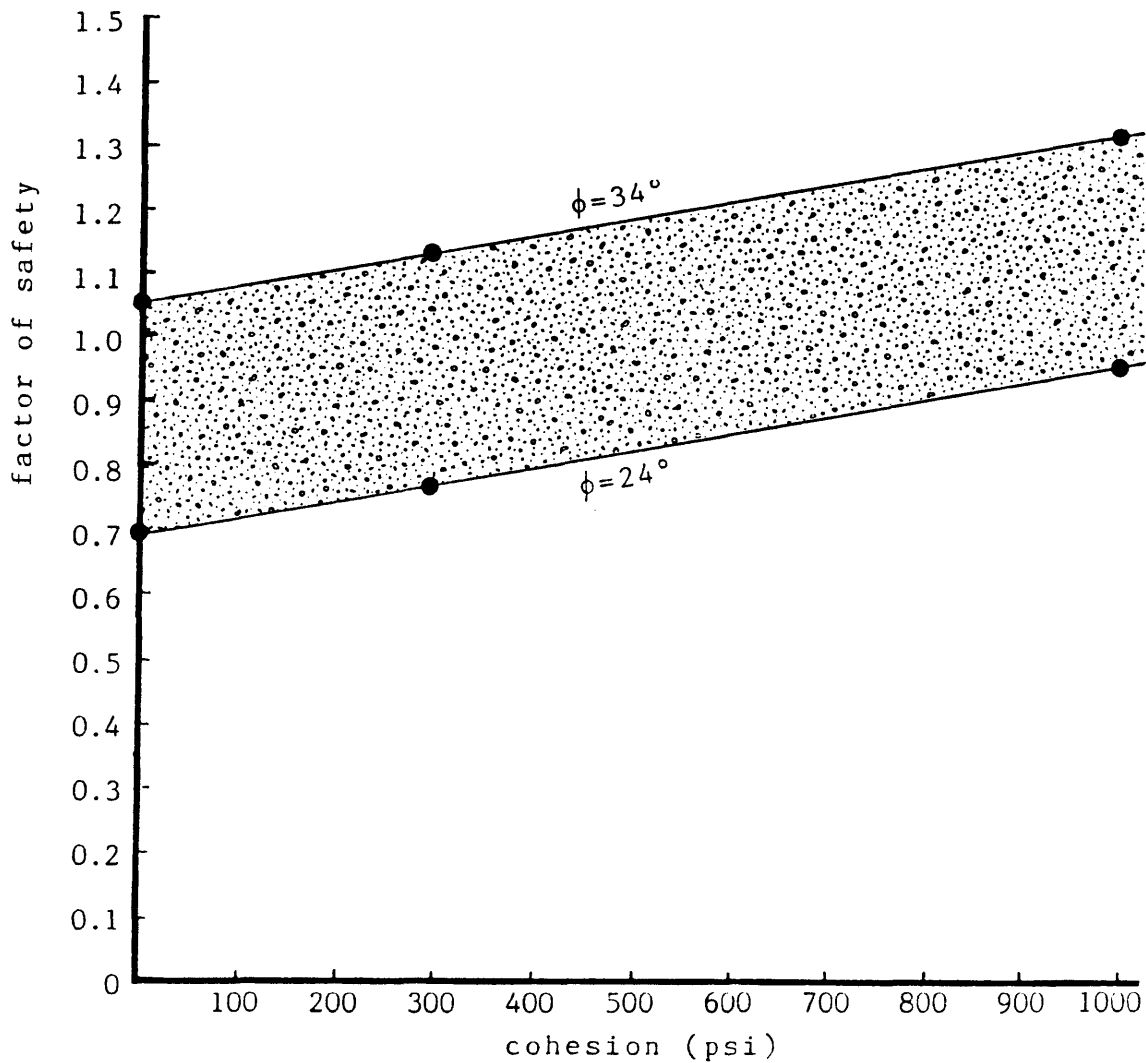
Figure 22 shows the relationship between cohesion and the factor of safety for various angles of friction. The shaded zone shows the area between the angles of friction of 24° and 34° . The limits of this area (cohesion of zero to 1000 psi and angles of friction of 24° to 34°) encompasses all likely subsurface conditions. The change in factor of safety, represented by the height of this area, as the angle of friction varies from 24° to 34° , is much greater than the change in factor of safety as cohesion varies from zero to 1000 psi. Therefore, these analyses show that the angle of friction is the most critical soil parameter in

Figure 22. Sensitivity analysis of soil strength vs. factor of safety. Factor of safety is more sensitive to changes in friction angle than cohesion. Stippled area includes conditions likely to be found in the failure zone.

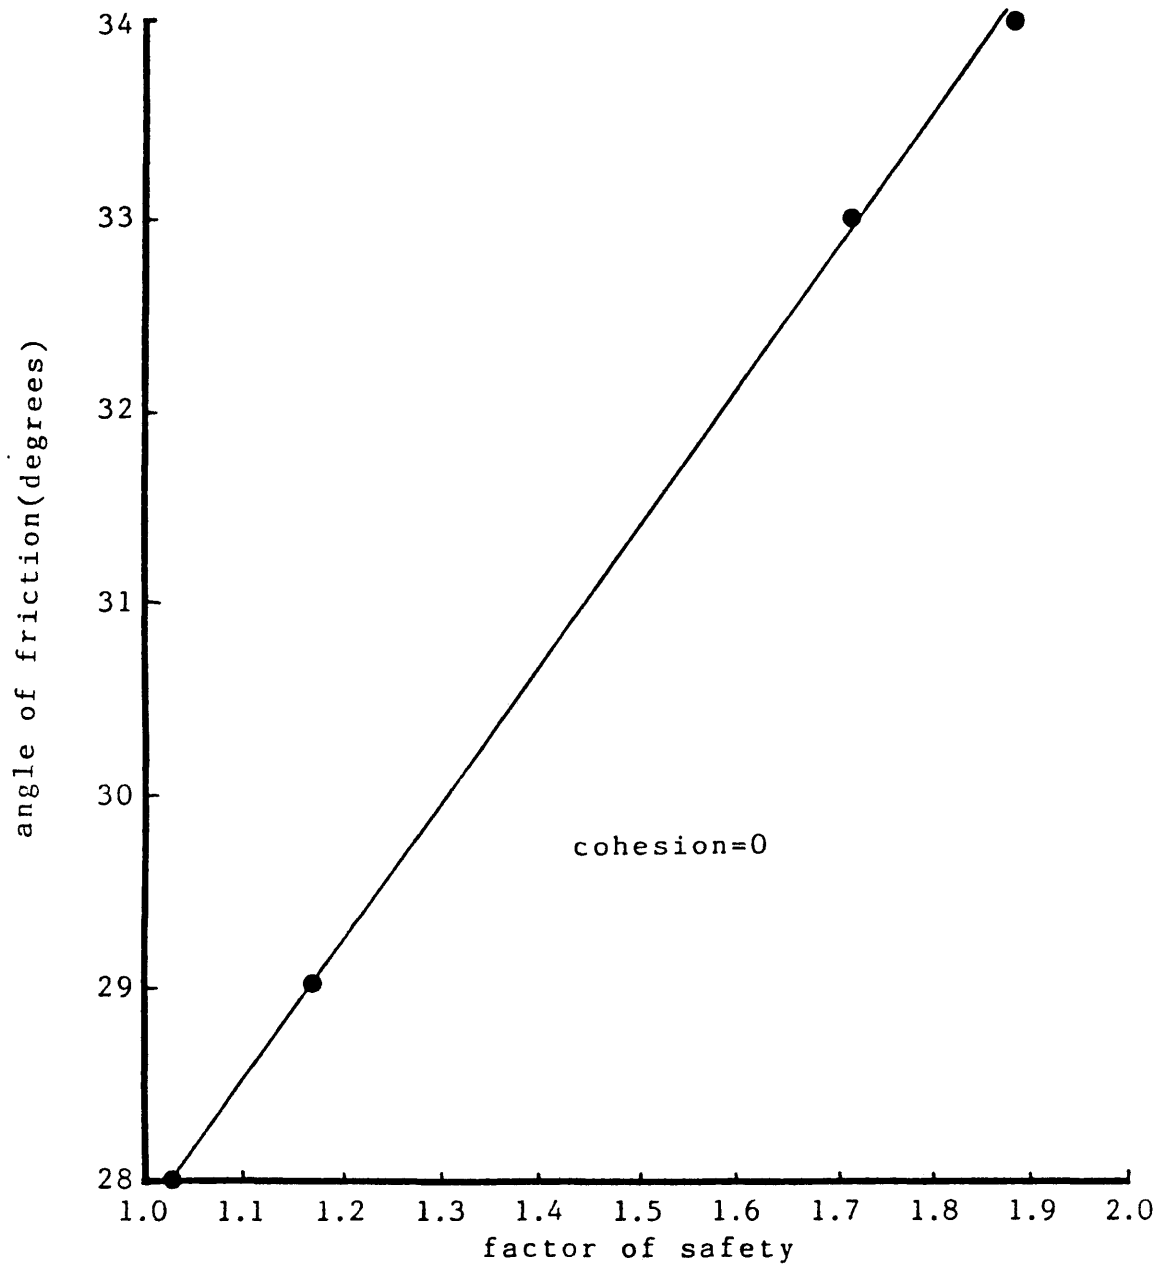
Run	Friction Angle (degrees)	Factor of Safety
1	34	1.884
2	33	1.716
3	29	1.171
4	28	1.028

Figure 23. Plot of factor of safety vs. angle of friction for road fill stability analysis.
