The Importance of the Visual Inspection for Ropeway Ropes

George A. Kopanakis
Control Body ICRS

The “Schilthorn” Incident

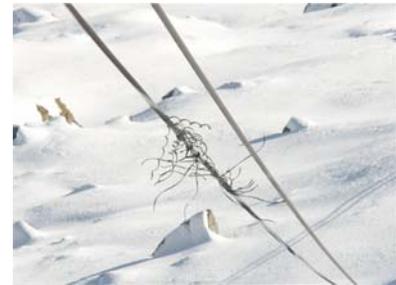
On December 29th, 2004, at approx. 1:44 PM, cabin no. 3 of the Mürren-Birg aerial tramway was situated, on its upward journey, just below Birg top station when a loud “metallic” noise was suddenly heard. The inspection that was carried out immediately afterwards revealed that all the outer wires on rope B were broken. The tramway was immediately taken out of service and the passengers were evacuated by helicopter; nobody was injured.

The metallic cross-section of the broken outer wire layer corresponded, on these older rope designs, to approx. 55% of the entire metallic cross-section. In addition to that, it is important at this point to underline the fact that the core of the rope apparently remaining undamaged became unlayered because of the lack of the outer layer and the ensuing loss of torque balance resulted in an unequal load distribution among the remaining wires. For this reason, it may be presumed that the remaining safety factor was not significantly higher than 1.

Fig. 1: View of the damaged

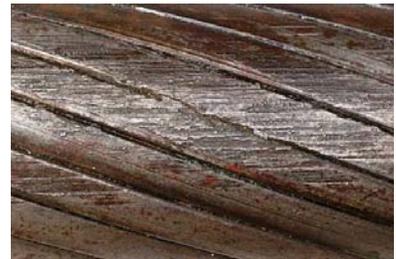
Signs of galling, abrasion and corrosion were found on the rope surface along the damaged section of rope. The material (steel) which had been deposited on the rope surface during the process of galling originated from the deflection saddle of the rope at the top station. The rope section which was found to be damaged after the incident was bent exactly over this deflection saddle in the top station during the first 14 years of operation.

Fig. 2: Damaged area with signs of galling

During the first relocation procedure -14 years after the opening of the system and 26 years before the incident- the rope slipped abruptly over the deflection saddle under great surface pressure. During this process both the rope, as well as the groove of the deflection saddle, were mechanically damaged. The decisive factor leading to the spontaneous breaking of the entire outer wire layer was, in the final analysis, the hydrogen induced stress corrosion cracking “HISCC” detected along the area of the above-mentioned damage, which led to brittleness of the material and to micro cracks.

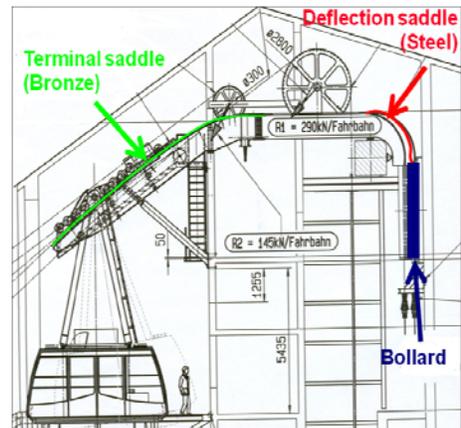
Fig. 3: Rope area bent over the deflection saddle (red)

- Design / Production deficiencies
 - The material of the deflection saddle, or, the combination of the material of the rope and that of the saddle adversely influenced the sliding properties of the rope over the saddle
 - The ratio $R/d \sim 50$ (instead of 65 as stipulated in the current EN standards), resulting in a higher pressure between the rope and the saddle
 - The fact that the groove radius was greater than the rope radius resulted in a higher pressure between the rope and the saddle
