SLOPE STABILITY ANALYSIS
OF THE
WOLCOTT LANDSLIDE
EAGLE COUNTY, COLORADO

By
Khalil Nasser

An engineering report submitted to the faculty and the Board of Trustees of the Colorado School of Mines in partial fulfillment of the requirements for the degree of Master of Engineering (Geological Engineer).

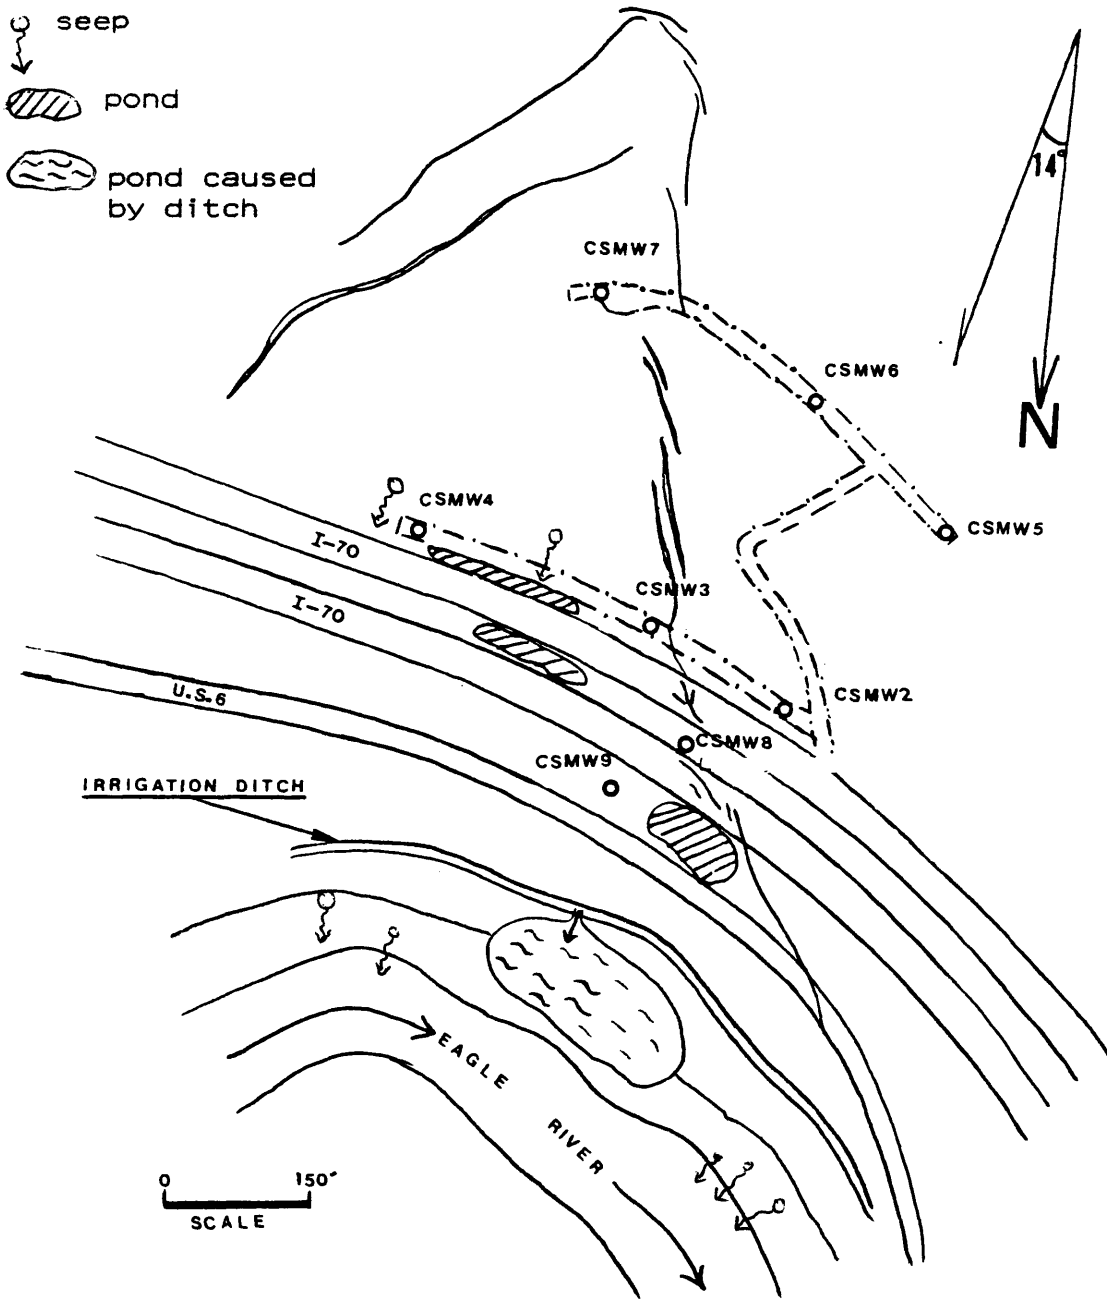
Standing water was observed at different locations early in the month of May. Ponds were observed along the southern edge of I-70 near the seepage area at CSMW4 and in the I-70 median. These ponds were probably associated with the malfunctioning of the French drain installed between CSMW4 and culvert C-1 (see Plate 1). In fact, water seeping out of the slide material was not carried by the French drain to culvert C-1; rather, culvert C-1 remained dry and the seepage was recharged into the slide material, locally raising the potentiometric surface.

Ponding was also observed near the toe of the landslide. This pond started in May 9, 1985 because the irrigation ditch passing above the toe was distorted due to the slide movement and began leaking water. This water recharged locally and probably triggered the renewed movement near the toe of the slide that migrated up to Interstate-70 by the end of May. This later movement cycle is believed to be the result of the ditch ponding, since the overall movement of the landslide had stopped by that time. The pond disappeared by May 22, 1985 when the water level in the ditch was lowered by highway department personnel and the ditch fixed temporarily. The pond and seep locations are shown in Figure 10.

Figure 10 : Pond and Seep Areas at the Slide Mass.

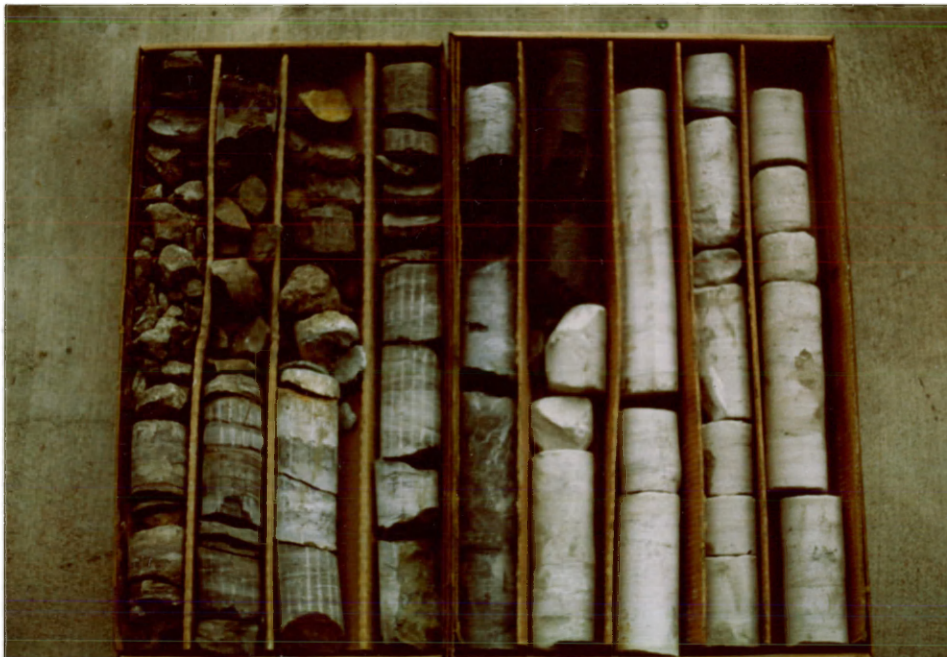
Two gouge zones were observed in the cores recovered from CSMW3 and CSMW9, (Figure 14). As discussed later, these apparently correlate with two clay rich zones which are respectively located at 8 and 18 feet above the base of the Benton formation when observed in an outcrop at half a mile to the west of the slide. They also occur at depths averaging 12 feet and 20 feet in the landslide. When the "deadman" probe was used in the piezometers, it indicated shearing at an average depth of 14 feet,(Figure 15), this appears to correlate with the shallower gouge zone identified in the cores.

Figure 14 : Core Samples Obtained at the Site.

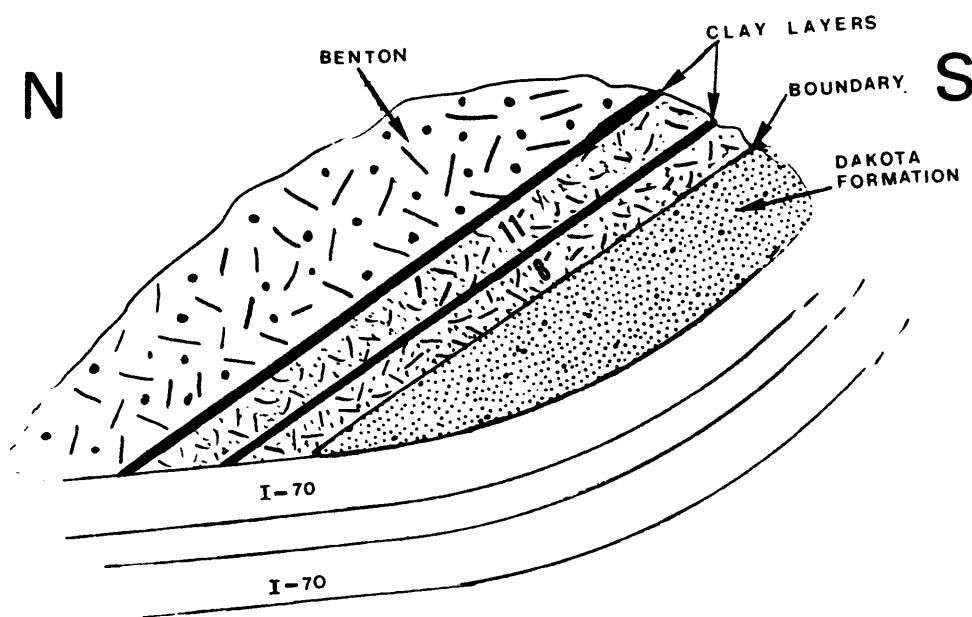
The contact between the Benton and the Dakota formation is exposed in an outcrop located half a mile towards the west of the landslide along I-70, (Figure 16). The rocks exposed in this outcrop correspond to the sliding material. This outcrop shows two clay layers above the contact between the Benton and the Dakota formation at elevations which closely correspond to those observed in the core samples. The upper clay layer was therefore correlated with the shallower gouge zone observed in the cores and made evident by the "deadman" probe. The second layer was correlated with the deeper gouge zone that was observed in the cores.

Figure 16 : Outcrop along I-70 Half a Mile West of the Landslide.

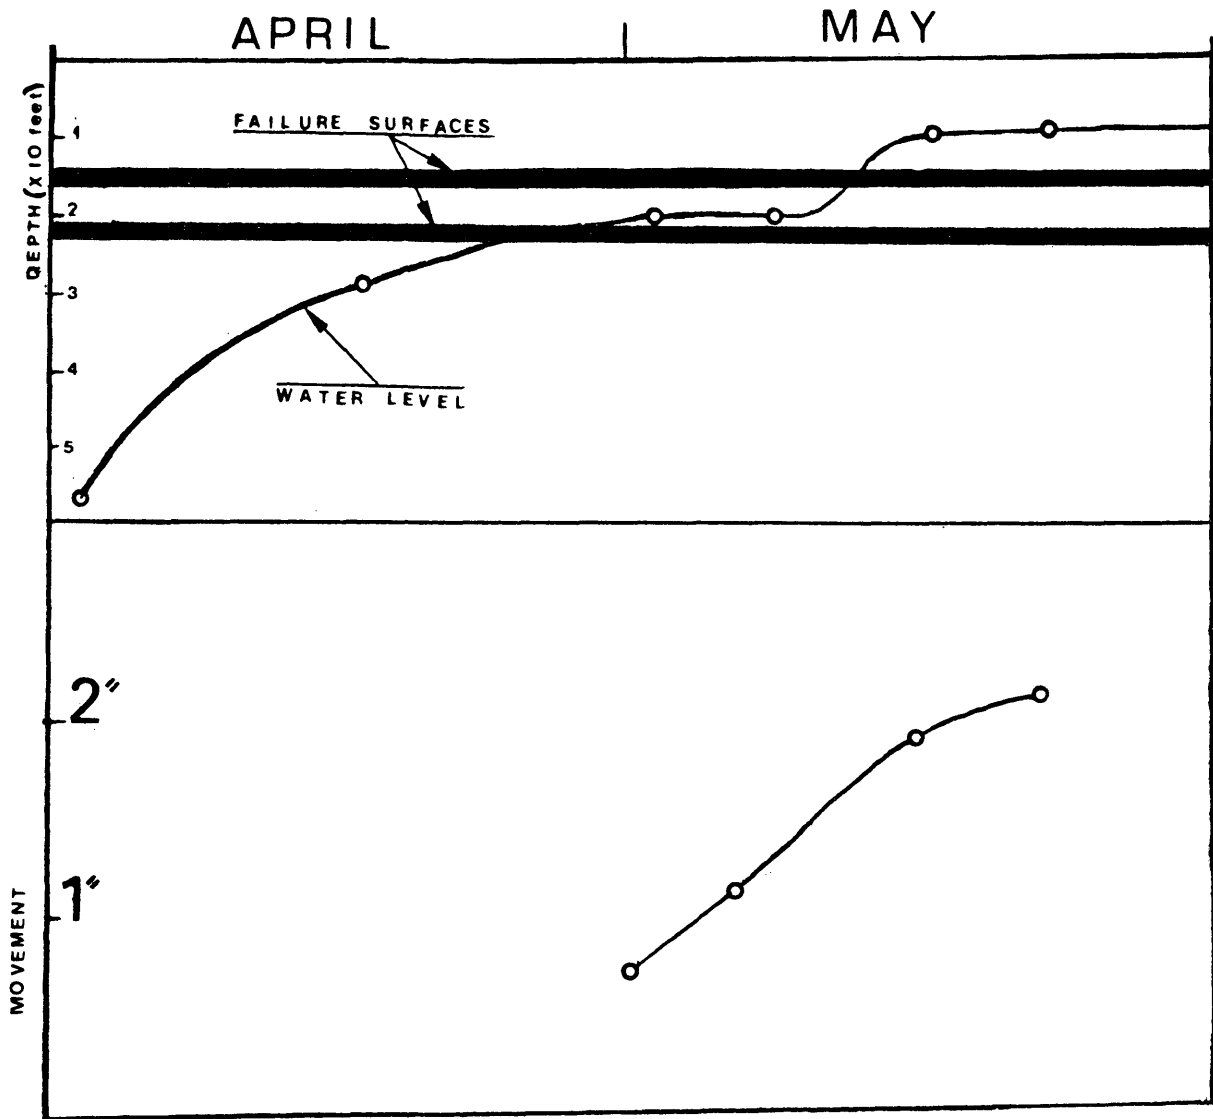
The rates of movement of the landslide correlate with the local rises in the water table (Figure 17). Movement is initiated once a threshold in the ground water level is reached. This threshold appears to occur when the water table rises to about 12 feet below the surface. Even after the water level drops below this threshold, loss of the soil strength and internal structural changes allow the slide to continue to fail.

Figure 17 : Water Level and Movement Correlation.

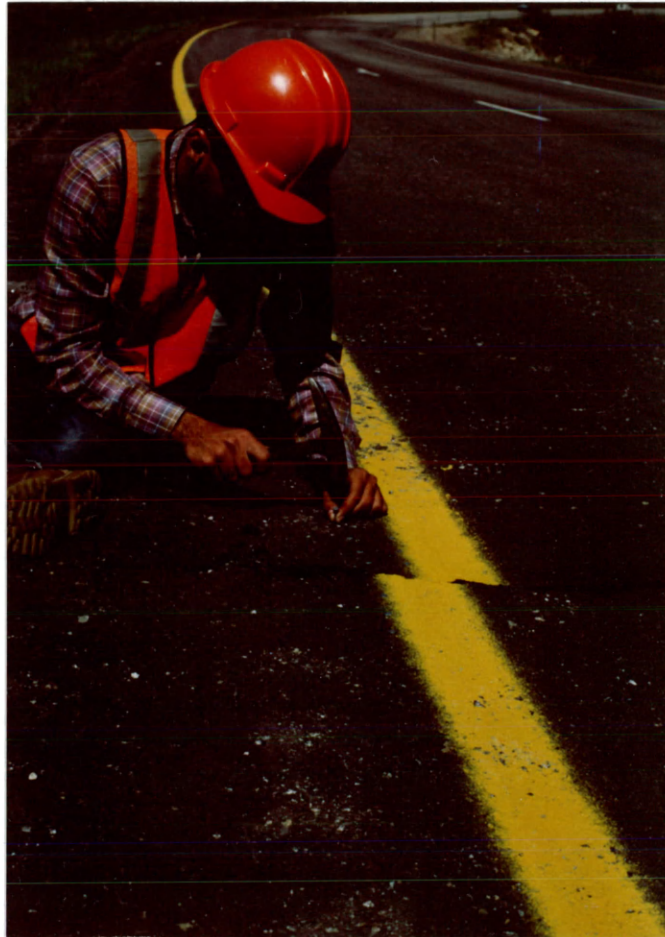
Near the eastern edge of the slide, total lateral movement of 2 inches was measured along a major crack on I-70 by May 15. This was not associated with any vertical movement (see Figure 18). A lateral displacement of 2 inches was observed along a crack on U.S.6 toward the western edge of the slide. This was associated with a vertical offset of 2.4 inches (see figure 19). Movements were noticed to be progressively larger towards Eagle River, especially towards the west. Accordingly damage to U.S.6

Figure 18 : Primarily Horizontal Movement on a Crack along Interstate-70 on the Eastern Margin of the Landslide.

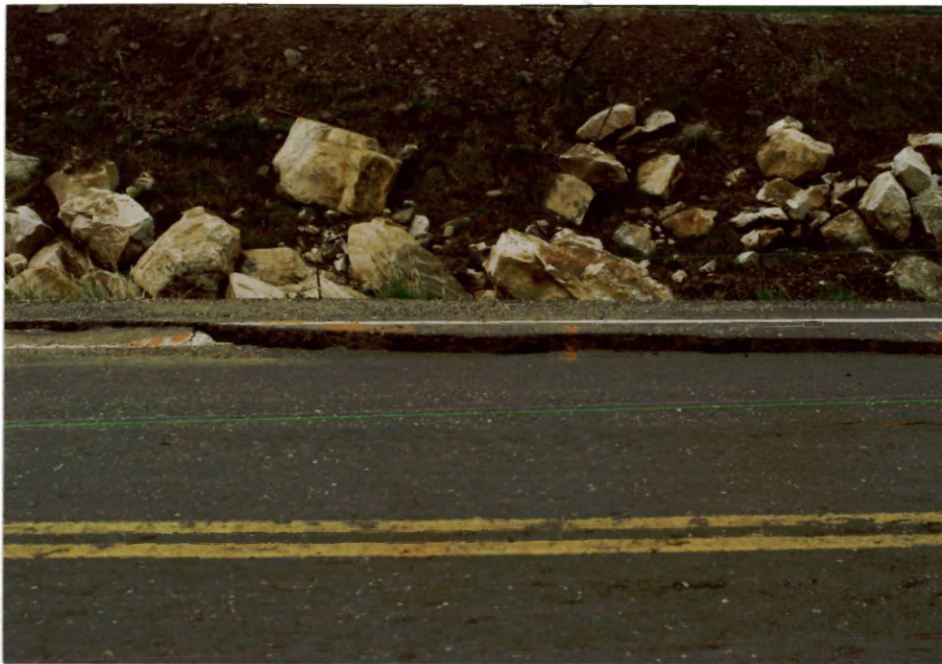
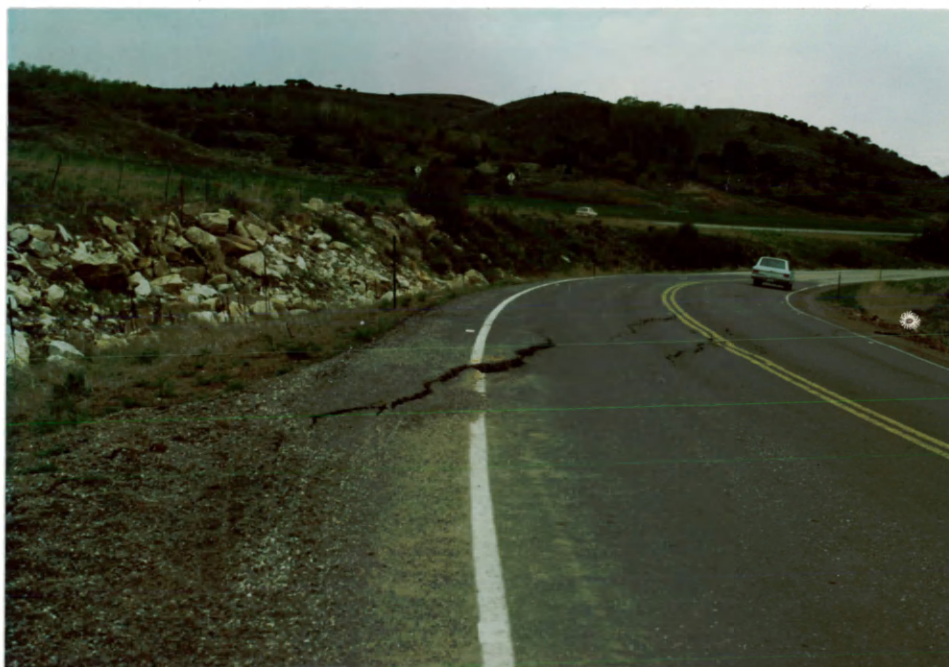
Figure 19 : Combined Vertical and Horizontal Movements on a Crack along Highway U.S.6 at the Western Margin of the Slide.

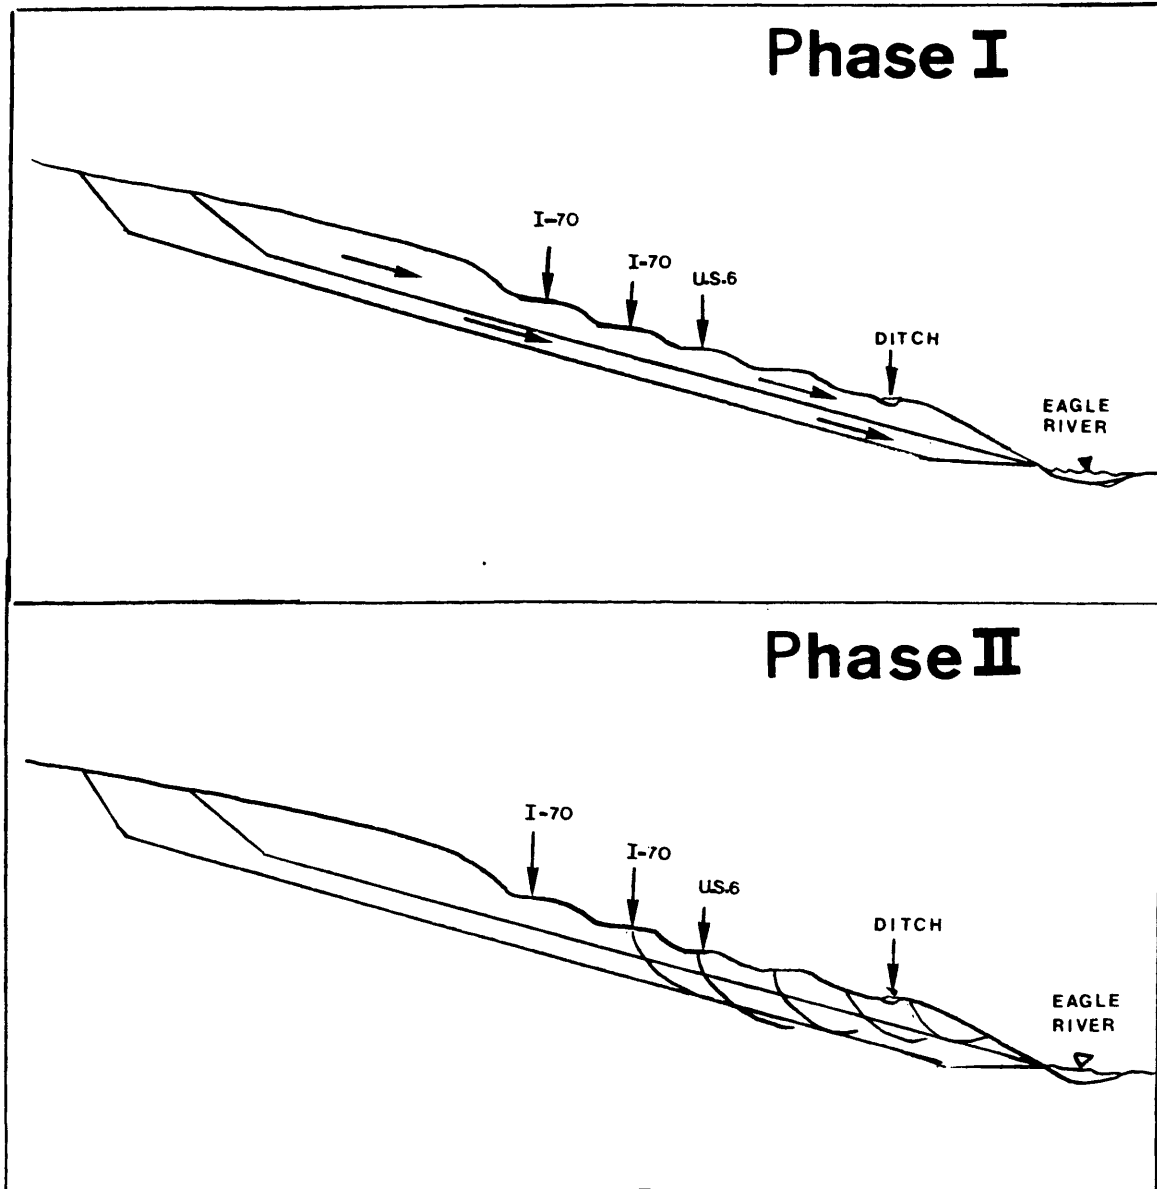
The failure at the Wolcott landslide consists of two phases, (see Figure 20):

In the middle of May 1985, leakage from an irrigation ditch saturated the toe of the slide. The lower portions of the slide were reactivated, initiating a second phase of retrogressive failure that migrated back up the slide. This caused further cracking of U.S.6 and the west bound lane of Interstate-70 by the end of May (see Plates 5 and 6).

Figure 20 : Phases of Movement.

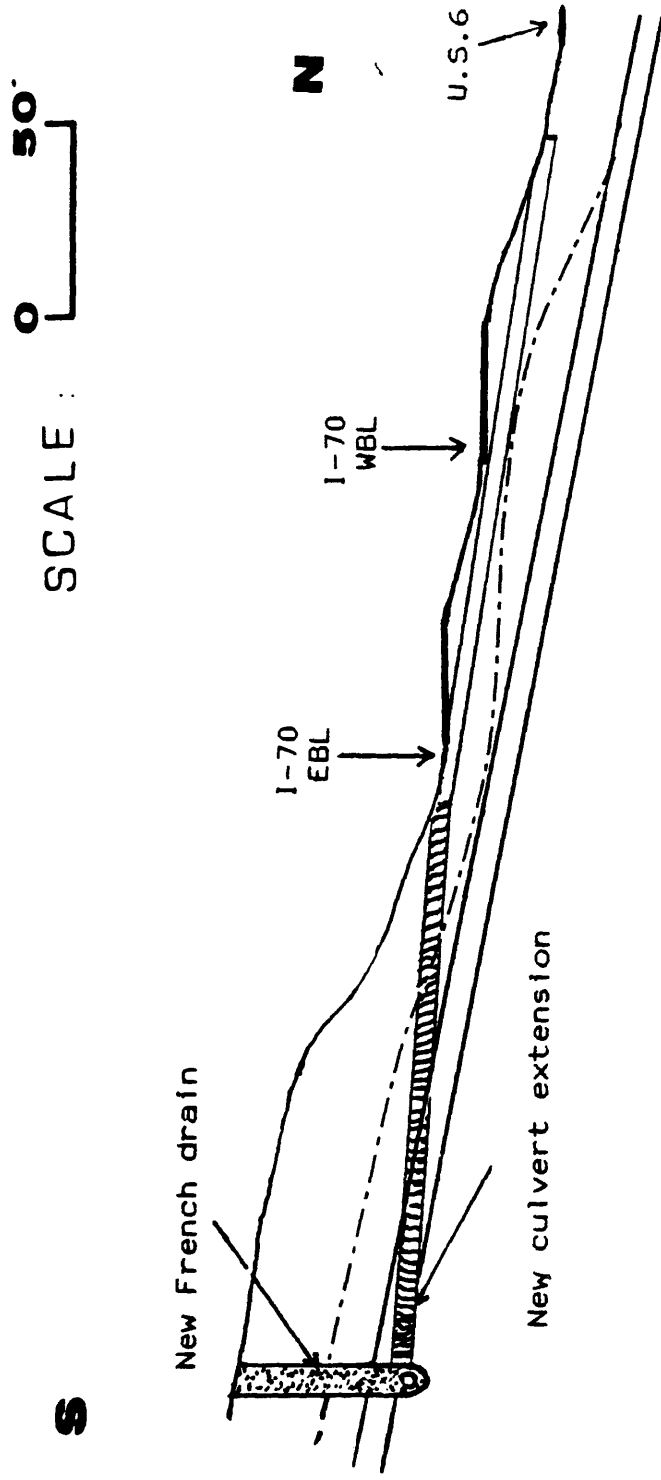
Figure 24 : The New Proposed Drainage System.

The French drain should be installed 110 feet upslope from the existing old drain. It should extend to a depth of 35 feet below the surface or one foot into the less

permeable Dakota sandstone, whichever is less. With an assumed Manning coefficient for the slotted pipe, and allowing a velocity of 1.4 feet per second and a capacity of one cubic feet per second, a 12 inch diameter pipe should be installed at an 0.13 % gradient towards culvert C-1. This drain should extend over a length of 325 feet to the east of C-1, with a N70W trend to efficiently intercept the major seepage zones located in the area (while maintaining the required 0.13 % gradient), and 200 feet west of culvert c-1 with an east-west trend. It should be lined with suitable permeable geotextile to prevent infiltration of fines and extend its life expectancy. Similar installations have been successfully used on the Colorado Highway 91 realignment on Fremont Pass in similar geologic conditions(. Figure 25 shows the design of the drain proposed at the Wolcott landslide.

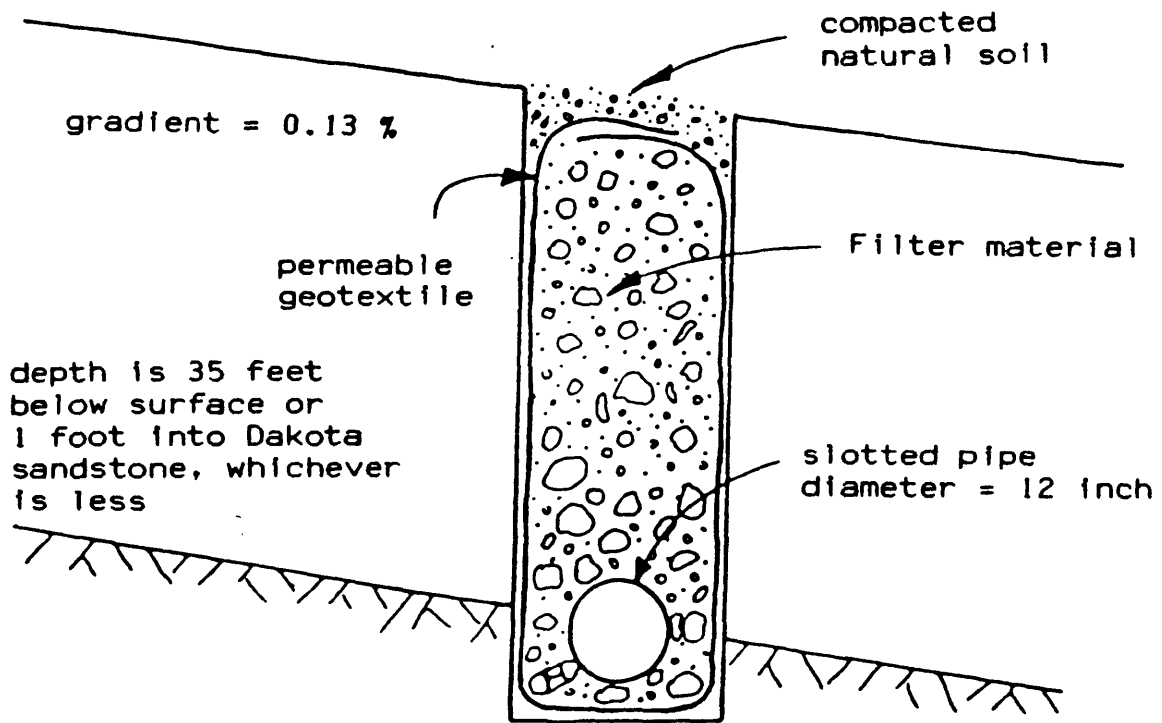
Figure 25 : Design of the Proposed French Drain.

This action will require about 3000 cubic yards of trench excavation and backfilling with 1500 cubic yards of gravel and 1500 cubic yards of slide material to close the trench. Around 1500 cubic yards of material must then be disposed of off the site. The cost of the installation of this drain together with the culvert extension is estimated to be about \$ 35,000.00 (Godfrey, 1984).
