Building an Icon – Constructing the New Jackson Hole Tramway

Stephen W. Dorau, P.E
Parametrix Consulting

Abstract

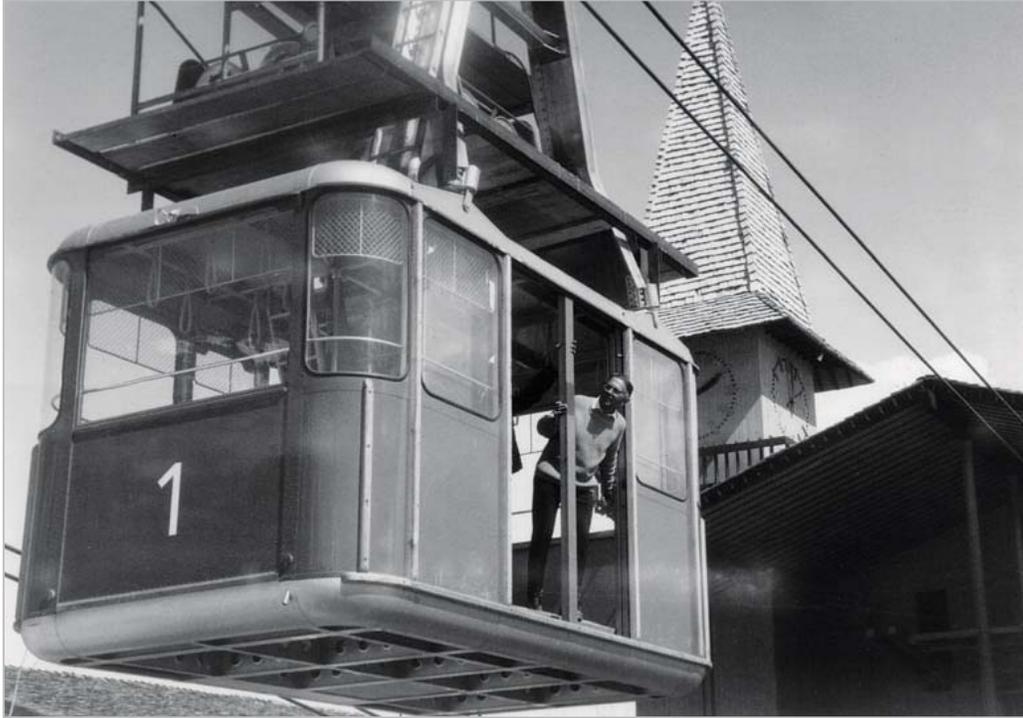
Figure 1 - Jackson Hole Tramway ca. 1966

The Jackson Hole Mountain Resort (JHMR) was founded in 1962 by Paul McCollister, Alex Morley and Gordon Graham. The area, modeled after a European ski village, shortly thereafter welcomed a tramway that would become world-famous. The original tramway system equipment was engineered by Robert McClelland. The tramway construction was completed for the 1966-67 ski season, offering the public unparalleled access to 4139 vertical feet of terrain. The tramway received major upgrades throughout the years, including cabins in 1989, a power system upgrade in 1993, a gearbox replacement in 1995, a gearbox rebuild in 2000, cabin hangers in 1999 and carriages in 2001. Other than these modifications, the majority of the tramway's equipment was operated and maintained for forty years, including the track ropes. (See Figure 1.)

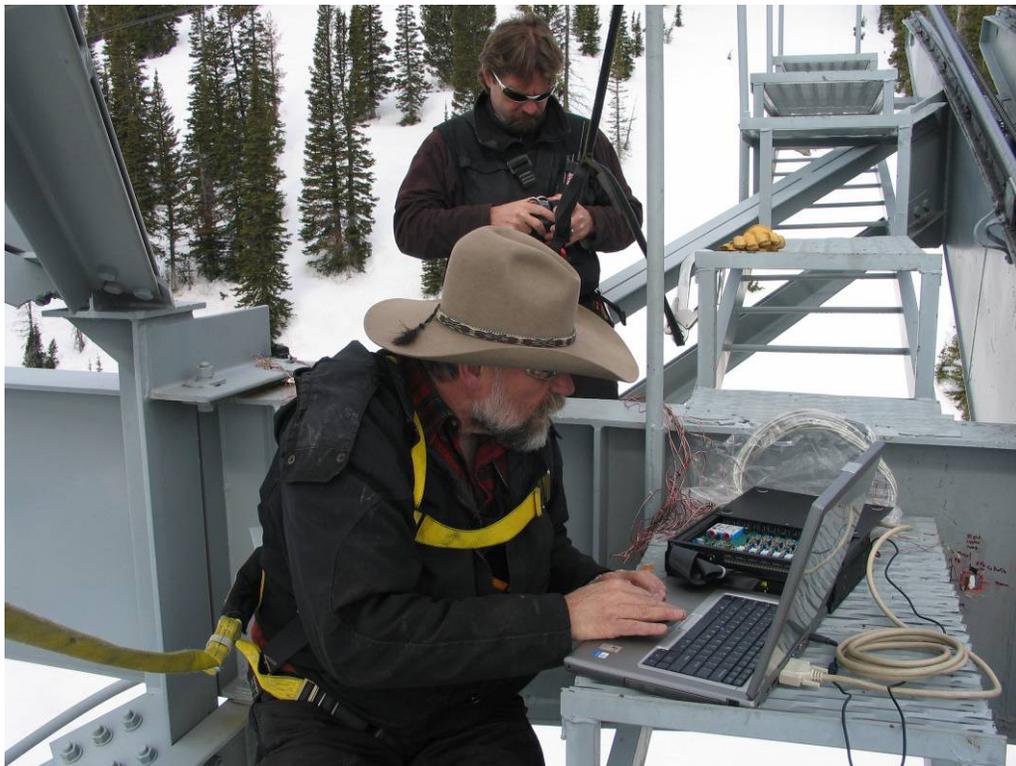
Figure 2 - Strain Gauging Tower 2 Crossarm 2006

Jim Fletcher and Jamie Bunch, of Parametrix Consulting (Parametrix), were contacted by the resort to perform a system-wide assessment and review of the Doppelmayr report to determine if the tram was capable of continued operations. (See Figure 2.) Parametrix determined that the amount of upgrades required to bring the tramway up to industry standards was too extensive, and the tramway had basically reached the end of its useful life. The tram had reached “technical obsolescence.” The obsolescence of the tramway had a cascading effect. Should the track ropes be replaced, it would be prudent to replace the tower rope saddle shoes. The saddle shoes are the brass liners that are in contact with the track ropes at each tower and terminal that dictate the curvature of the rope. If the saddle shoes were replaced, the new shoes should be updated to have a radius compliant with the modern standards. If the shoe radii changed, then the saddles supporting the shoes would need to be replaced with longer saddles, and consequently the towers may have needed modification. And of course, the tower foundations which were already in question would likely receive an increased load, further complicating the situation. The domino effect caused by upgrading a single component of the tramway could have carried through nearly the whole system.

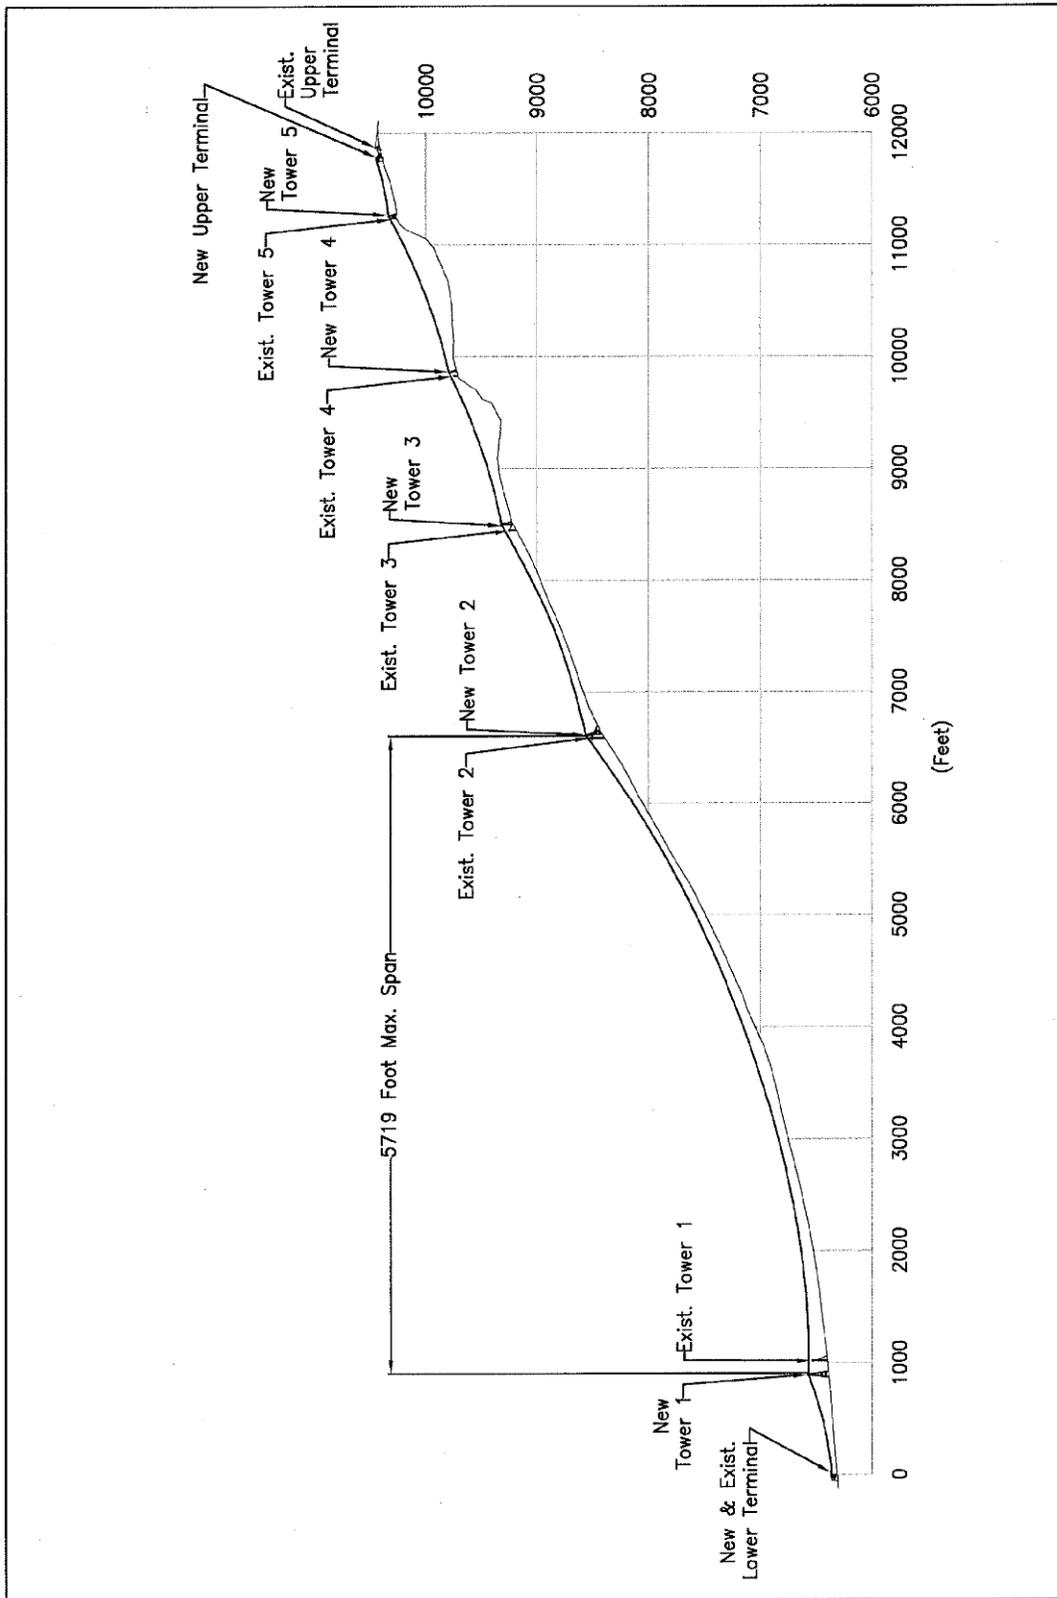
Figure 3 - Tramway Profile

Planning a tramway with over 4,000 vertical feet of travel in a remote location presented some unique challenges. Spanning elevations of 6,300’ to 10,400’, the seasonal weather constraints played a large role in the system planning. The construction schedule was not only limited by the ski season, which ranged from December through April, but access to the upper towers and the upper terminal was limited more than 9 months of the year. Constructing a tramway in these conditions in a cost-effective manner prohibited the use of helicopters for all material transports, and the short construction season made foundation construction difficult. A creative solution was necessary. (See Figure 3.)

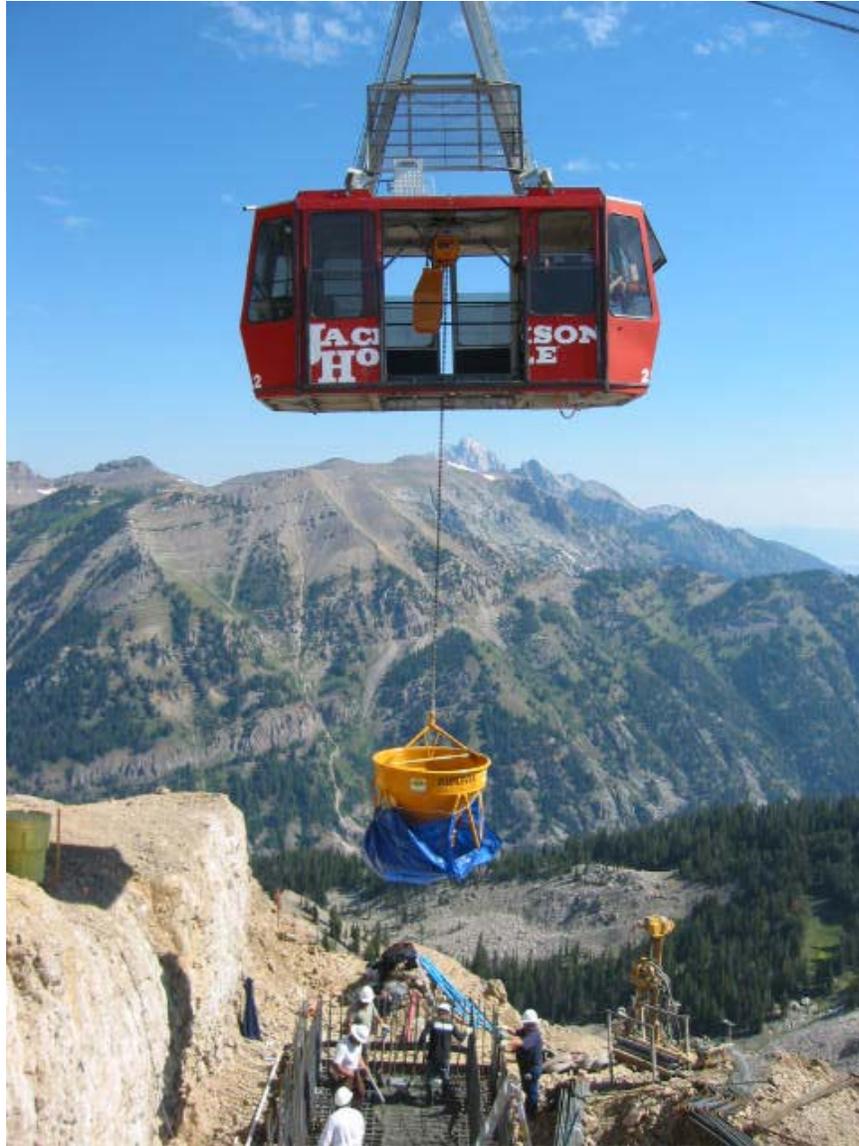
Figure 4 – Concrete Placement with Material Tram

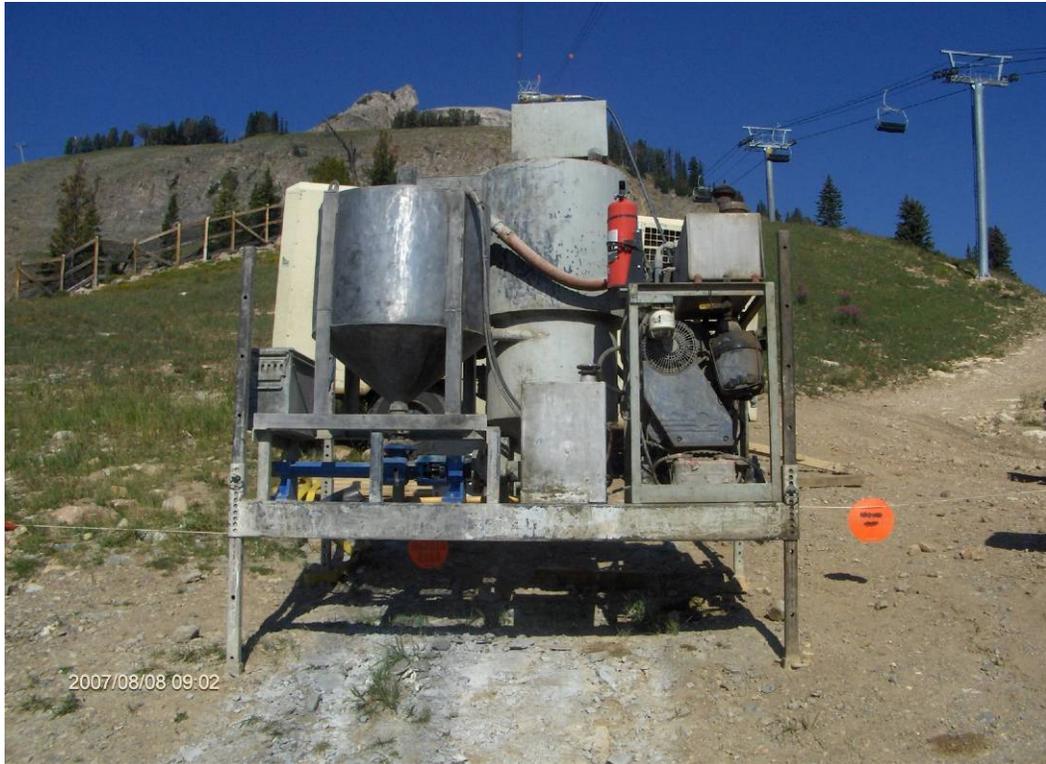
Figure 6 - Batch Plant at Upper Terminal

Given that the largest volume of concrete, other than the lower terminal, existed at the upper terminal, and this was the furthest distance to travel by road, a concrete batch plant was placed at the top terminal location. The batch plant consisted of a hopper and mixer which could supply up to three yards of concrete per batch. (See Figure 6.) The concrete was transported by the material tram cars by means of a suspended concrete bucket lifted and lowered by the in-car winch. It was realized early in the process that the small batch plant was insufficient for the volume of concrete that needed to be placed, and a cement mixer truck was driven to the upper terminal site and utilized as batch plant. The concrete mix was transported to the top of the mountain by a combination of road vehicles and with the material tram in super-sacks. The super-sacks contained the cement, aggregate and admixtures in the proper proportion for a batch of concrete. Water was available 1,000 feet below the top of the mountain from a natural spring. The water was trucked from this spring to the top of the mountain and stored in a temporary pond. By batching the concrete at the top of the mountain, the number of trips that the material tram was required to make was lowered, and the tram cars could be utilized for concrete delivery rather than hauling concrete from the base of the mountain.

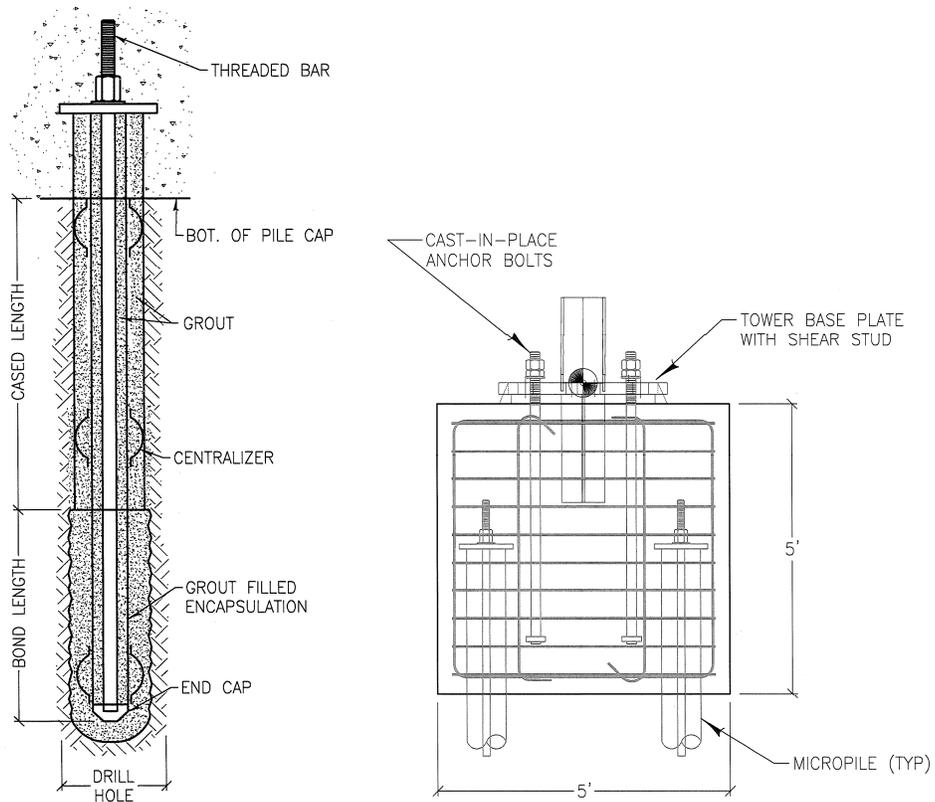
Figure 7 - Micropile Diagram & Pile Cap Elevation

A micropile foundation consist of a small borehole, ranging from six inches to twelve inches in diameter, and with enough depth necessary to transfer the axial loads on the pile to the soil through friction along the sides of the pile. Following the drilling of the borehole, a large diameter threaded rod is inserted into the borehole. For the tower foundations, the rod was inserted full depth into the borehole. During the drilling process, a steel casing is advanced with the drill-head to stabilize soils. Following the drilling, the casing is partially retracted leaving a section approximately ten feet in length at the top of the borehole, protruding several feet. This casing provides additional shear resistance for the pile by increasing the area of steel at the interface with the ground level. The micropile is then grouted with a high strength grout. The grout provides a friction surface with the soil and transfers this friction load to the threaded rod. A large plate is placed on top of the casing, above the ground, and a nut is threaded onto the rod. The piles are then typically encased in a pile cap which is loaded by a structure. (See Figure 7.) The micropiles for the Jackson Hole Tramway project utilized a Class I multiple corrosion protection system. The threaded rods were encased in a plastic, ribbed encapsulation in which grout separated the rod and the encapsulation. This created a triple layer protection system for the threaded rods, helping to ensure a long service life.

Each tower leg for the newly constructed Jackson Hole Tramway utilized four micropiles below each tower leg with a pile cap measuring sixty inches cube. These pile caps included cast in place anchor bolts to secure each tower leg. The micropile boreholes were drilled with a small track-mounted, pneumatic drilling rig which was light enough to be transported by the material tram. This expedited the foundation construction process, as the rig could be quickly moved over rough terrain between each of the foundations of a tower or from tower to tower. The material tram also delivered the micropile materials and concrete by way of a suspended bucket to each foundation site. Temporary steel platforms that could be carried by the material tram were utilized to create a level surface for the drilling rig where required. The adjustable legs of the platform could conform to any surface. (See Figure 8.)

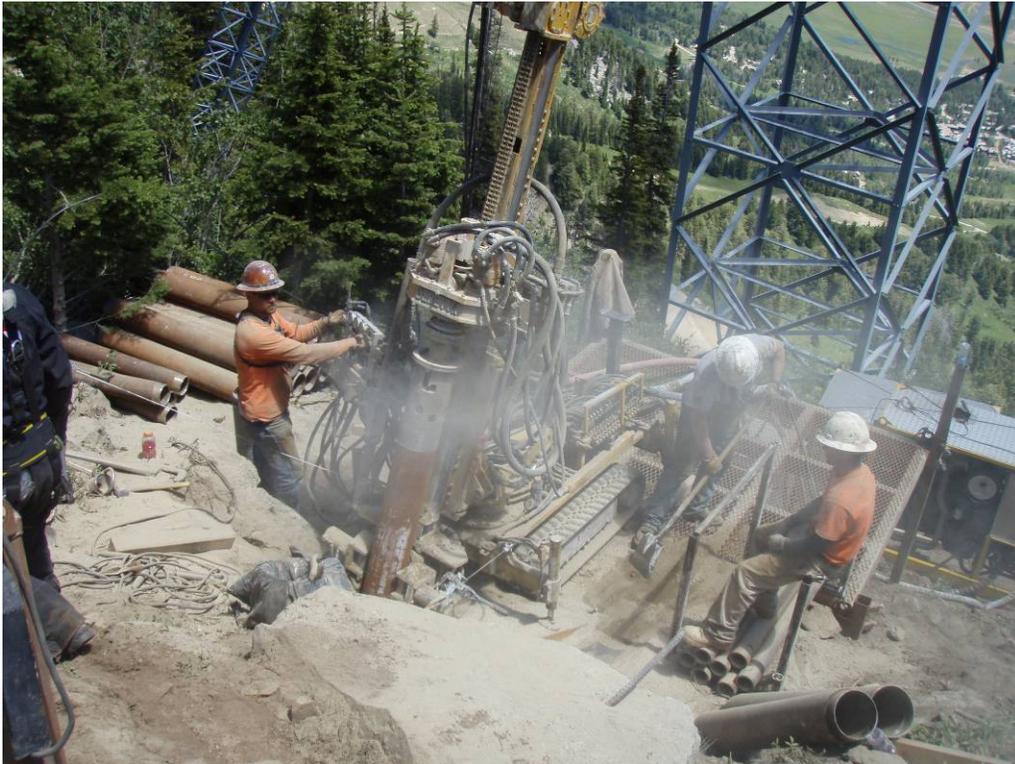
Figure 8 - Micropile/Rock Anchor Drill Rig

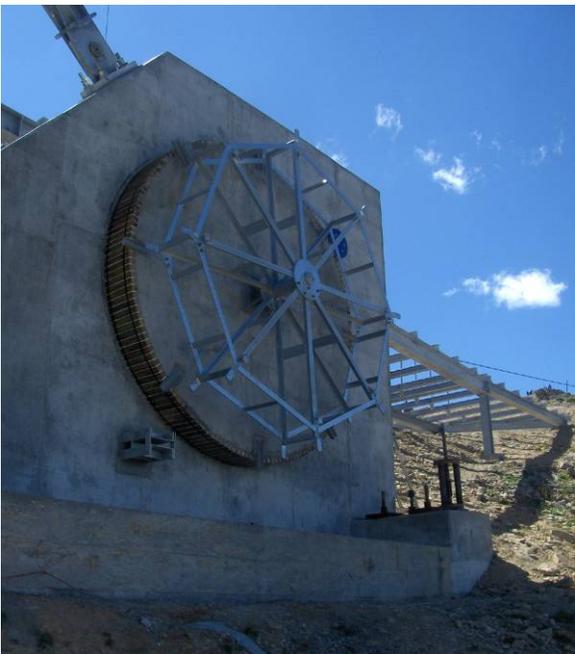
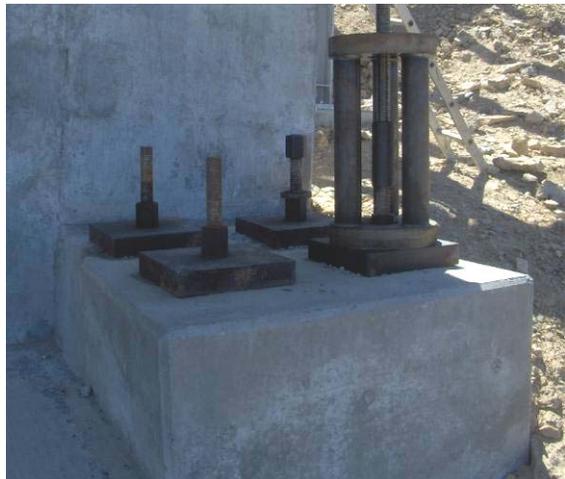
Figure 9 - Upper Terminal Bollard Structure

The upper terminal foundations consisted of concrete bollard structures to tieback the track ropes, a concrete hoistway used to encase the haul rope counterweight and support the main terminal structure, and a number of small spread footings and micropile foundations to support the extensive walkways for the upper terminal. The bollard structures utilized eight rock anchors each for hold-down retention and sliding resistance. The rock anchors were constructed in a similar manner as described above for the micropiles with one key deviation; the rock anchors passed through the bollard structure foundation, and the anchors were pre-tensioned such that the cyclic loading of the track ropes would not induce fatigue into the rock anchor rods. (See Figure 9. and Figure 10.)

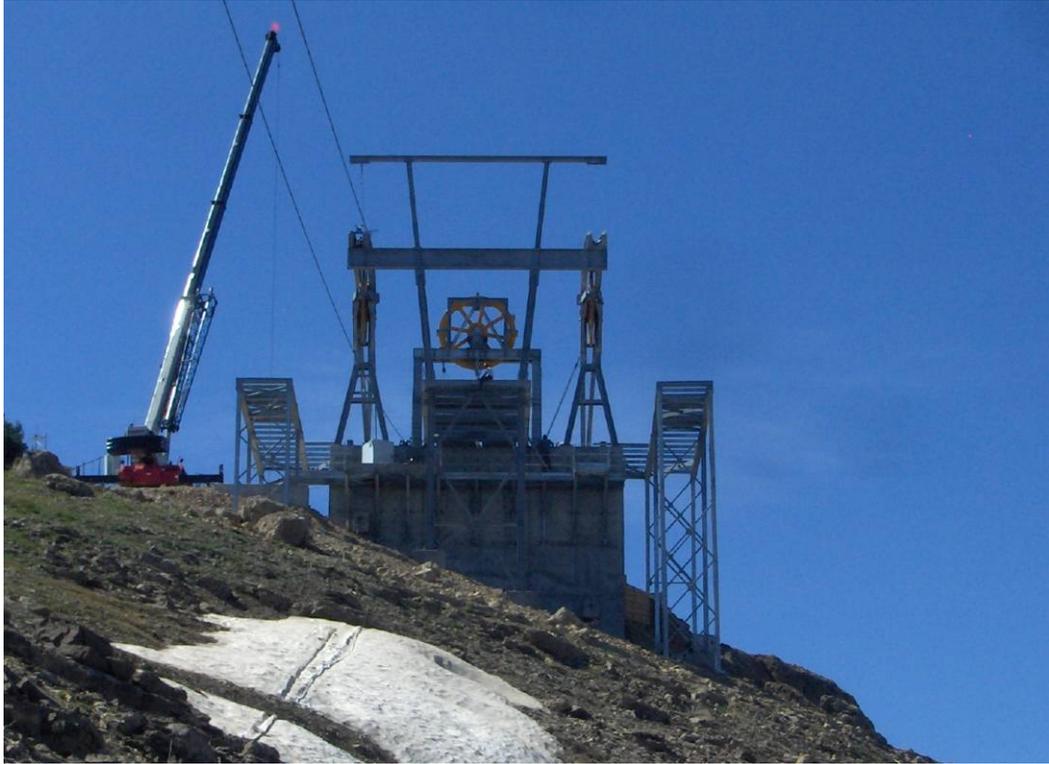
Figure 10 - Upper Terminal Haul Rope Counterweight Hoistway
