Prevention of Aerial Tramway Failure by Safety Factors ?

R. Kieselbach *)

* Swiss Federal Laboratories for Materials Testing and Research (EMPA)
Ueberlandstr. 129
CH-8600 Duebendorf, Switzerland
Tel.: ++41 1 823 55 11
FAX: ++41 1 823 40 11
e-mail: rolf.kieselbach@empa.ch

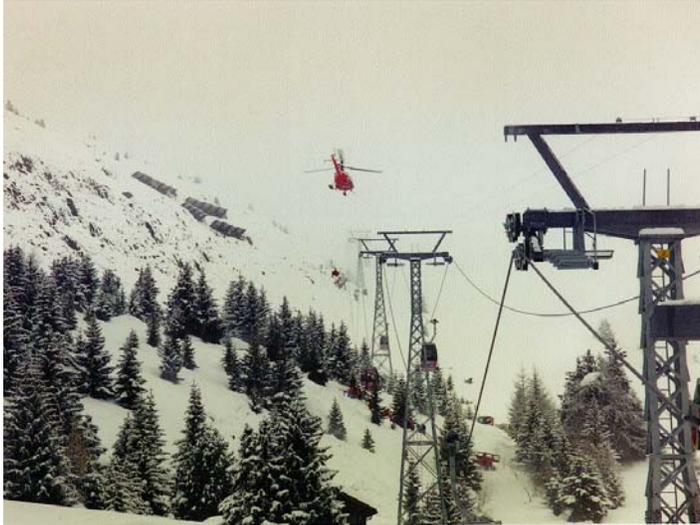
Fig. 1 Cableway after the accident

At the moment of the accident, the axle in the downhill station, that carries two deflecting wheels required to furnish the necessary pretension in the wire rope had broken. As a consequence one wheel had been hurled away and the wire rope had relaxed until it was held back by a concrete pillar. This slackening led to the fatal events. As turned out in the course of the failure analysis, similar cases had occurred in the past and have since been discussed in the literature (E. Corazza, 1997)

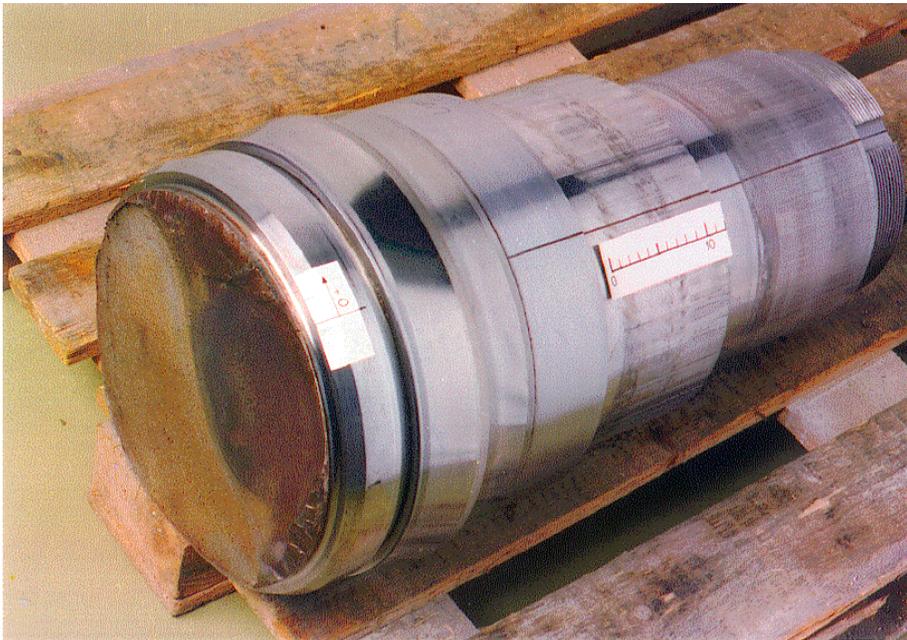
The thorough investigations showed that the axle had been broken because of a fatigue crack which had already covered approximately 50 % of the cross-section in only one year of service.

Fig. 3 Fracture surface of broken axle

It was observed that the crack did not originate in the vicinity of the calculated high stress location but had been initiated by fretting corrosion under the seat of the hub of the bull wheel.

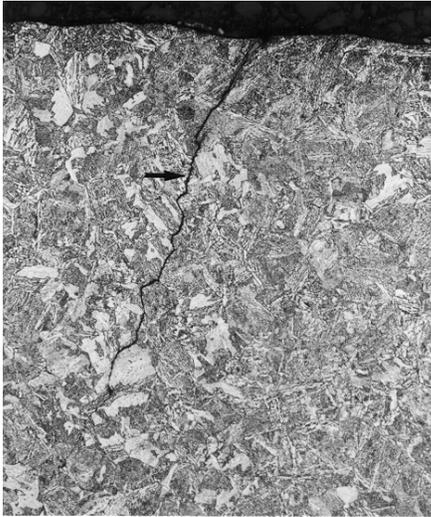
The damage to the axle outer surface resulted from the simultaneous action of the pressure from the bull wheel hub and the very small but repeated relative slipping movement between the hub and the axle. This continual fretting action was responsible for the initiation of the crack as shown in Fig. 4

Fig. 4 Crack initiated by fretting fatigue
