A PERFORMANCE EVALUATION OF VARIOUS NOZZLE DESIGNS  
FOR WATERJET SCALING IN UNDERGROUND EXCAVATIONS

A thesis submitted to the faculty and Board of Trustees of the Colorado School of Mines in partial fulfillment of the requirements for the degree of Master of Science (Mining and Earth Systems Engineering).

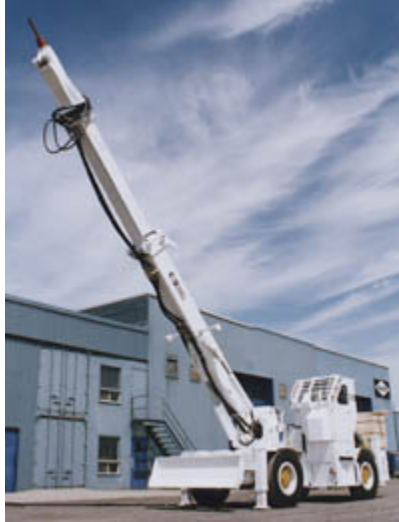
Mechanized scalers are common in large underground operations. They are easily transported to new headings and are arguably the best tool for removing extremely large and unstable slabs from hard to reach places. They are usually mobile, diesel-powered vehicles equipped with hydraulic jack-hammers at the end of a heavy-duty extendable boom (Figure 1.2). Alternative designs may include a large, sharpened claw at the end of the boom with several axes of rotation and powerful prying action. Mechanical scalers are designed with dozens of features meant to keep the operator safe, but because of the inherent danger of scaling and the unpredictable nature of unsupported ground, accidents are known to happen.

Figure 1.2 Dux® DS30RB scaler

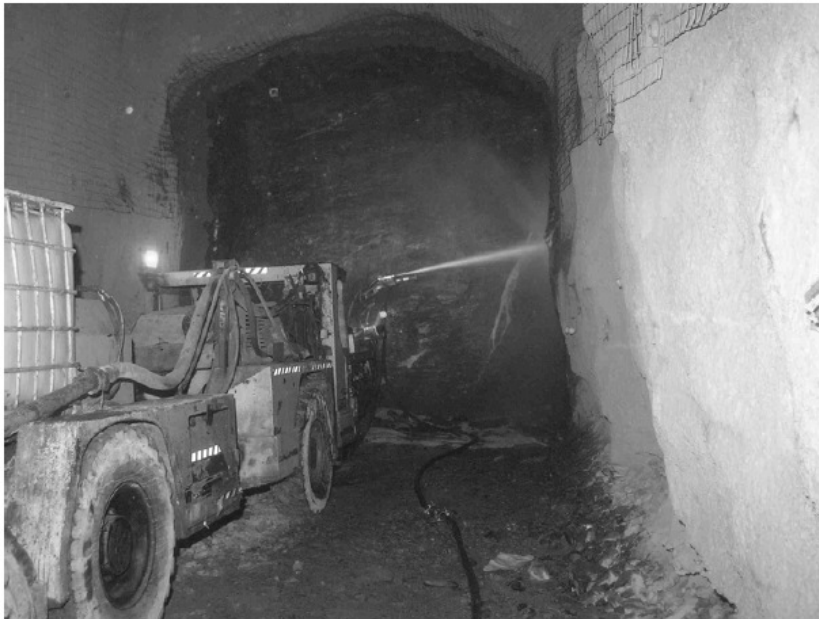
Figure 2.1 Waterjet scaling rig by MIRARCO, Sudbury, Canada

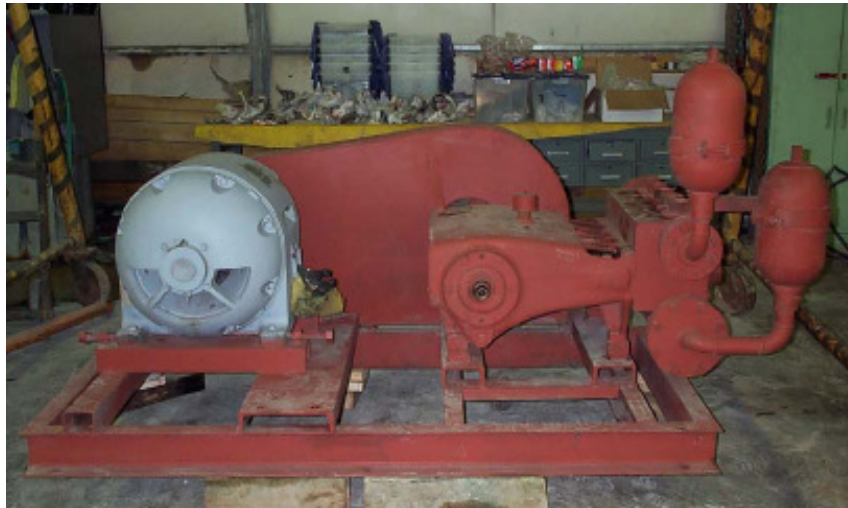
The pump was positioned underground in a crosscut that was close to the research area yet protected from blasting concussions and fly rock. To avoid frictional losses that can be expected in extended lengths of high-pressure hose, the pump was kept within 200 feet of the scaling experiments.

Figure 4.2 Wheatley Quintuplex high-pressure pump

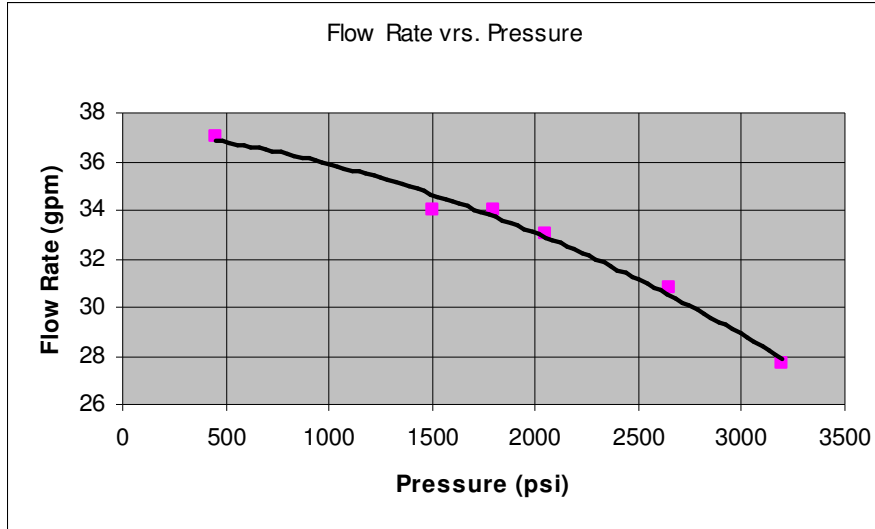
Determination of the operational parameters of the pump, including pressure and flow rate for any given nozzle diameter, required a repetitive testing process with several different nozzles. The graphical results of such a test are commonly referred to as a pump curve, where pressure and flow rate are plotted along the X and Y axes respectively. The curve provides a quick reference of the relative pressures and flow rates that can be achieved by the pump. The curve generated by the rebuilt Wheatley Quintuplex pump is shown in Figure 4.3, and detailed records of the data can be found in Appendix C.

Figure 4.3 Pump Curve for Wheatley high pressure pump.

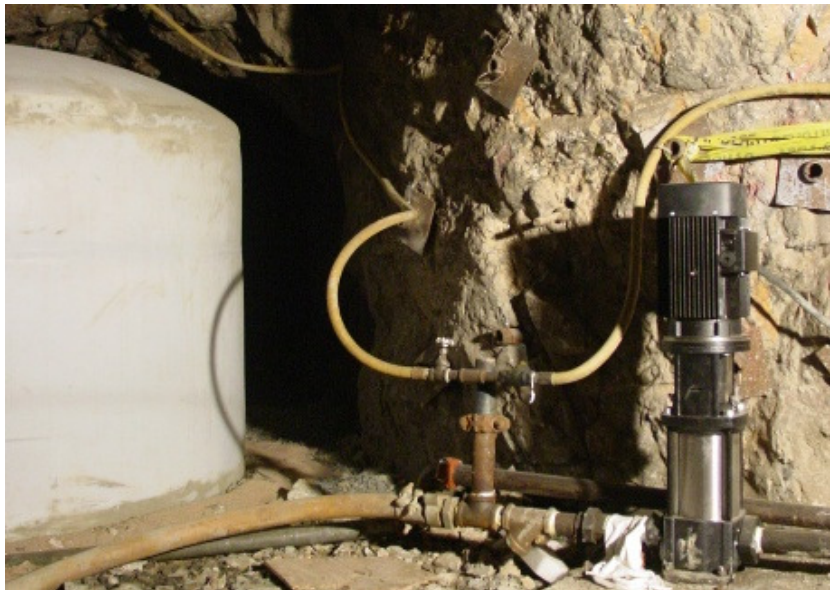
Water was supplied from a 4800 gallon plastic water reservoir system located approximately 300 feet away from the high pressure pump. A 10 hp rotary pump, capable of maintaining 100 psi and up to 100 gpm in the water supply lines, was located at the reservoir. It is always necessary to supply a high pressure pump with adequate flow rate in order to avoid internal damage. The water reservoir and 10 hp supply pump can be seen in Figure 4.5.

Figure 4.5 Water reservoir and priming pump

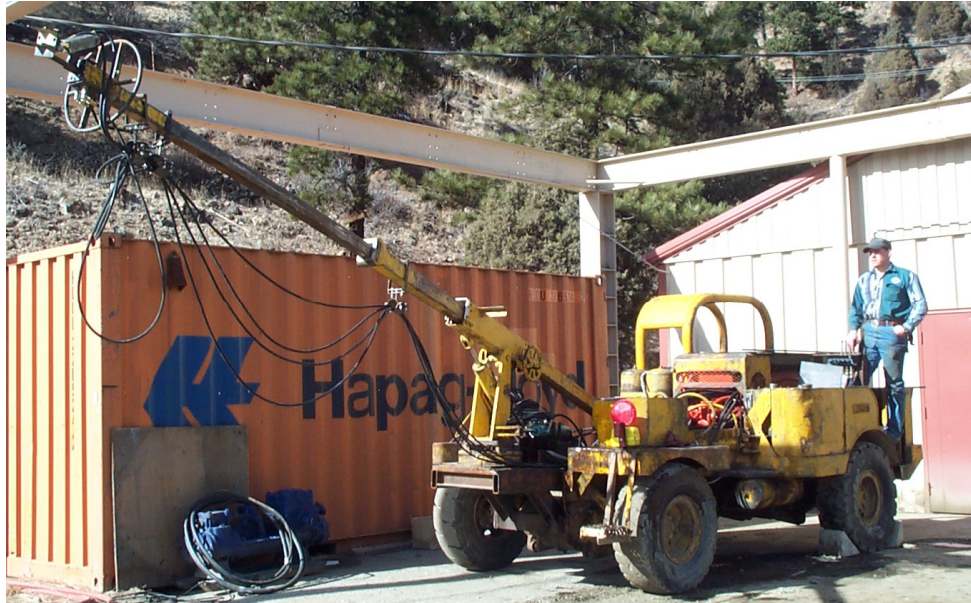
years before the launch of this research and came fitted with a 15 ft extendable, hydraulically-actuated boom. The original setup of the vehicle was unknown. A photograph of the waterjet carrier vehicle is shown in Figure 4.6.

Figure 4.6. The CSM waterjet carrier vehicle

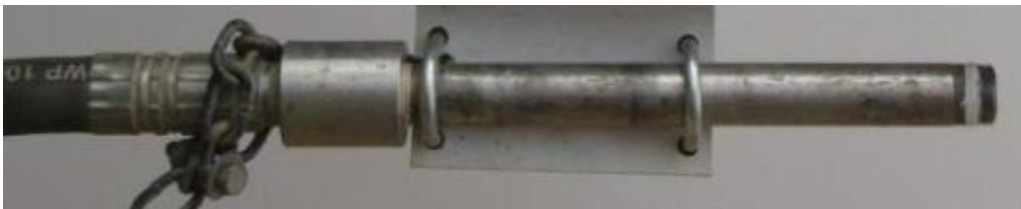
Figure 4.7. High pressure hose, female end fitting, and pipe.

A 20 ft length of high pressure 3/4" hose was mounted to the boom of the carrier vehicle. The rear end connected to the other conveying lines by means of an additional quick-release coupler. The forward end had a female threaded fitting matched to a ten inch high pressure pipe. The purpose of the pipe was to provide a clamping surface at the boom interface and to straighten the flow of the high velocity, high pressure water before it entered the nozzle. The hose, fitting, and pipe are shown in Figure 4.7.

Each of the nozzles had a female threaded end capable of mounting directly to the ten inch pipe. The nozzles were tightened to the pipe using an open end wrench and a pipe wrench. Teflon tape was wrapped around the pipe threads each time a nozzle was removed and installed.

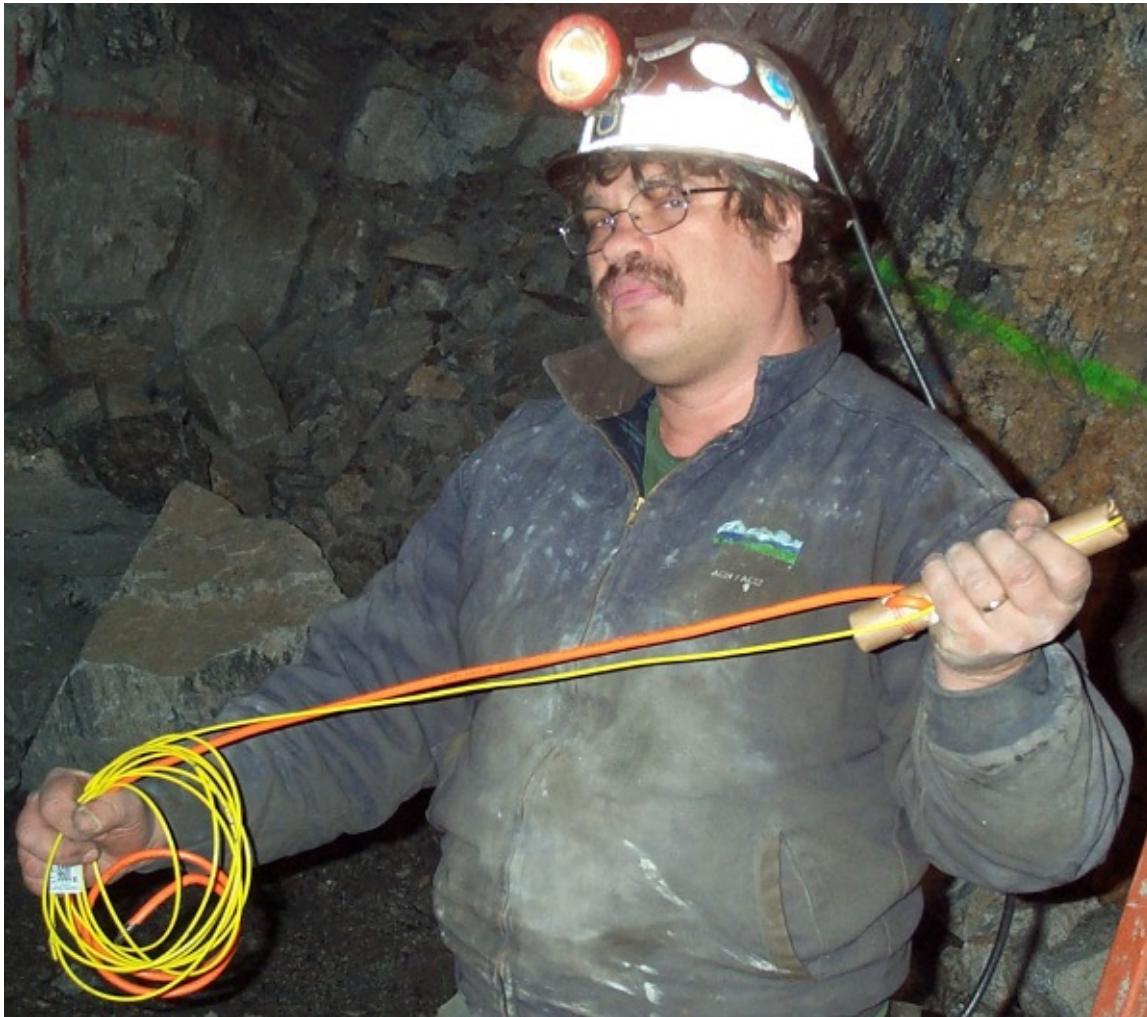
The 200-grain detonating cord was inserted twice through the stick of emulsion in order to reduce the chance of misfiring. It also helped prevent separation between the emulsion and the detonating cord in the event that the explosives had to be pulled from the hole for any given reason. A photograph of the 200-grain detonating cord and shock tube attached to the stick of emulsion is shown in Figure 4.12.

Figure 4.12 Stick of emulsion primed with an 8-gram blasting cap and attached to a 200-grain detonating cord

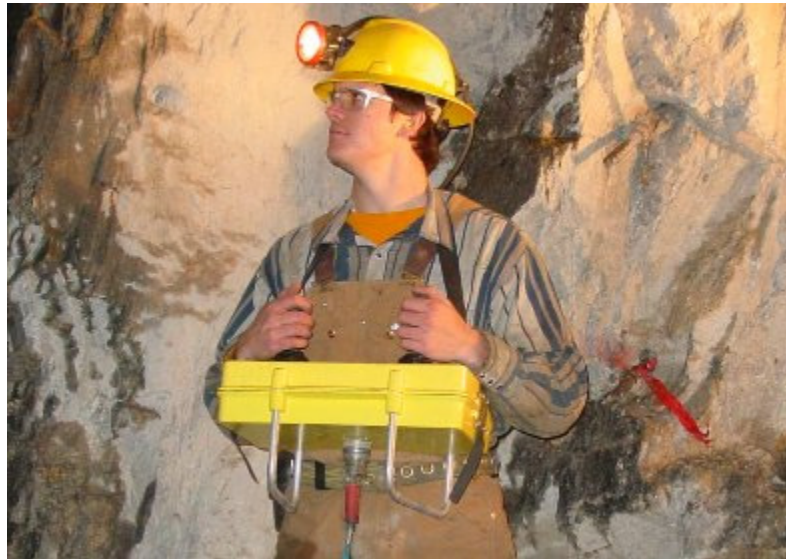
The joystick box was attached to a canvas strap which was worn around the neck of the operator. Functions included tilt, swing, and extension of the main boom, as well as tilt and rotation of the nozzle. An auxiliary button, capable of supplying power for oscillation of the nozzle, was not used. The joystick apparatus is shown in Figure 4.13.

Figure 4.13 Joysticks for operation of hydraulic boom

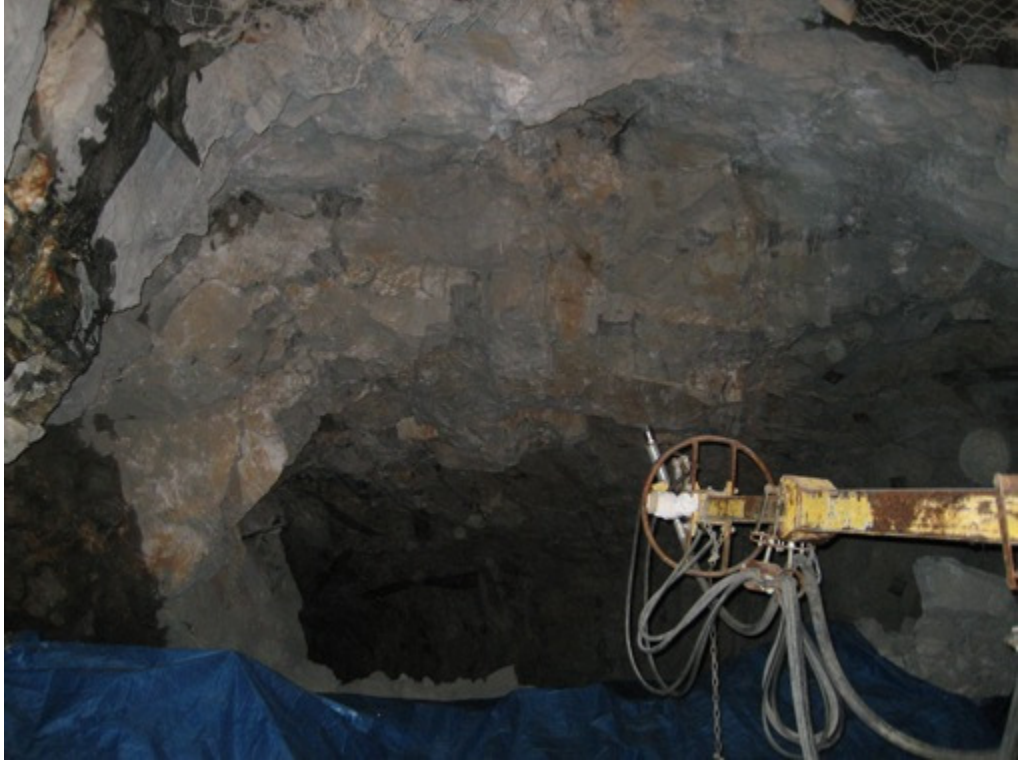
Figure 6.2 Before Experiment #1

Photographs taken before and after the scaling experiment, under the same lighting conditions and from the same physical location, illustrate the cleaning effect offered by the waterjet (Figures 6.2 and 6.3). Also notable in the photograph taken before the experiment is the presence of moisture along the left rib. Although this area was noted for being wet year-round and containing exceptionally soft and weathered material, the formation did not intersect the scaling area. It did, however, indicating the type of groundwater activity present in the rock mass and the effect it has on the materials in contact.

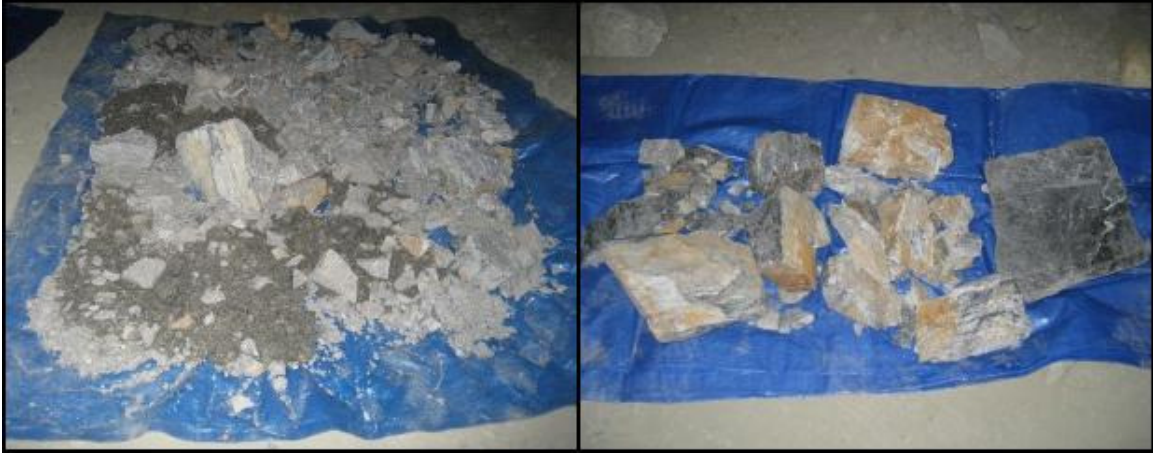
Figure 6.5 Waterjet and Manual scaling results

All of the material removed in Experiment #1 was placed on tarps in a nearby drift for screening, as shown in Figure 6.5.

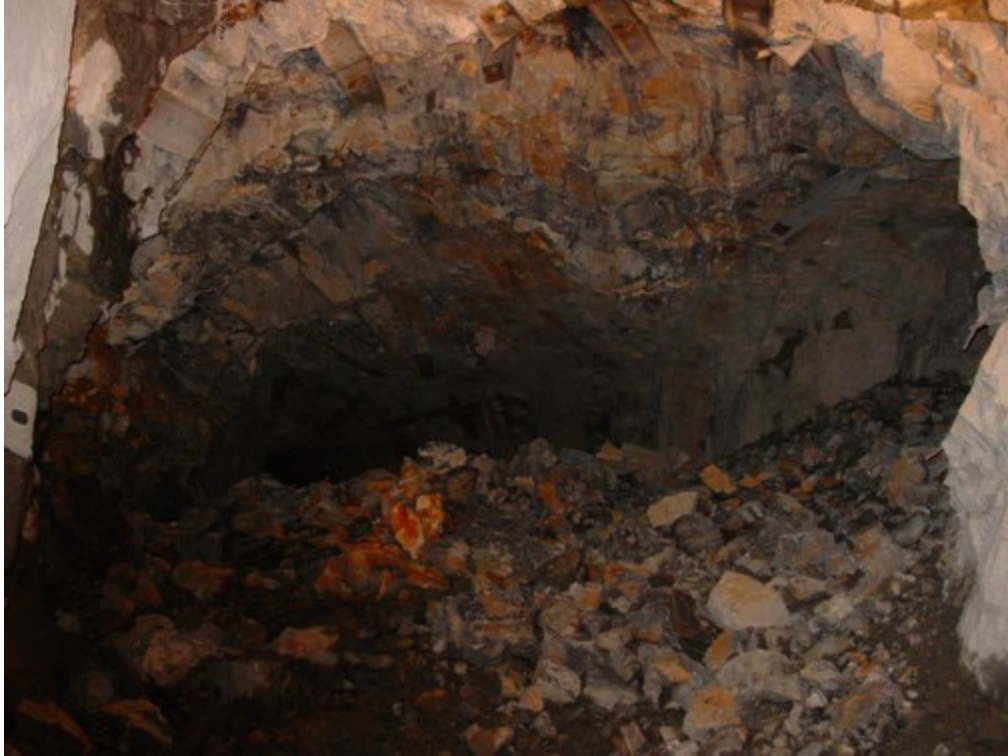
Figure 6.8 Photograph taken before Experiment #2

The rock mass in Experiment #2 shared many features with that of Experiment #1. The first feature was the presence of the highly weathered, soft, oxidized precipitates on the left rib. Although the material was not in the scaling zone, similar colored precipitates were noted in many of the surrounding discontinuities, which suggests some previous movement of water and weathering through the area. Additionally, as more time was spent in the area during later waterjet experiments, droplets of water were known to fall from the back through the wetter seasons of the year. A photograph taken before the start of the experiment is shown in Figure 6.8.

Another significant feature noted in the scaling area was a large, nearly horizontal surface that most likely formed the top half of a discontinuity before the blasting of the drift. Though difficult to distinguish in Figure 6.8, the surface was angled 20-30 degrees from horizontal and sloped up into the rock mass above Experiment #2. The presence of such a discontinuity plane at a nearly horizontal orientation further diminished confidence in the integrity of the rock mass.

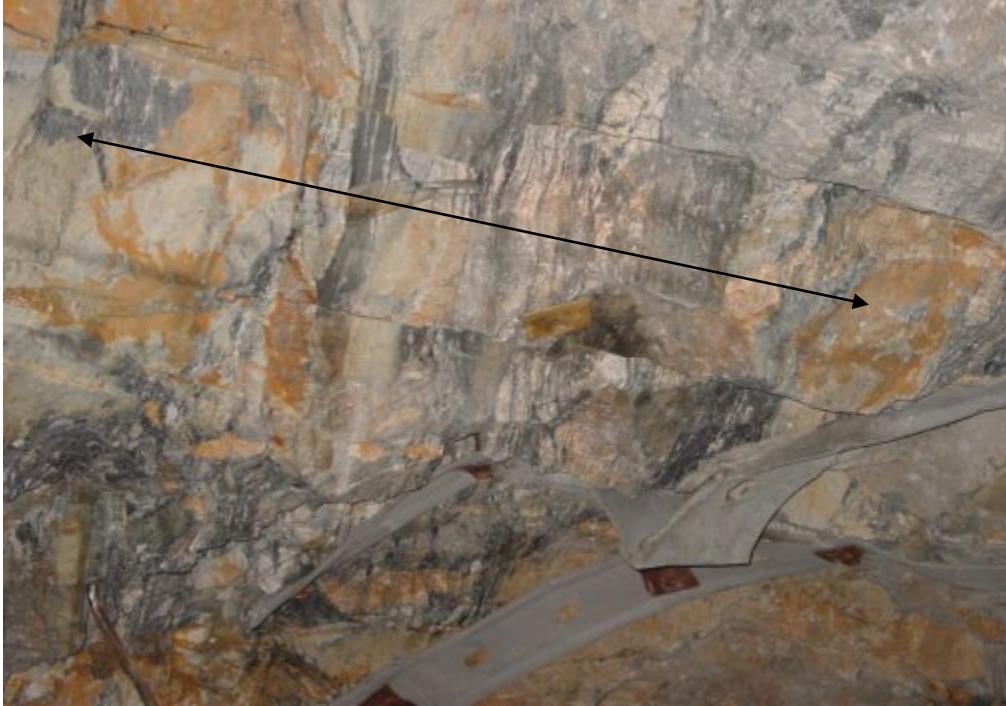
The most significant feature in the rock mass was the presence of several near-vertical, parallel discontinuities. Some of them had approximate 1/8" gaps, and some of them were intersected by perpendicular discontinuities creating conditions favorable for large rock fall. Before the start of the waterjet test, a photograph was taken of the discontinuities that posed the greatest danger. The photograph is shown in Figure 6.9 with an arrow to indicate the trend of the joint set.

Figure 6.9 Troubling discontinuities noted before Experiment #2

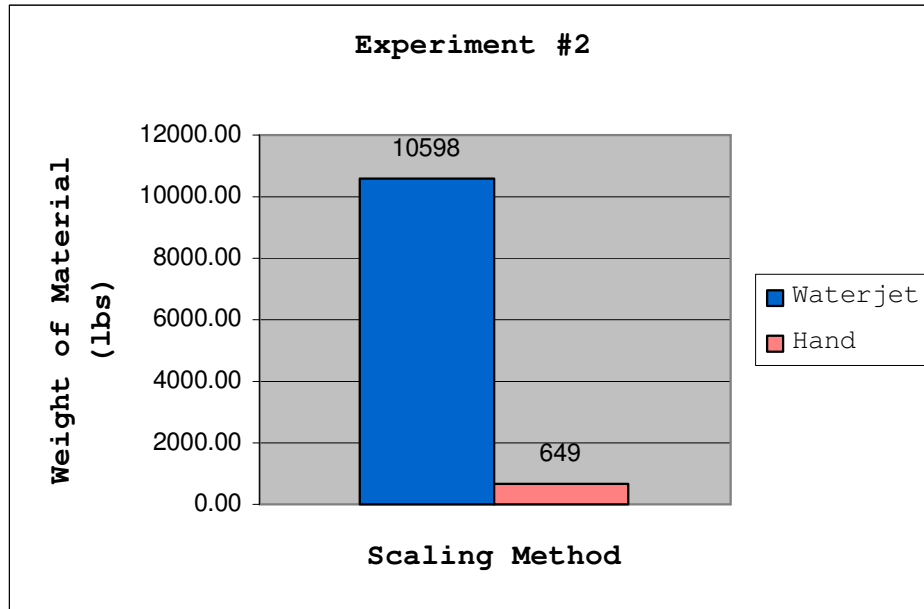
entering the area for manual scaling or the collection of data. The known condition of the rock mass and the amount of material seen falling to the tarp justified the extra scaling time. The results of Experiment #2 are shown in Figure 6.10.

Figure 6.10 Results of Experiment #2

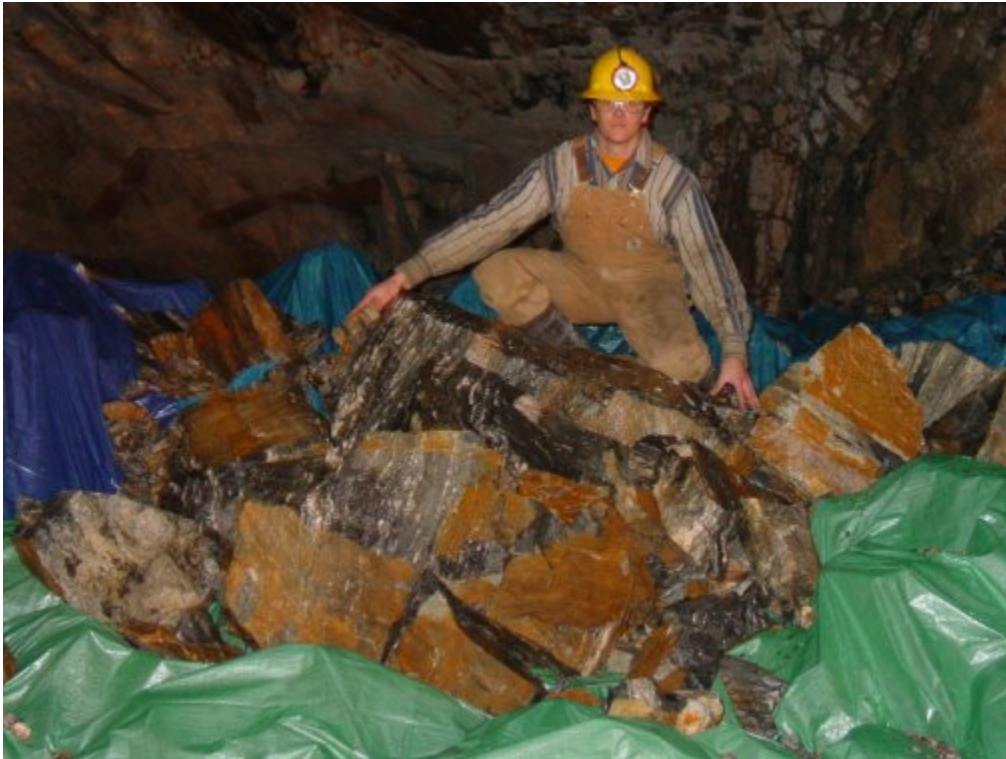
Figure 6.11 Slab of rock that skewed results for Experiment #2

Most of the rocks were still too large to be moved by hand, and thus the total weight of material removed in Experiment #2 is an estimate based on the rough dimensions of each block. The slab of rock is shown in Figure 6.11 with the waterjet operator positioned above for scale. All of the rock in the immediate foreground fell at once.

The massive rock that fell during the waterjet experiment was bound by the discontinuities pictured previously in Figure 6.9. Based on the photographs of the rock taken before and after the experiment, it was believed that much of the material fell as a whole and broke into several pieces when it hit the ground.

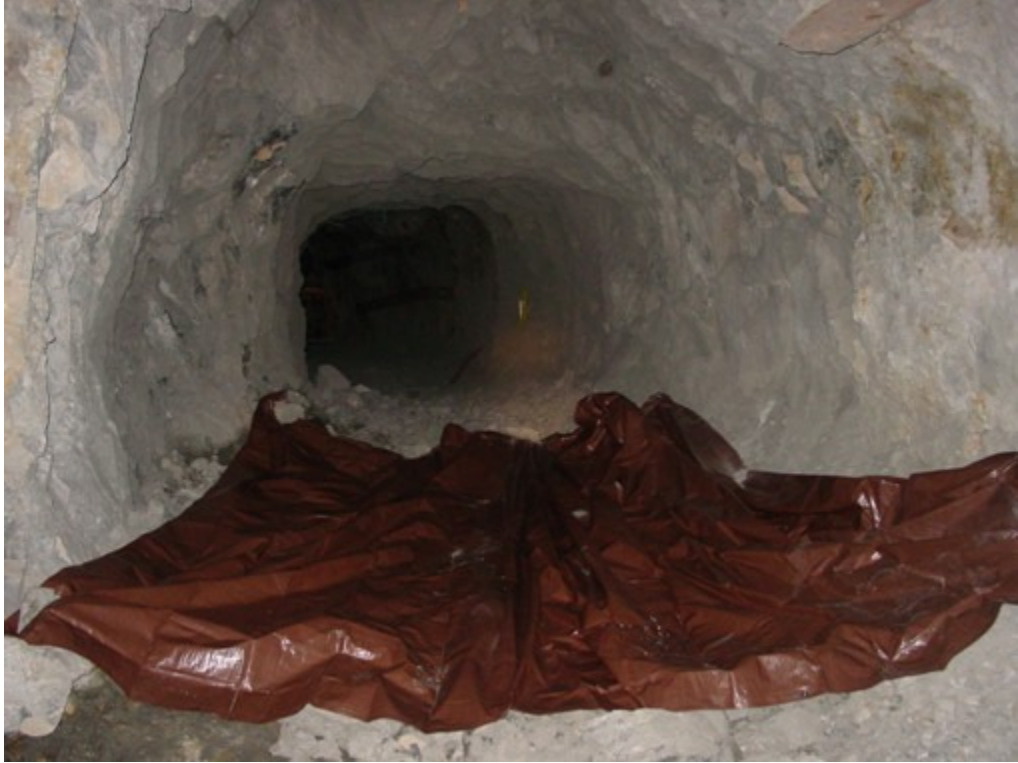
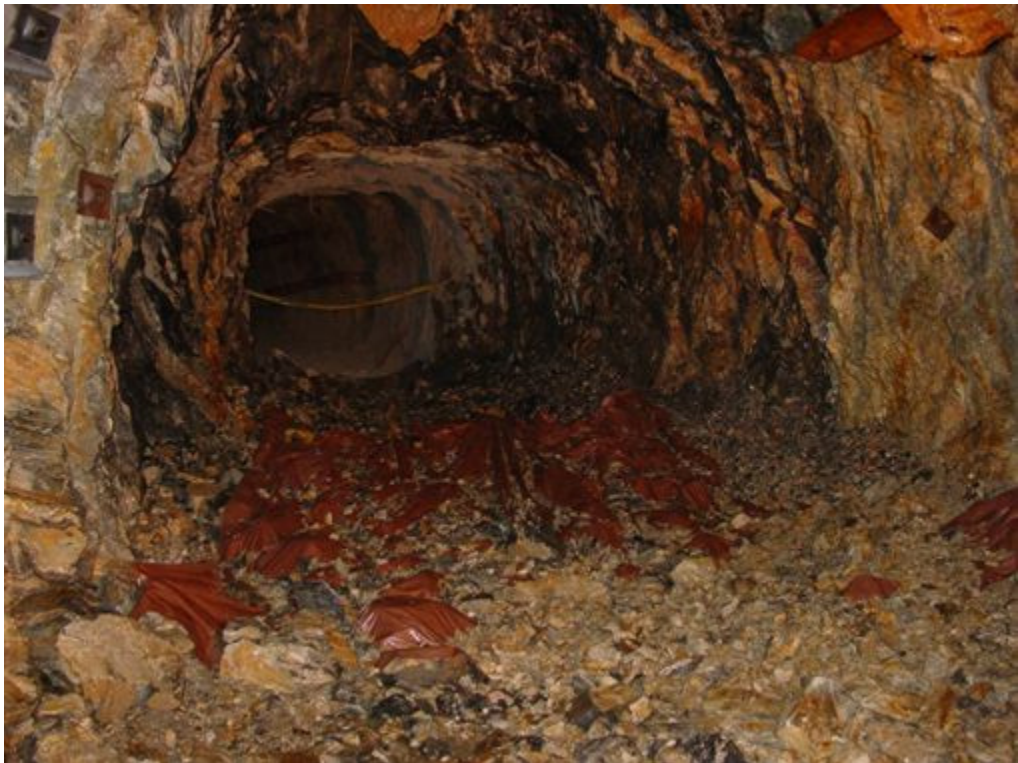
The largest single rock scaled by the waterjet weighed approximately 80 lbs, and the largest rock removed manually weighed 25 lbs. Given the relatively good condition of the rock mass over 90% of the back, the amount of material that fell to the tarp would have been lower if not for the shear zone. Photographs taken before and after the experiment make the location of the shear zone fairly evident. The southeast corner of tarp is inundated with lightly colored, highly fractured rock with a general northeast - southwest trend. See Figures 6.18 and 6.19.

Figure 6.18 Photograph taken before Experiment #3

Figure 6.19 Photograph taken after Experiment #3

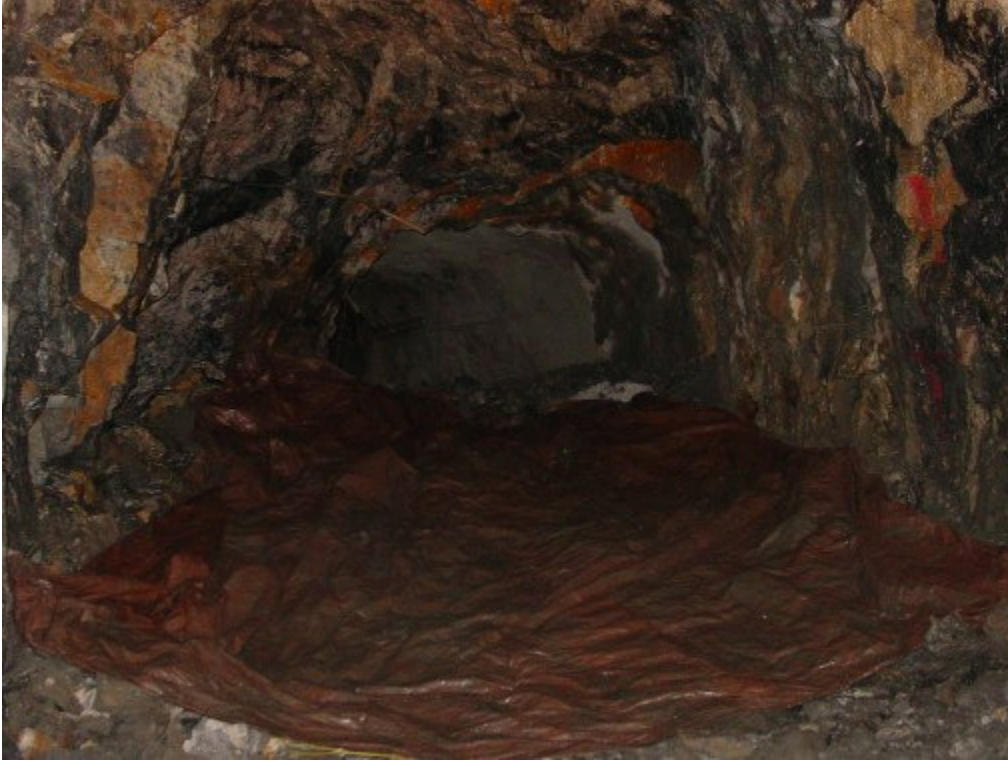
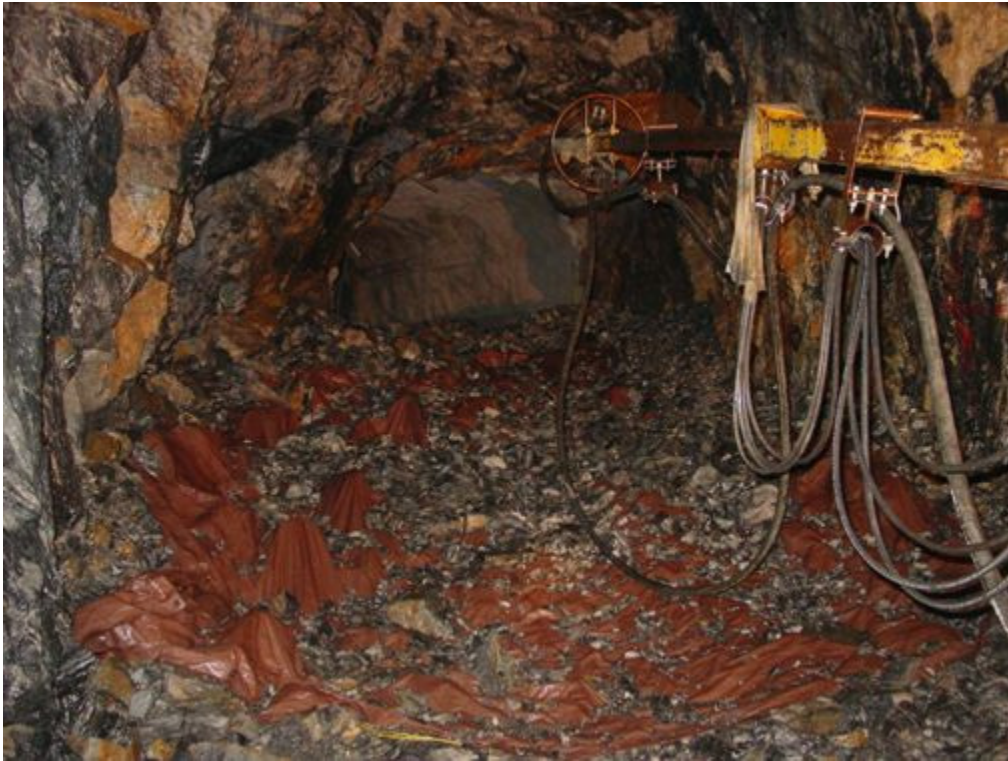
The task of manual scaling was completed by a combination of eight individuals and took place for roughly 75 minutes. The duration of the waterjet test, at 35 minutes, was also abnormally long because of the participation of U.S. Army Rescue personnel in the control of the joysticks. The material that fell during the process of manual scaling was simultaneously collected and weighed while the experiment was in progress, and therefore, there is no photograph of the results. The results of the waterjet scaling can be seen in the before and after photographs shown in Figures 6.26 and 6.27.

Figure 6.26 Photograph taken before Experiment #5 waterjet test

Figure 6.27 Photograph taken after Experiment #5 waterjet test

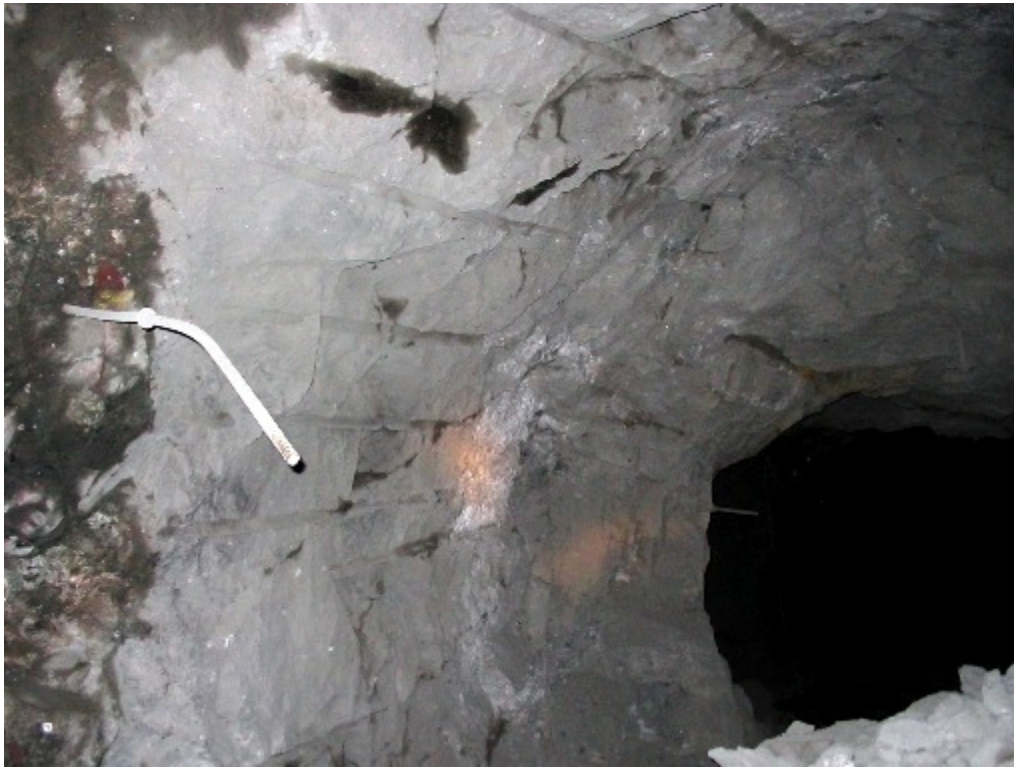
Figure 6.29 Half-cast drill holes visible after blast

The surfaces of the back and left rib formed an ideal arch as a result of the precision perimeter blasting. The success of the blast was also made evident by several half-cast drill holes, plainly visible upon first glance through the drift. See Figure 6.29 for a photograph of the left rib immediately after blasting.

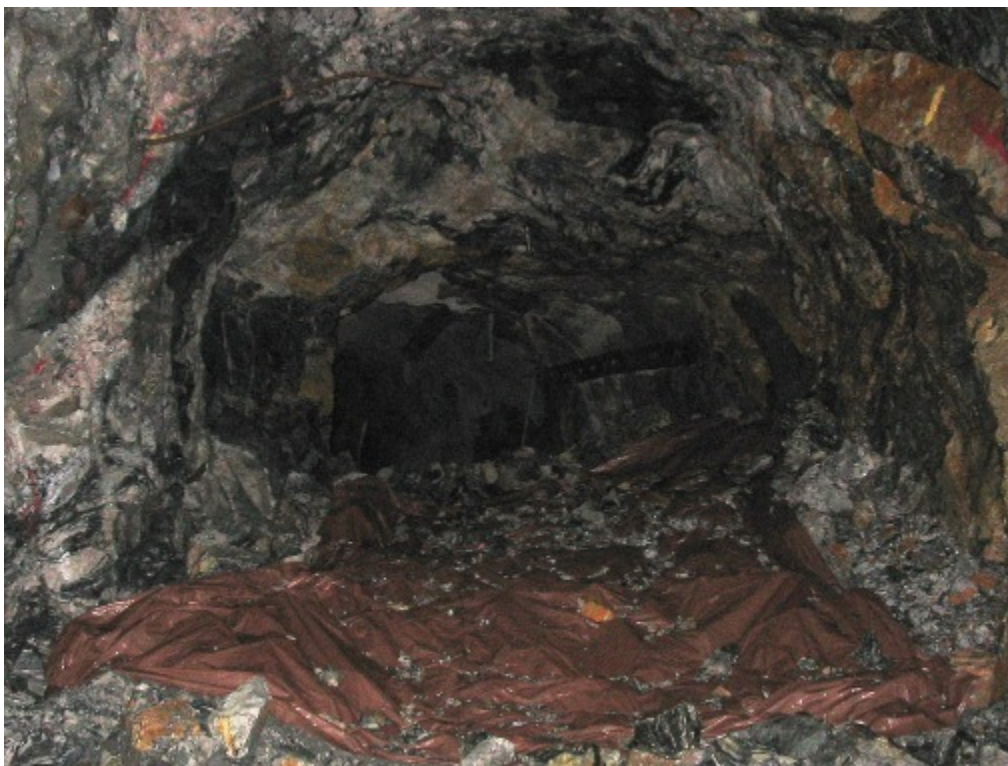
Figure 6.31 Material removed in Experiment #6 waterjet test

The photograph in Figure 6.31 illustrates that the tarp contained very little rock after scaling with the waterjet. It's also evident in the picture that most of the fallen material came from the far side of the blast round, where the drill holes ended and the drift reduced back to a eight foot square profile. The transitional surface at the far end of the blast did not benefit from the smooth wall techniques and therefore required more scaling.

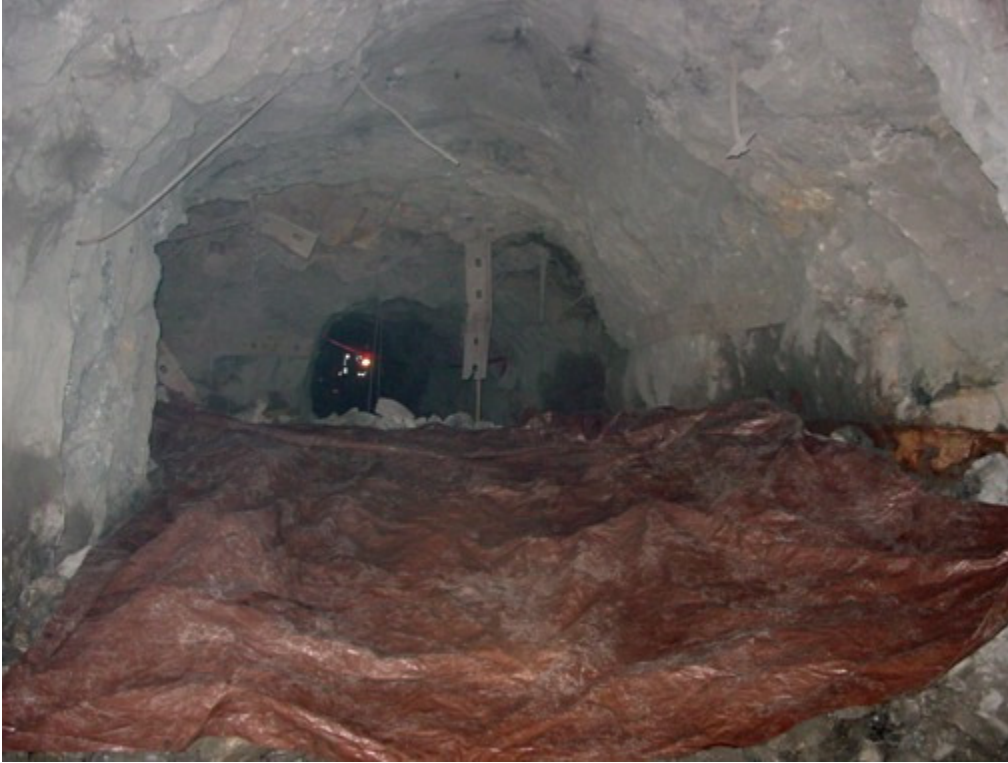
Figure 6.33 Photograph taken before Experiment #7

The nose at the south west corner of the intersection was highly damaged by the blast and manual scaling had to be performed on the rib before it was considered safe to enter the area for setup of the waterjet test. The area that bordered Experiment #7 to the north was littered with remnants of ground support that was damaged but not removed by the blast. See Figures 6.33 and 6.34 for photographs of the area taken before the waterjet test.

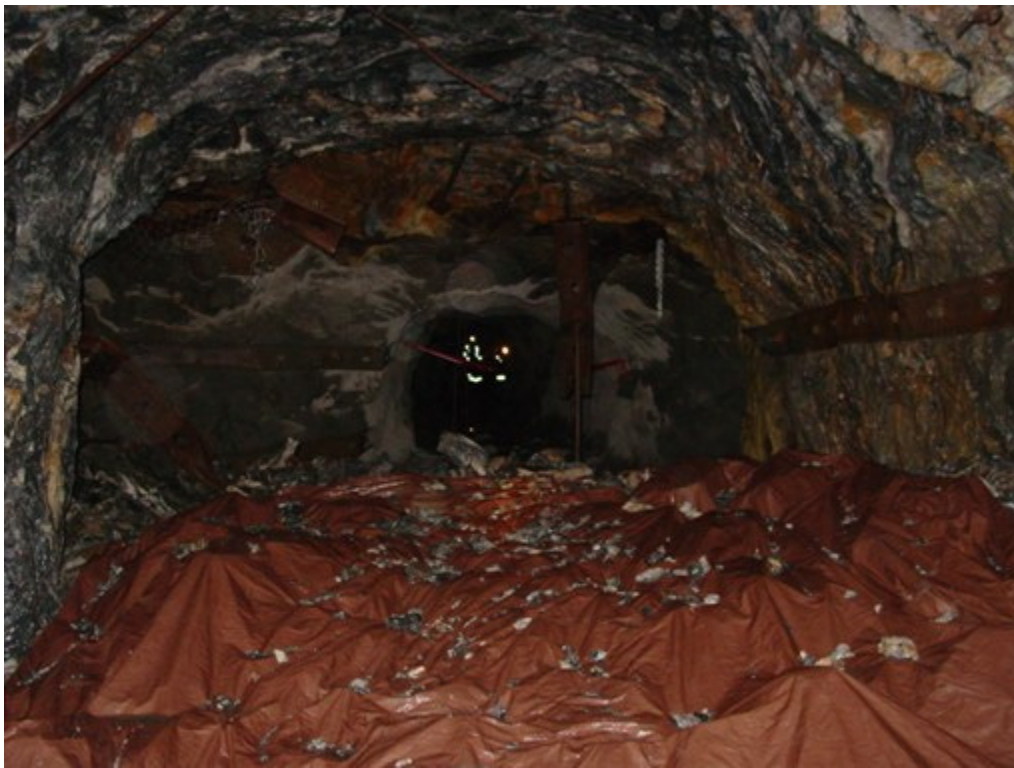
Figure 6.35 Material removed in Experiment #7 waterjet test

The waterjet scaling test commenced for 19 minutes, and surprisingly none of the large blocks of fractured rock noted beforehand fell to the tarp. The block pictured in Figure 6.34 was targeted for several minutes, and though high pressure water aimed at the back side of the rock was seen shooting out the front side of the large fracture, the rock proved to be more stable than first estimated. A photograph of the material removed during waterjet scaling is shown in Figure 6.35.

As evident in the photograph, the smooth wall blasting technique once again resulted in a relatively low overall quantity of scaled material. The largest single rock scaled by the waterjet weighed approximately 90 lbs, and the largest single rock removed manually weighed approximately 120 lbs. The graphical results of the experiment are shown in Figure 6.36.

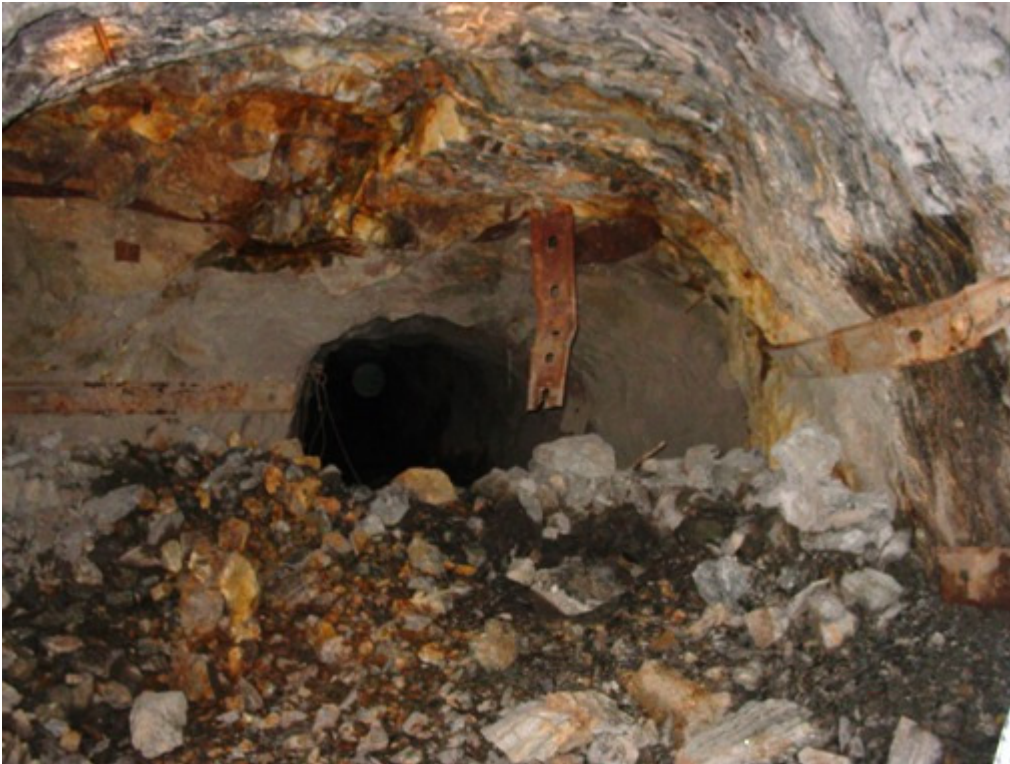
Figure 6.38 Fractured and weathered weak zone in Experiment #8

The rock mass present in Experiment #8 was highly fractured and highly weathered with oxidized staining in nearly every discontinuity and evidence of mineralization in areas. See

Figure 6.38 for a photograph of the area taken before the experiment.

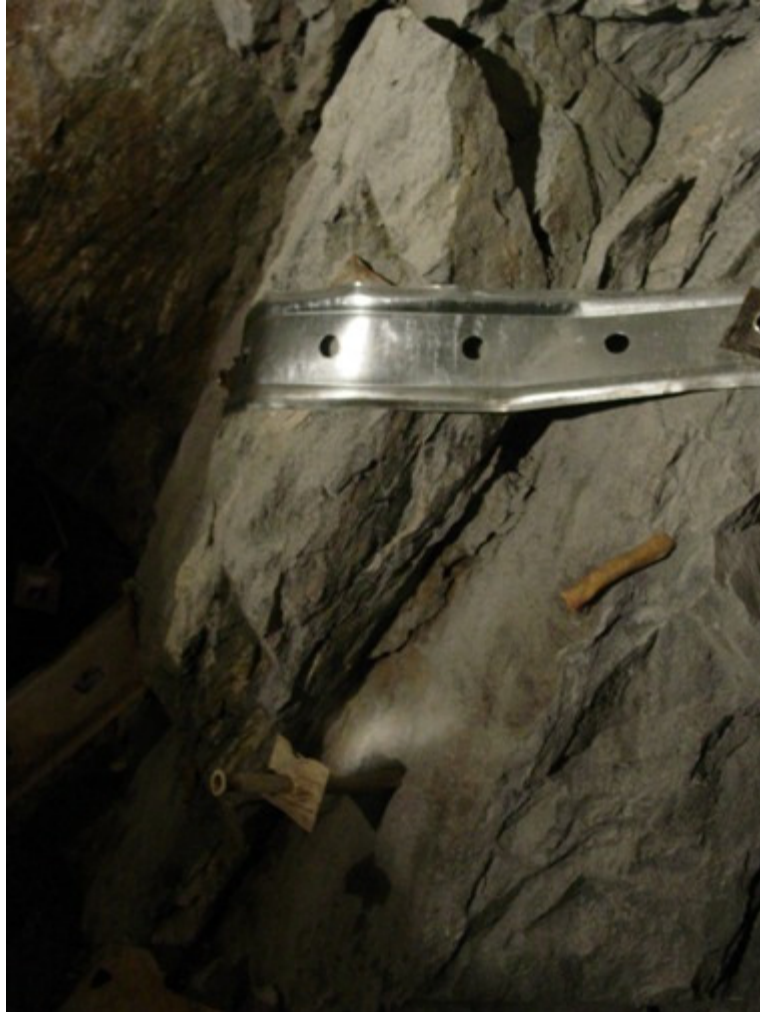
Figure 6.39 Large slab bound by open discontinuities

There was very little similarity to the rock seen in previous experiments. After the blast, there were extremely large and unstable slabs on the north west rib of the intersection. Some were bound by clay-filled discontinuities and others by open fractures. See Figure 6.39 for a photograph of one of the slabs taken after the experiment was complete and rock bolts were installed.

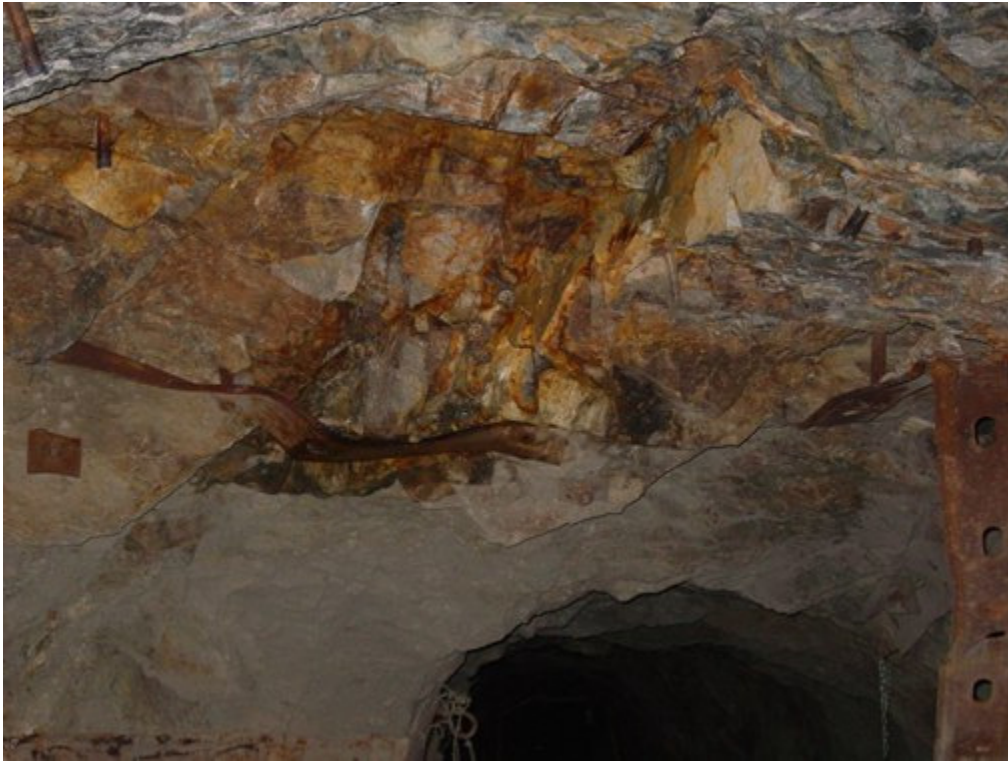
Figure 6.40 Closer view of rock mass in Experiment #8

The profuse orange staining on nearly every visible surface made it difficult to determine exactly what rock types were present in the zone. See Figure 6.40 for a closer view of the rock mass.

The rock seemed to consist of nearly everything known to the area, including granite, feldspar, biotite, pegmatite, and weathered schist, with bands of mineralization including quartzite and pyrite. It would be extremely difficult to map or describe individual geologic features in the area, but extensive fracturing was noted in the north east corner of the back and clay filled discontinuities were common all along the north edge of the zone.

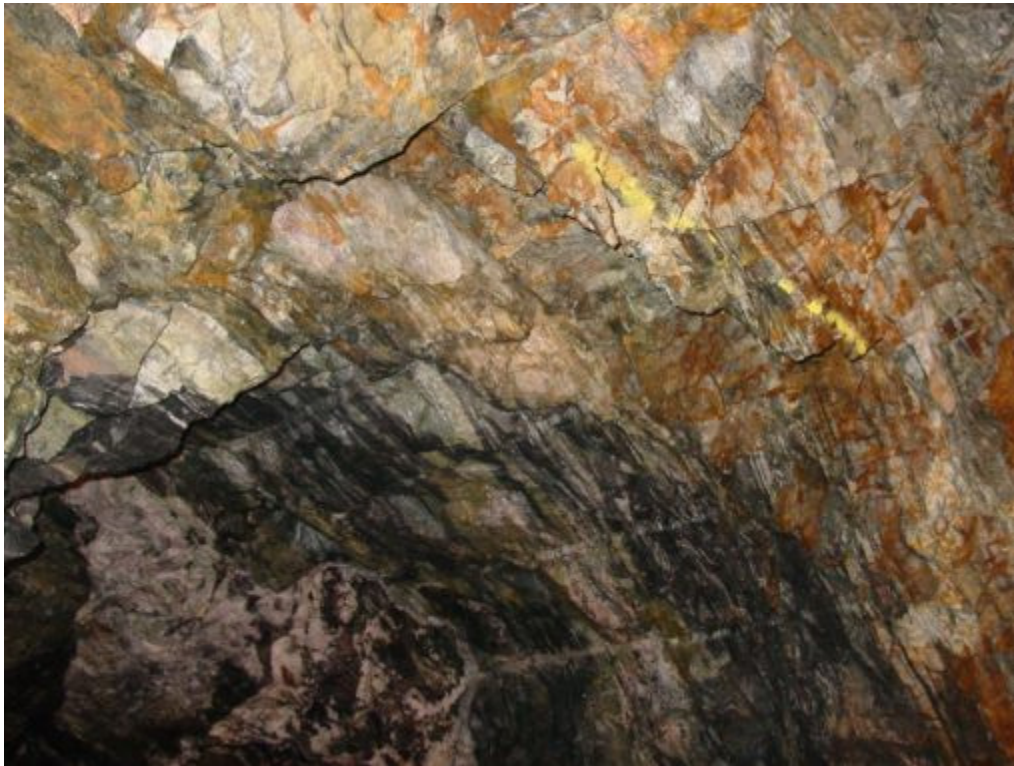
Figure 6.43 Variation of rock type in Experiment #8

middle of the scaling area contained a few discontinuities with a thin clay filling, and the south end, bordering the massive weak zone, was characterized by extensive fracturing and weathered fill material. See Figures 6.43 for a photograph of the back taken after waterjet scaling.

For scale, the yellow spray-painted lines mark the southern end of the round, and the white and black surface at lower left is the transition to the old drift height. The length between the two features is approximately ten feet. Though difficult to distinguish because of the bright lighting, the area between the yellow lines and the darkly colored rock to the left is actually a cavity 0.5 to 1.5 feet deep. The photograph in Figure 6.44 may help illustrate the presence of the void.

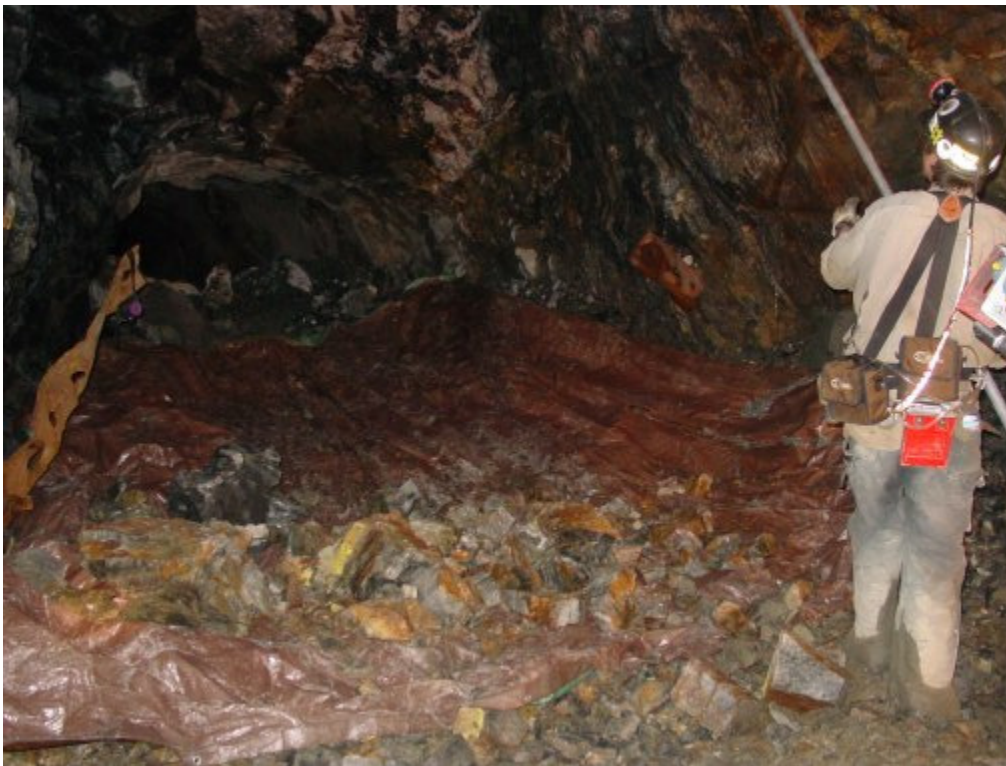
Figure 6.46 Manual scaling during Experiment #9

Similar to Experiment #7, the results of this experiment were dominated by the activity in the weak zone at one end of the drift. Very little scaling took place in the competent, darker colored rock at the north end of the drift. The proportion of material that came from the weak zone is illustrated by the photograph in Figure 6.46, where the north end of the tarp is seemingly bare.
