A PERFORMANCE EVALUATION OF VARIOUS NOZZLE DESIGNS  
FOR WATERJET SCALING IN UNDERGROUND EXCAVATIONS

A thesis submitted to the faculty and Board of Trustees of the Colorado School of Mines in partial fulfillment of the requirements for the degree of Master of Science (Mining and Earth Systems Engineering).

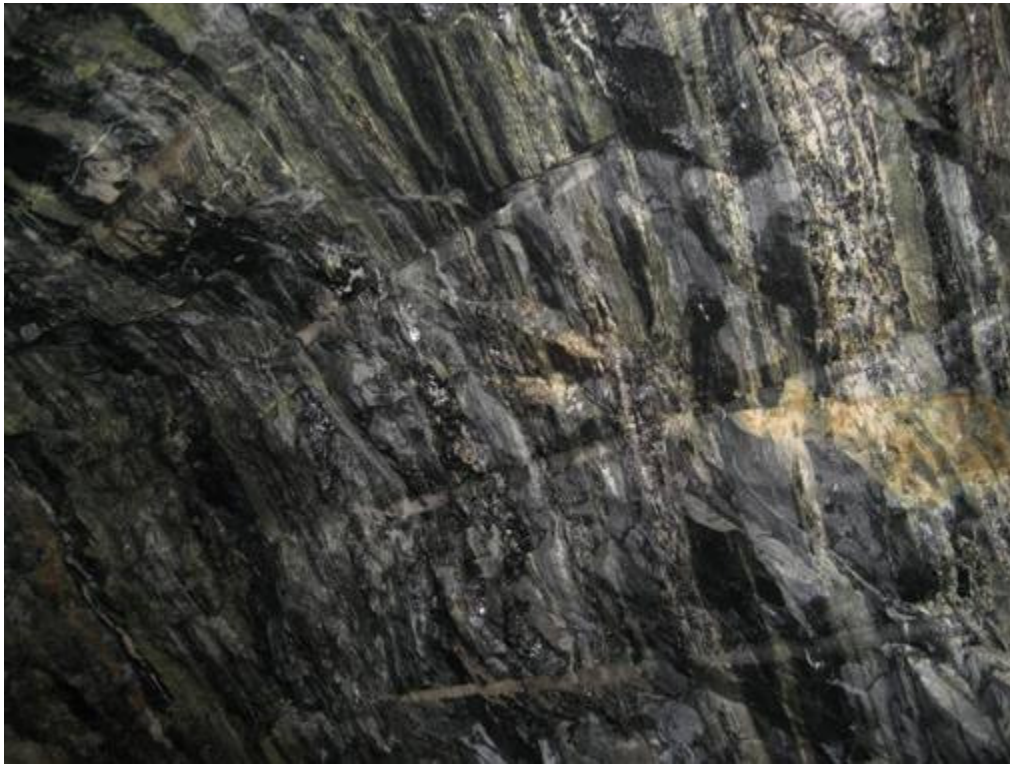
Figure 6.48 Right rib of Experiment #10 drift

that ran through the back and ribs contained a very thin white filling and did not appear to serve as weaknesses during the blast. There was no separation in the joints and the slightly rough surfaces followed irregular paths. See Figure 6.48 for a photograph of the right rib after cleaning with the waterjet.

The drill holes visible in Figure 6.48 are spaced approximately 2 feet from each other, and as illustrated by the photograph, most of the rock broke extremely well during the blast. The first two to three feet of the back and left rib, however, suffered from extremely poor fragmentation. There were approximately two tons of slabs that had to be barred down manually before setup and preparation of the experiment could begin. The RMR analysis, available in Appendix A, did not reveal any geologic features that would likely influence the blast in such a way. Most of the material that had to be removed was already fractured along the perimeter of the intended new drift

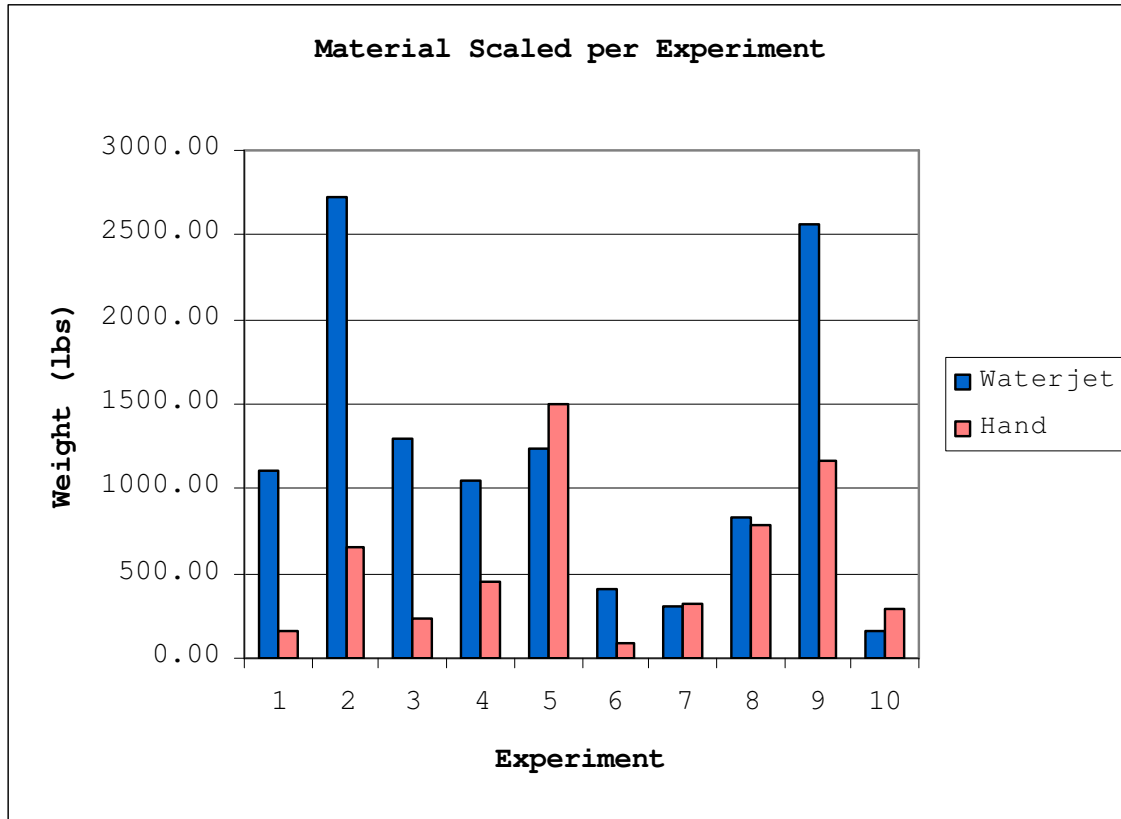
Figure 7.6 Cumulative Results of all experiments by weight

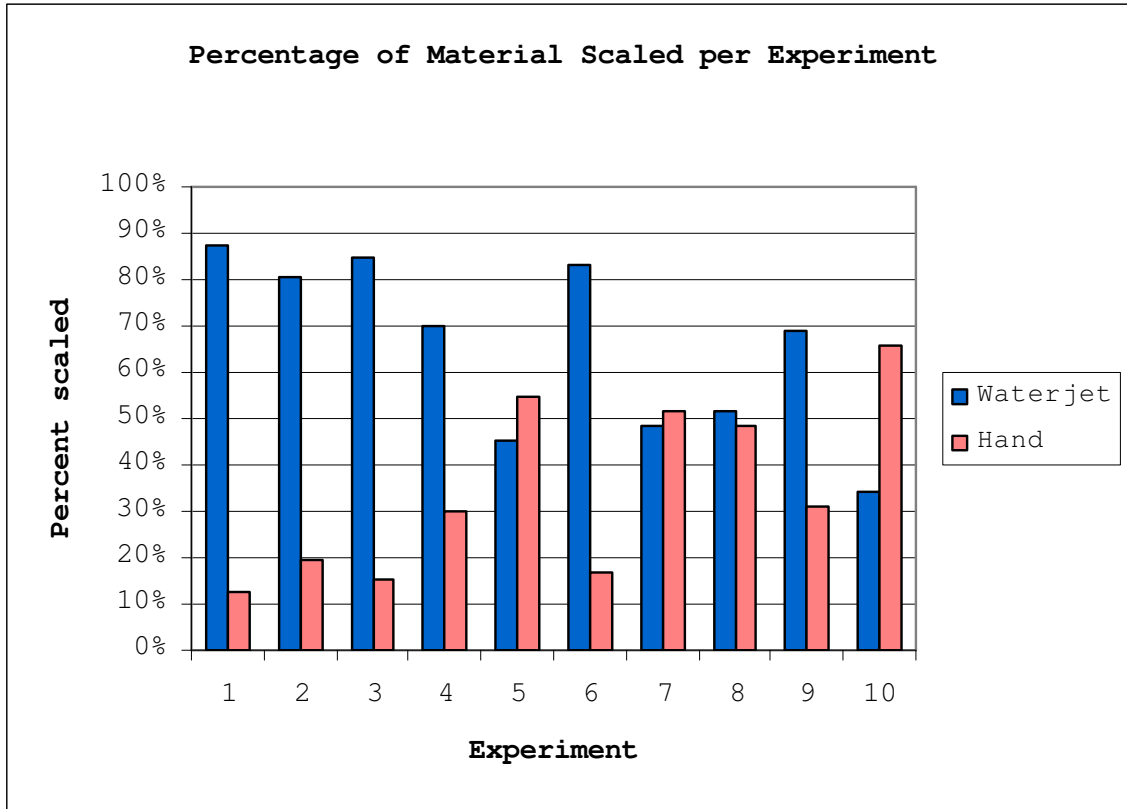
Figure 7.7 Percentage of material removed per scaling method in each experiment

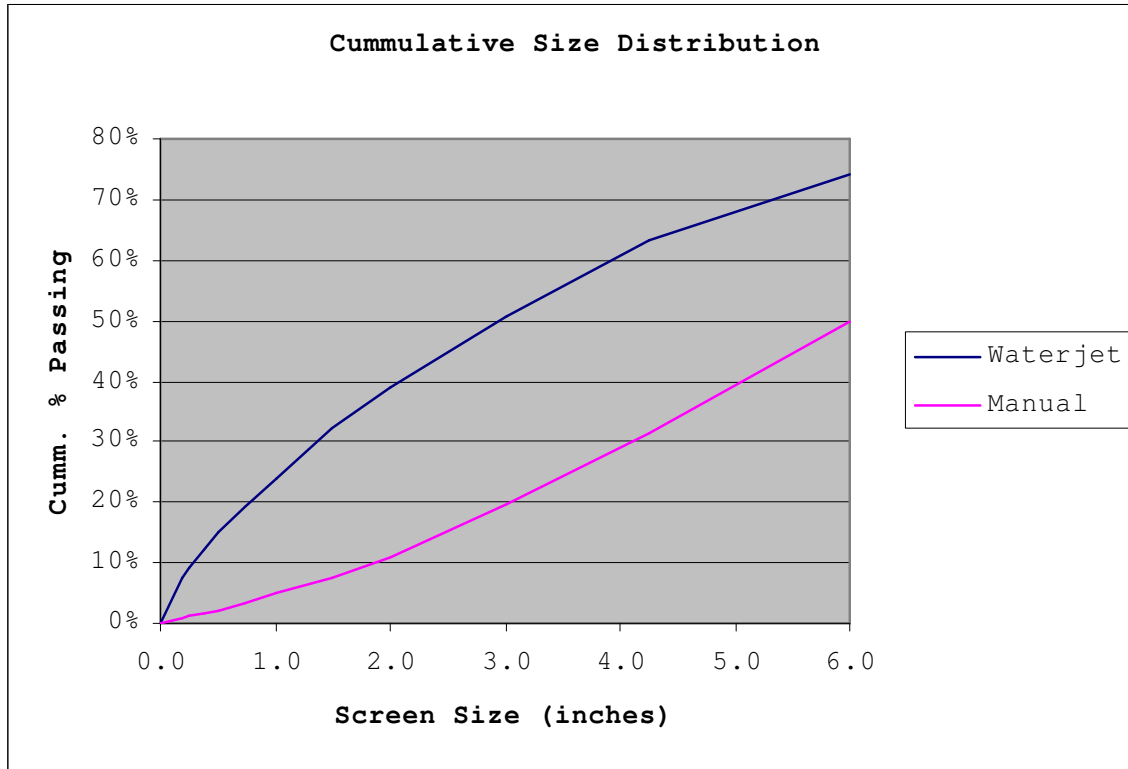
Figure 7.8 Particle size distribution for Experiments 1-4
