A METHOD AND STUDY OF THE STRESSES AROUND AN OPENING
UNDER CONCENTRATED STATIC LOADS USING STRESSCOAT

A thesis submitted to the Faculty and the Board of Trustees of the Colorado School of Mines in partial fulfillment of the requirements for the degree of Master of Science.

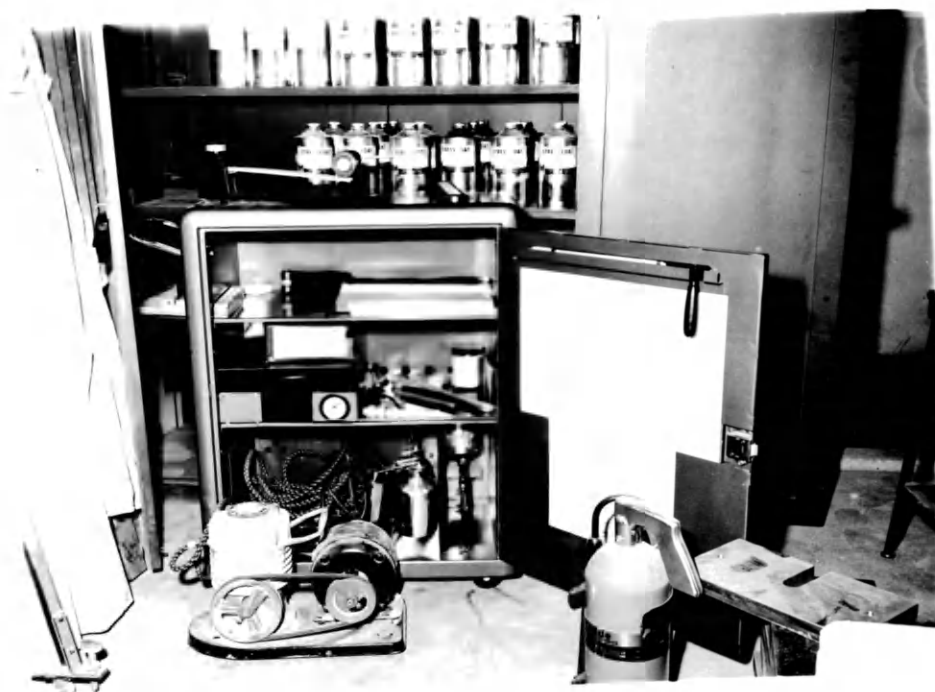
Fig. 4

The Stresscoat materials and application equipment are contained in the model ST-103 Stresscoat apparatus shown in Fig. 4. The materials include various brittle lacquer coatings for use under different conditions of temperature and humidity, aluminum-pigmented undercoating lacquer, dye-etchant for bringing out all patterns formed during testing, etchant emulsifier, and thinners for the undercoating lacquer and for the brittle coatings. Spraying equipment consists of an air compressor oper-

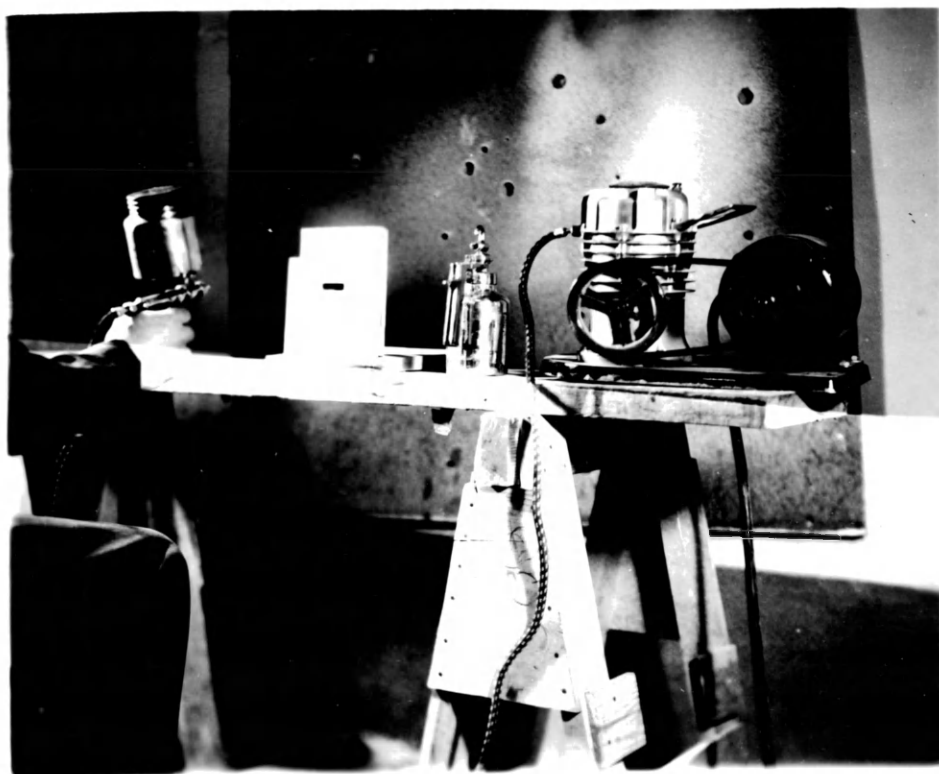
Fig. 10

The application of Stresscoat is the most difficult step in the coating of models. Thick or uneven coatings cause formation of drying cracks which obscure the crack patterns. The formation of heavy, yellowish dust on the surface can be eliminated by diluting Stresscoat with thinner, which does not change the characteristics of the coating. The spraying is done as shown in Fig. 10. Both sides of the model are coated. The model is propped against two nails, one at each side of a wooden backstop, which touch the masked edges of the model and keep the freshly sprayed reverse surface from being marred. In Fig. 10, the spray gun being held by the operator is used for Stresscoat; the other spray gun is used for undercoating. (Under normal operating conditions the

compressor was placed on the floor.) These spray guns were cleaned carefully with thinner after each use to prevent clogging. The use of a galvanized iron hood and exhaust fan eliminated the need for using a gas mask as formerly required.
