ULTRA WIDE GAP BRAZING OF HIGH TEMPERATURE
CAST STEEL BOILER VALVES

A thesis submitted to the Faculty and the Board of Trustees of the Colorado School of Mines in partial fulfillment of the requirements for the degree of Master of Science (Metallurgical and Materials Engineering).

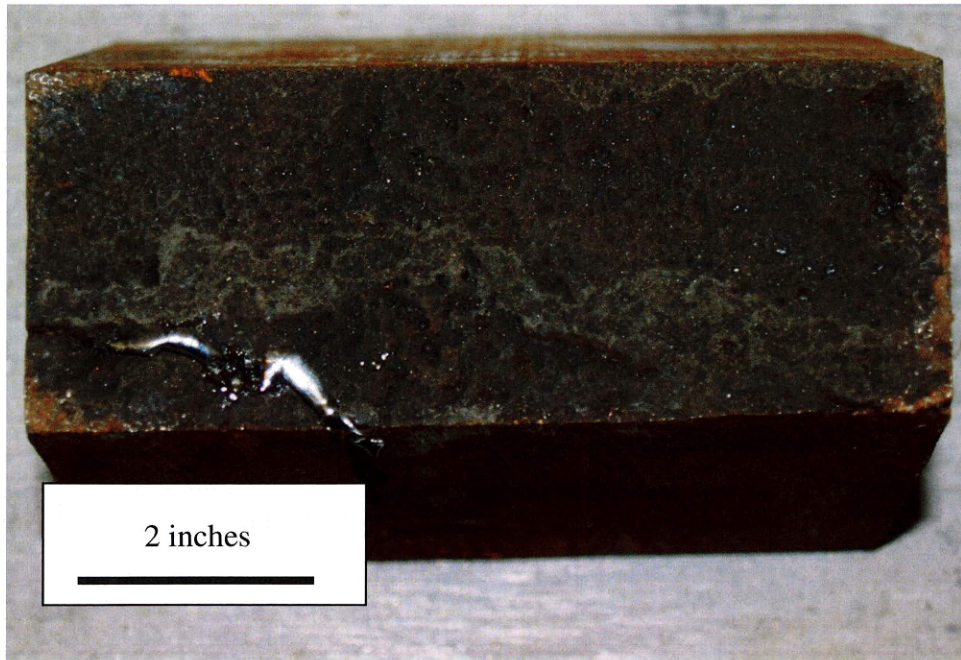
The dimensions determined by ultrasound suggest that the cracks in the physical samples must be characterized in greater detail than simple surface examination. Casting was selected as a method to gain a detailed replica of the cracks of interest. The initial casting material tested was a low temperature solder. While the solder was able to be melted on the cracked surfaces, it did not penetrate into the cracks to any significant depth. Instead, the solder balled up as illustrated in Figures 2.1 and 2.2. This observation is not surprising because of the thick oxide layer on the valve samples that creates non wetting conditions for the molten solder. In an attempt to alleviate this problem, a fluxed solder was used. However, the volume of oxide present in the crack was far too significant to be removed by fluxing action. As a result, solder was disqualified as a viable casting material for this application.

Figure 2.1 – Solder cast in place at surface of boiler valve crack

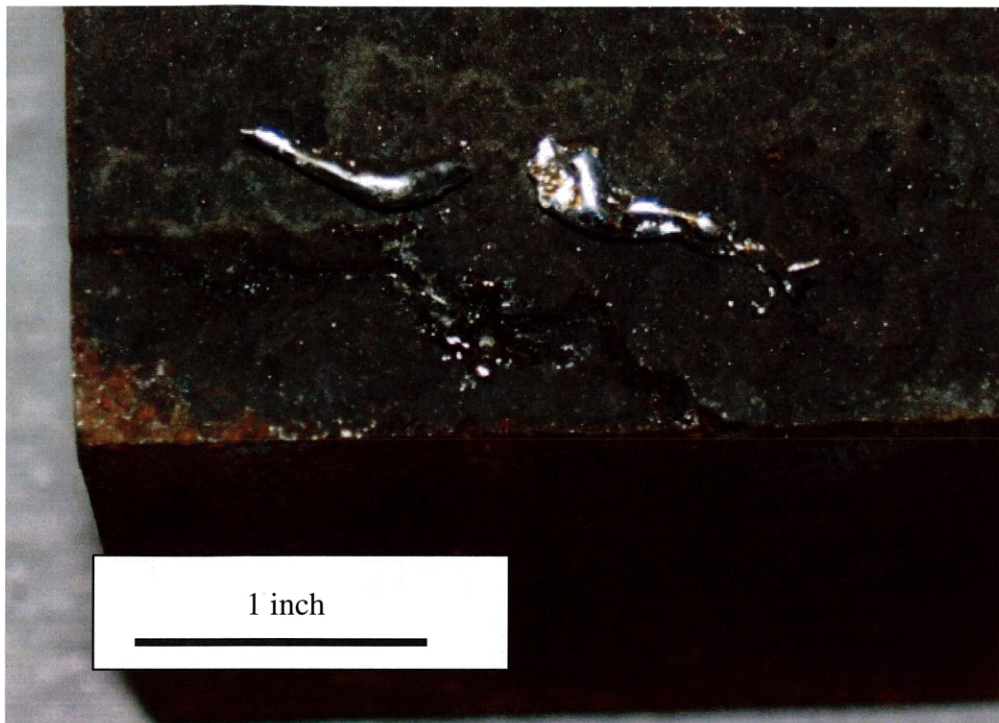
Figure 2.2 – Solder cast removed from crack and shown inverted, cast shows lack of penetration into crack root and poor replication of crack morphology

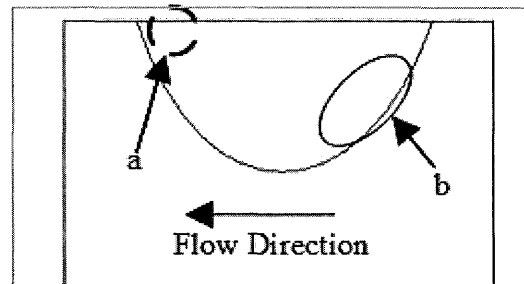
During flow tests using the surrogate systems, two separate types of defects were observed. The most frequently observed defect was the formation of a fillet, which appears as a lack of fill at the joint edge opposite from where the filler liquid was introduced. It is referred to as a fillet-type defect because its physical appearance

Figure 3.10 - Locations of Observed Defects
 a- Fillet-type Defects
 b- Pore-type Defects

resembles a fillet. This defect was only observed with shallow joints with a depth-to-width ratio less than 0.3, and could not be eliminated by introducing additional liquid to the joint or by vibrating the entire joint after filling. Liquid can be added in quantities greater than required to fill the joint. In these cases the filler liquid builds up on the inflow edge of the joint and does not eliminate the defect. The only way found to eliminate this defect type was to physically disturb the flow profile by providing additional liquid directly at the defect location and slightly overfilling the joint.

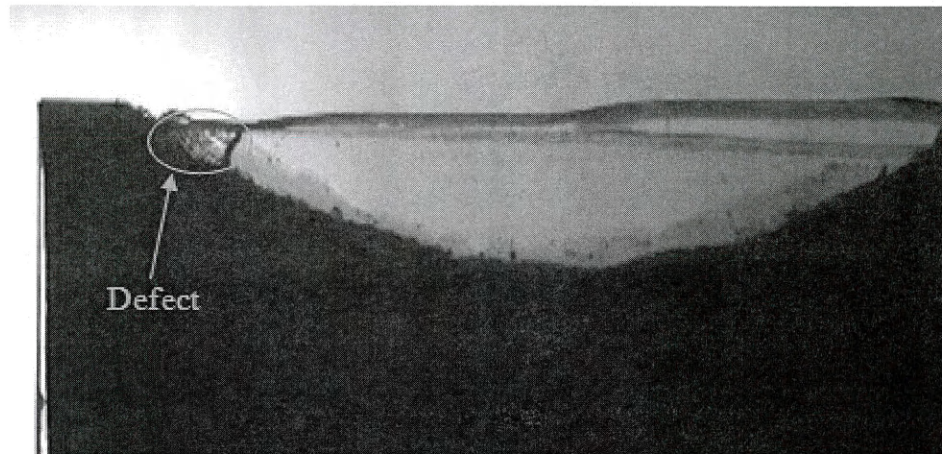
The mechanism for formation of fillet defects is consistent with surface tension-controlled flow. As the liquid fills to the top of the joint and the fluid flow stops, the liquid-solid contact angle is maintained with the bottom curved edge of the joint as shown in Figure 3.11. When the joint is relatively deep and narrow, surface wetting and the equilibrium contact angle causes the edge to reach the surface before the remainder of the fluid, allowing for the joint to fill completely. Figure 3.12 shows a deep crack configuration in which fillet-type defects are not observed. However, in shallow joints

Figure 3.11 - Unfilled Joint End Illustrating Incomplete Filling at Terminal End of Flow Causing Fillet-Type Defect and Additional Filler Accumulating Above Top Surface of Joint
