ENGINEERING GEOLOGY OF THE BATTLE MOUNTAIN LANDSLIDE
SOUTH OF MINTURN, COLORADO

by
Brendan F. Shine

An engineering report submitted to the Faculty and the Board of Trustees of the Colorado School of Mines in partial fulfillment of the requirements for the degree of Master of Engineering (Geological Engineer)

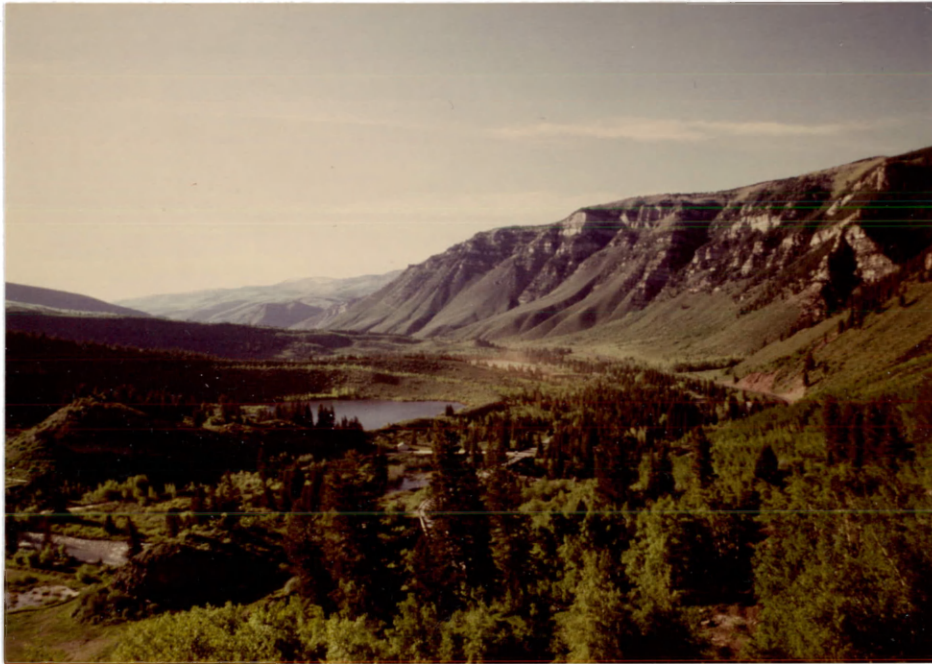
Figure 3. Pinedale terminal moraine at the mouth of Cross Creek Canyon that diverted the Eagle River to the east, oversteepening the valley walls.

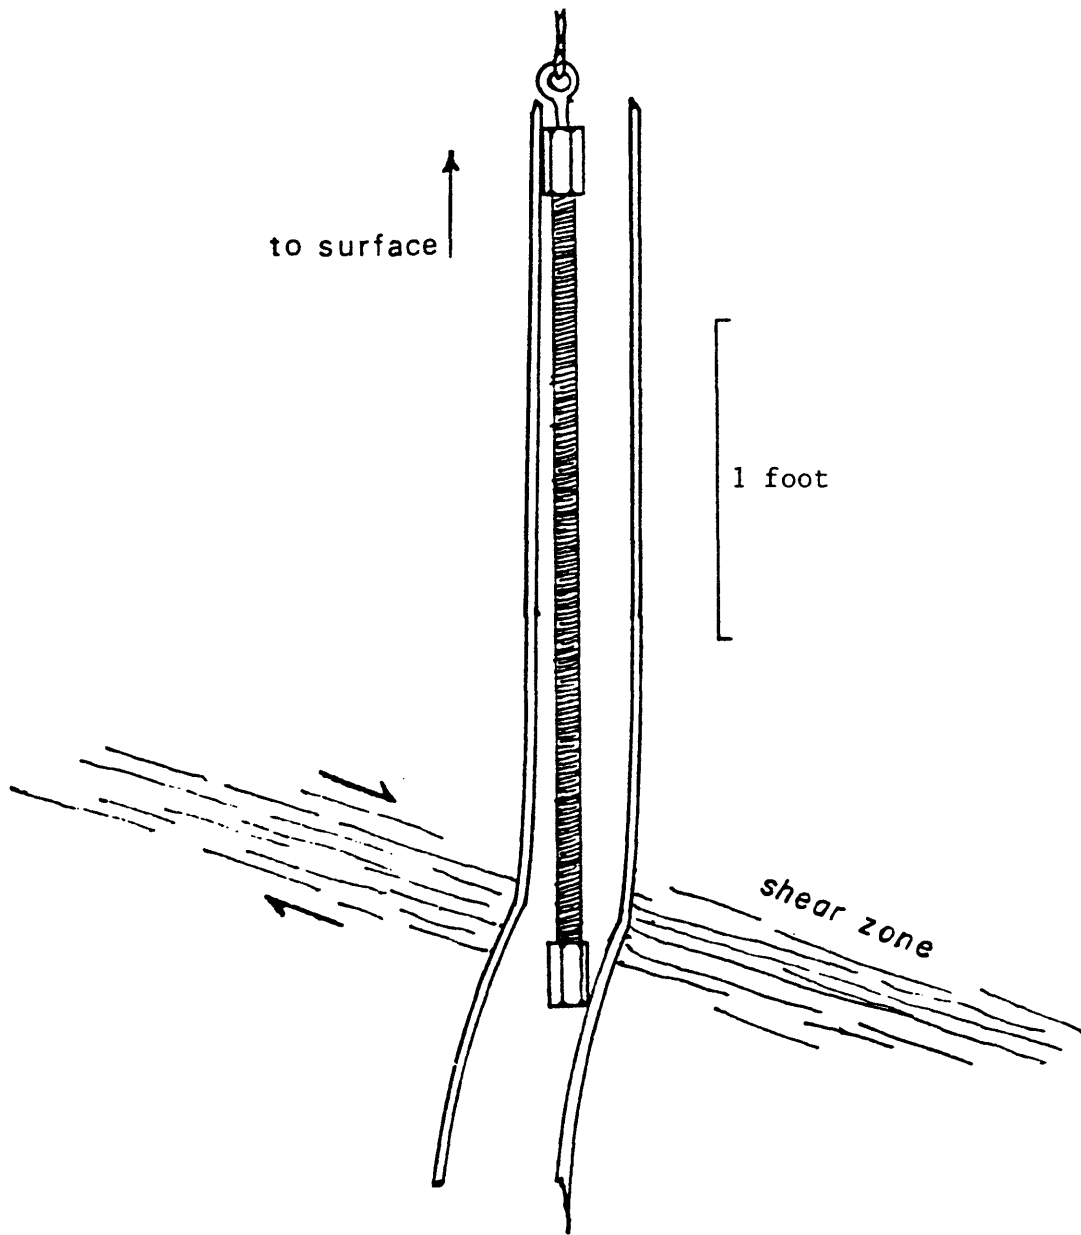
Additional locations of these failure surfaces were desired. Where they intersected the ground surface, cracks or scarps might result, so the locations of all such features on the map were carefully checked. The remaining observation wells were not designed as inclinometers, however, if movements occurred, their casings would bend or break at the shear zones. Accordingly, a "deadman", shown in figure 9, was lowered down these holes to locate such bends. Only the uppermost failure surface, if indeed there were more than one such surface, could be located in this way, but the data were believed to be of value.

Figure 9. "Deadman" used to detect bends or distortions in observation well casings.

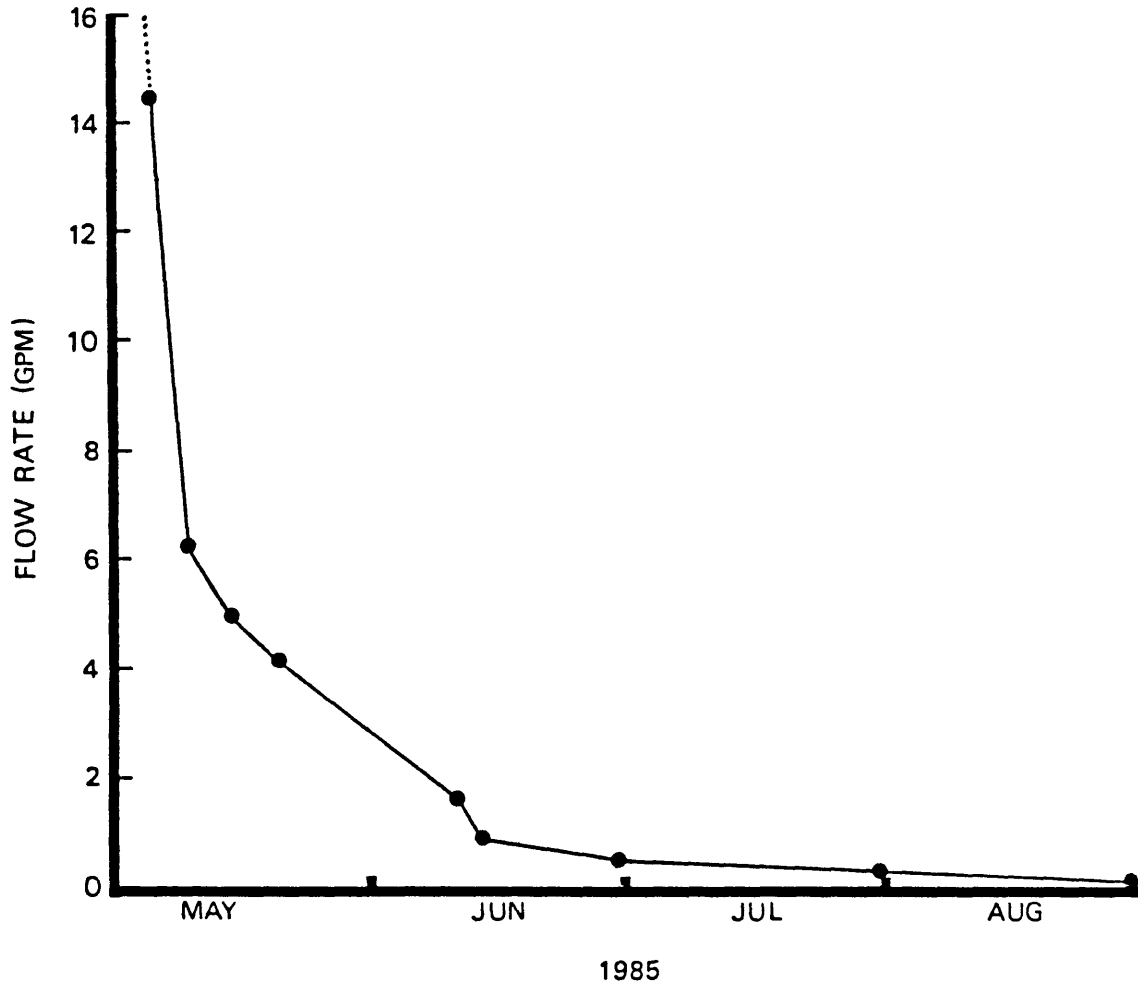
Discharge from the base of the slide was measured by diverting the surface flow originating from the toe area. The flow was directed through a rectangular section galvanized steel gutter down pipe measuring 2 x 3 inches. Flow was directed over the edge of the bank of the gravel road, where the discharge could run directly into a plastic bucket. The bucket was filled repeatedly, and average times were used to determine the flow rate. Discharge rates were determined only in dry weather in an effort to eliminate contributions from overland flow. The flow rates, as a function of time, can be found in figure 12 and table 1. The flow rate decreases as available snow melts from the hillside. All snow was gone by June 5 and flow completely ceased by September 1.

Figure 12. Discharge at toe of landslide.

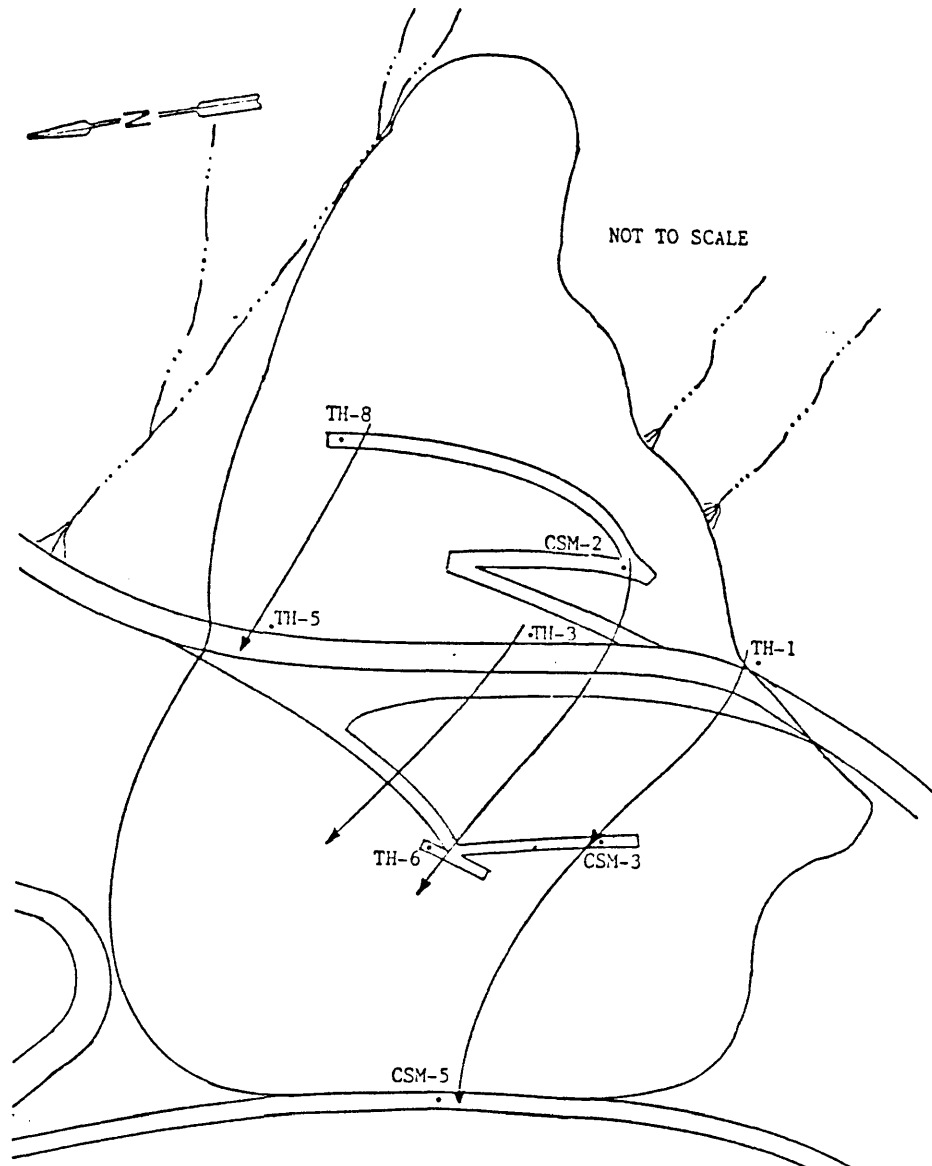
well interval	date of spikes	flow distance (feet)	travel time (days)	potentiometric change (feet)
CSM2-TH6	4-30 to 5-9	340	10	90
TH3-TH6	4-30 to 5-9	280	10	70
TH1-CSM3	4-16 to 4-30	280	14	90
TH8-TH5	4-30 to 5-9	200	10	160
CSM3-CSM5	6-7 to 6-13	370	6	120

Figure 13. Flow paths and data used in hydraulic conductivity calculations. Flow is perpendicular to equipotential lines on Plate 2, hydrograph spikes are shown in figure 10.

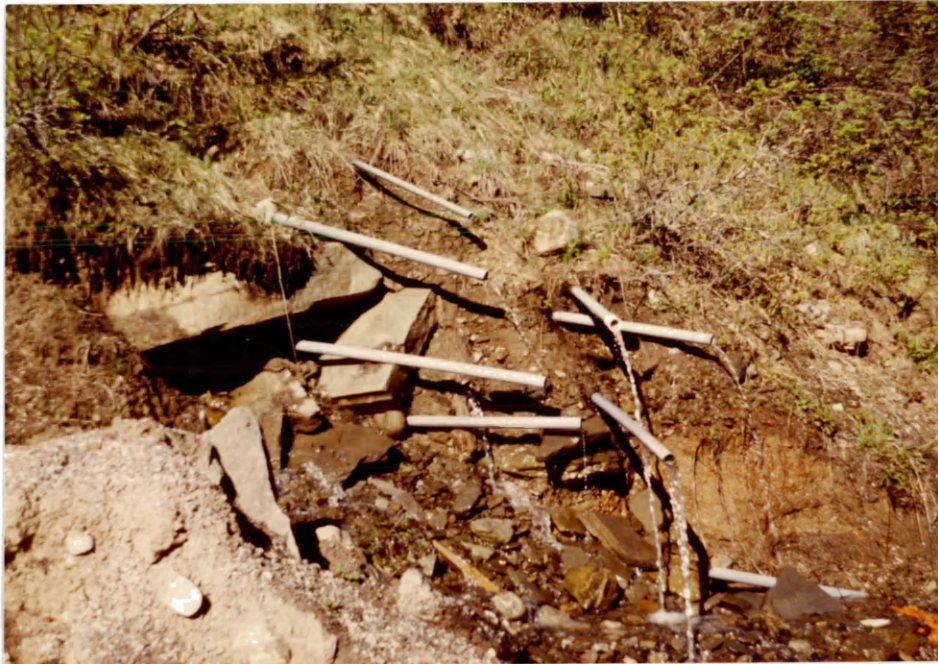
Figure 24. Horizontal drains used on the Whiskey Creek Landslide, north of Minturn.

The Battle Mountain Slide appears to be favorable to treatment by horizontal drains. Generally, these drains are drilled in roughly fan-shaped arrangements from a small number of "drill pads". Economic and technical considerations mandate the use of drill pads which should be located in accessible areas to maximize the potential drainage while minimizing the total amount of drilling.
