SLOPE STABILITY ANALYSIS
OF THE
WOLCOTT LANDSLIDE
EAGLE COUNTY, COLORADO

By
Khalil Nasser

An engineering report submitted to the faculty and the Board of Trustees of the Colorado School of Mines in partial fulfillment of the requirements for the degree of Master of Engineering (Geological Engineer).

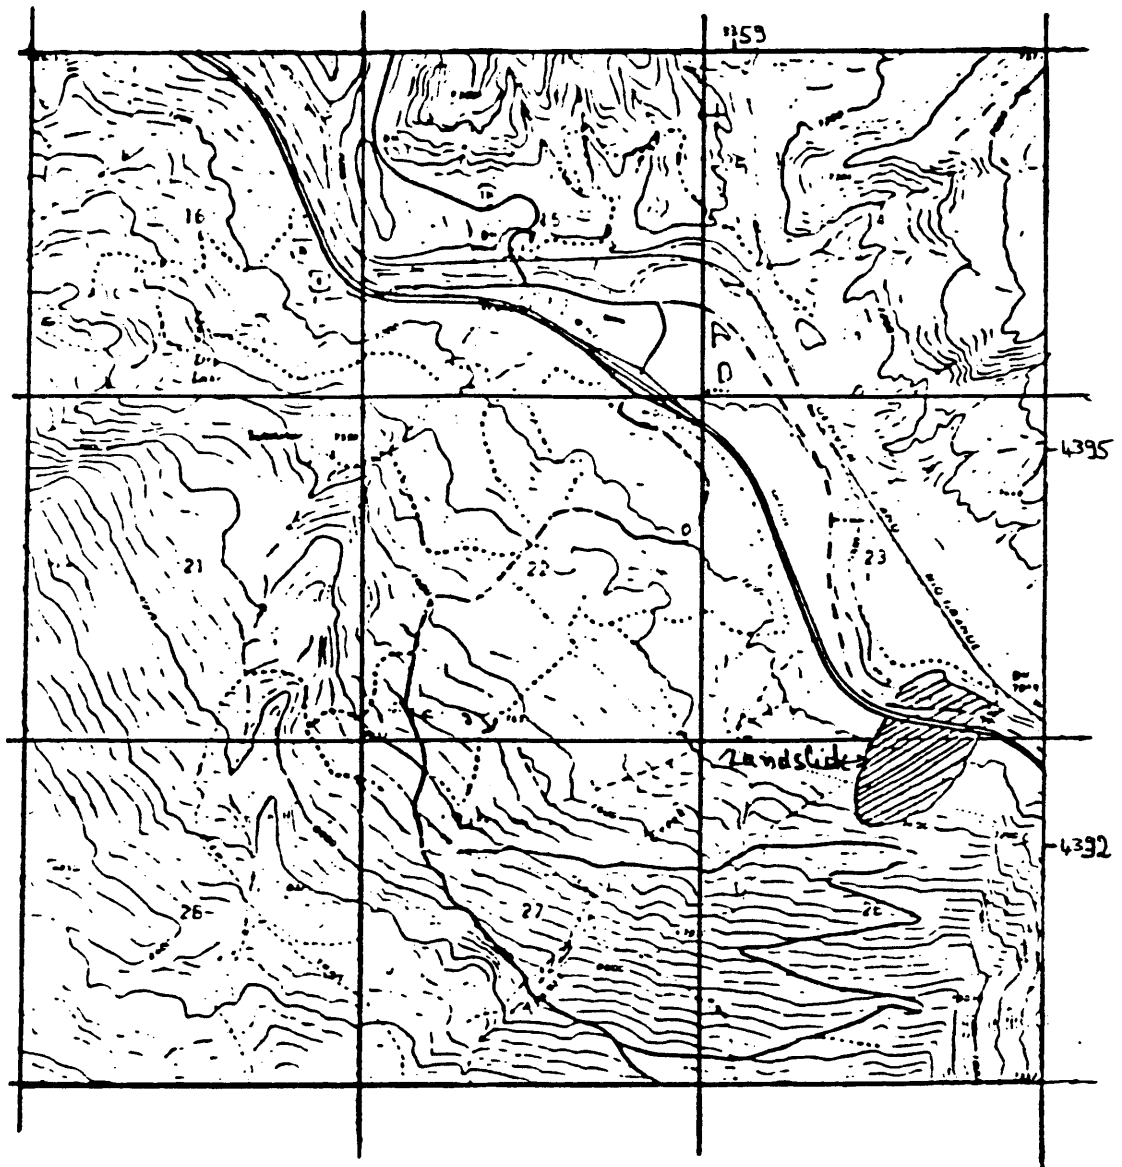
Figure 3 : Topography at the Immediate Landslide Area.

The Wolcott area is structurally low and surrounded by the Gore and Park ranges towards the east and the northeast, the Sawatch range to the south, and the White River Plateau to the west. Figure 3 shows the general topography at the immediate landslide area.

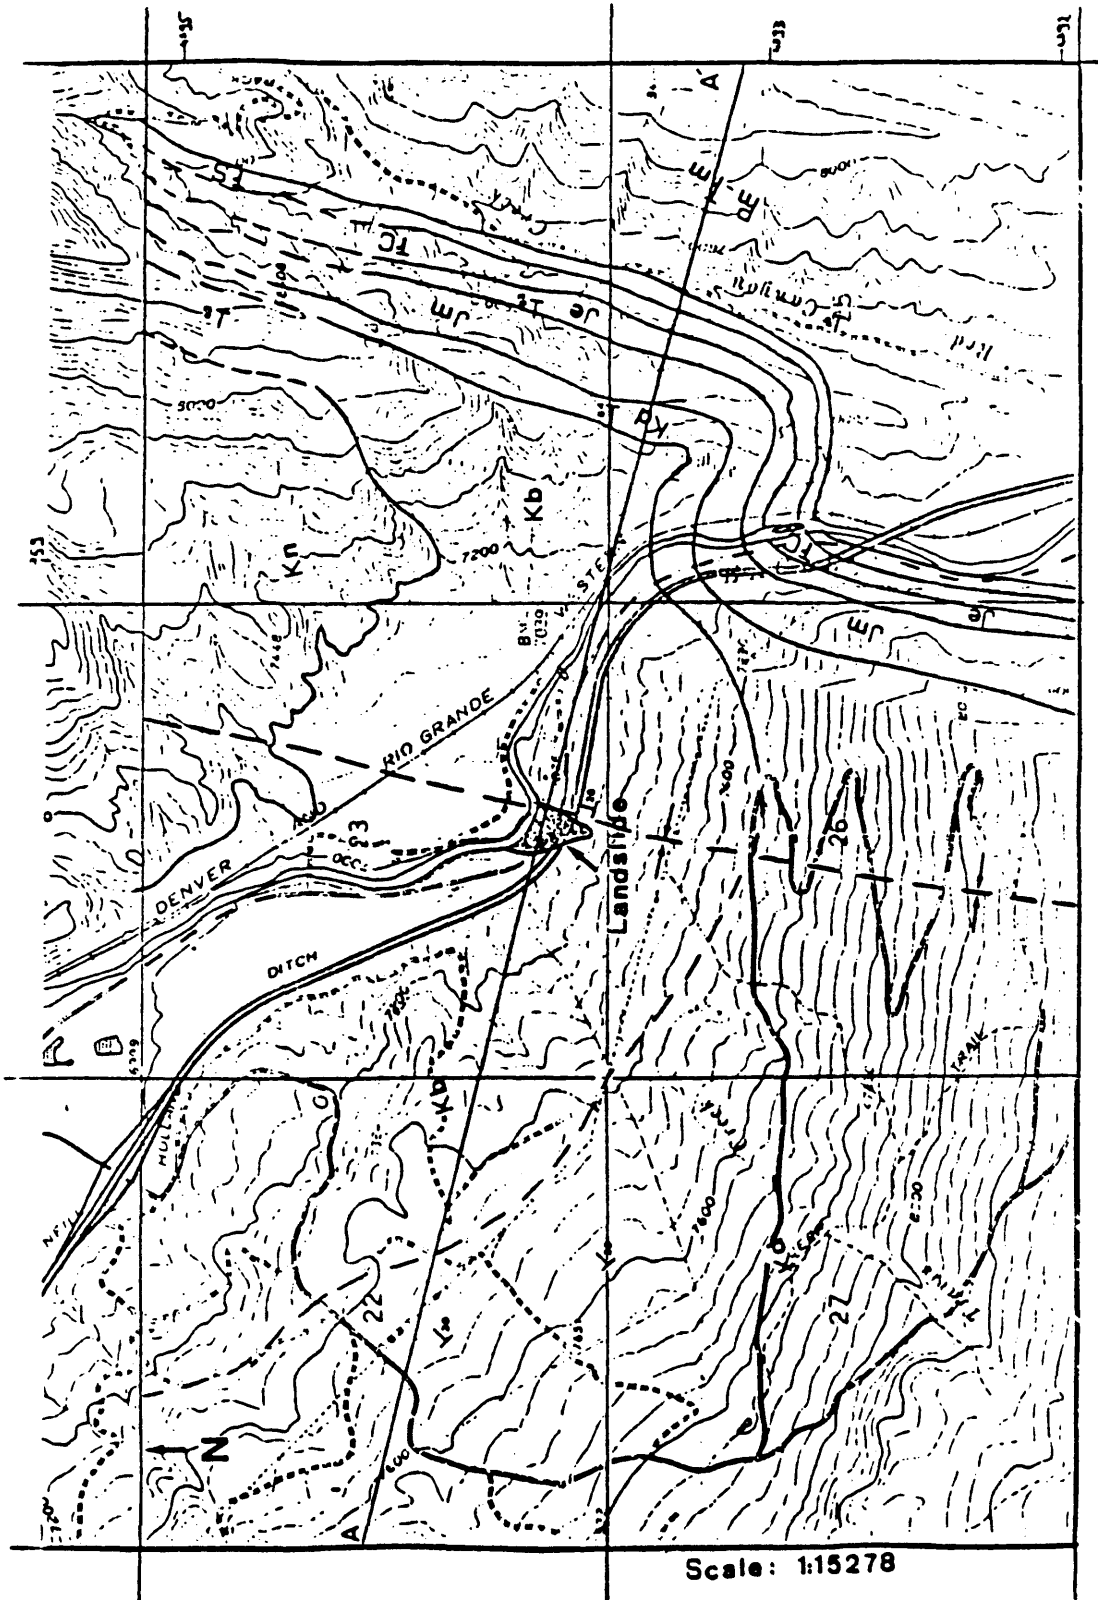
Figure 4 : Geologic Map of the Study Area.

The geologic setting of the landslide was critically evaluated during this investigation; an existing 1:24000 scale geologic map by Wanek (1952) and aerial photos were used to guide the field mapping. Detailed geologic field work was completed by the author during the month of August 1985. The bedding attitudes and stratigraphy were checked and corrected to accurately relocate the axis of the Wolcott syncline, the main structural feature in the area. The resulting updated geologic map is shown in Figure 4.

The lower sections of Bellyache Ridge are underlain by the Benton formation while the upper sections are underlain by the Dakota sandstone. The contact between the two formations is covered and could not be precisely located in the field (see figure 4). The landslide occurs in the interbedded sandstones, siltstones and shales of the Benton formation. It is located near the axis of the Wolcott

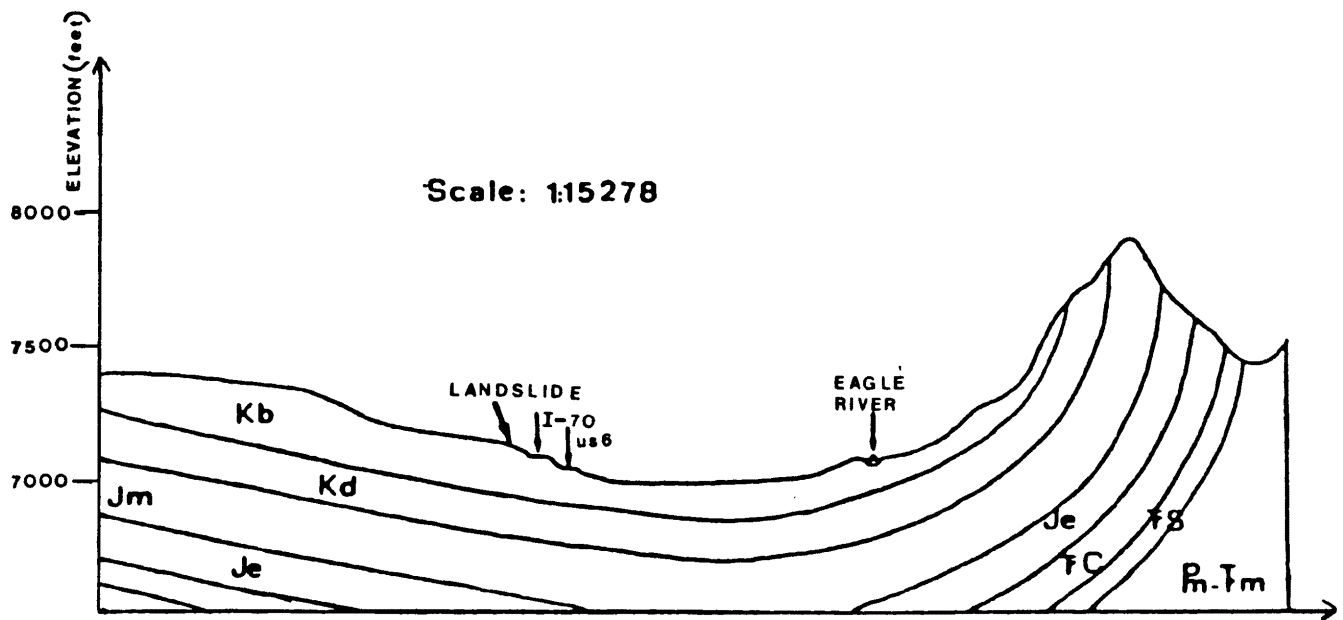
Figure 6 : Structural Cross-Section along Line A-A' Shown on Figure 4.

The Wolcott syncline plunges towards the north with its axis passing near the distinctive meander of Eagle River that faces the toe of the landslide. Dips on the western limb of the Wolcott syncline range from 8 to 25 degrees northeastward, while beds on the eastern limb rise gradually away from the synclinal axis until they steepen very abruptly to nearly vertical attitudes at the east of the map area. Figure 6 is a structural cross section across line A-A' indicated on the geologic map (Figure 4).

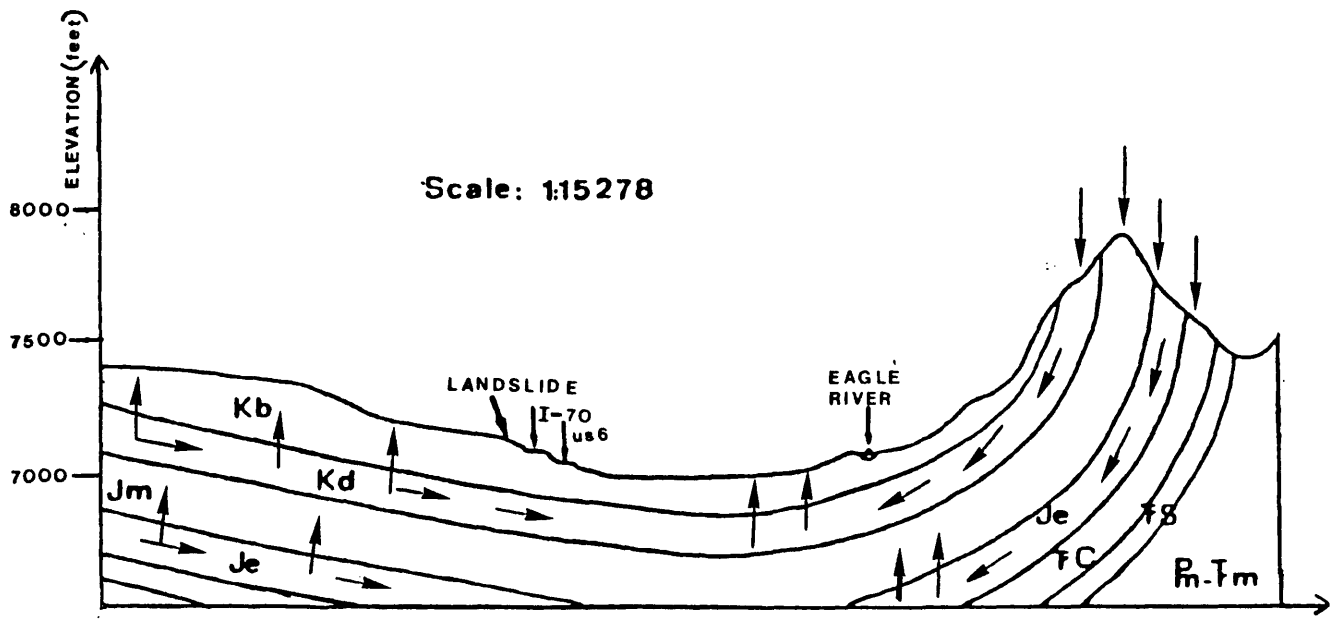
Figure 7 : Regional Groundwater Flow Conditions near the Slide Area Suggested by Field Observations.

The ground water flow within the slide mass is essentially part of a larger regional groundwater flow regime shown in Figure 7. The area is characterized by a series of low transmitting capacity aquifers (Lohman, 1979) that are confined by very low permeability beds of siltstone, mudstone and/or shale. The main aquifer in the area is the Entrada formation.

The regional ground water flow appears to be directed toward the Wolcott syncline axis. Groundwater, coupled with seepage and infiltration of large volumes of water from precipitation through the heavily broken siltstone.

composing the surface over much of Bellyache Ridge uphill from the slide, caused a marked rise in the potentiometric surface during April and early May. The net result is a high level of saturation through the landslide material which undoubtedly contributed to its instability.

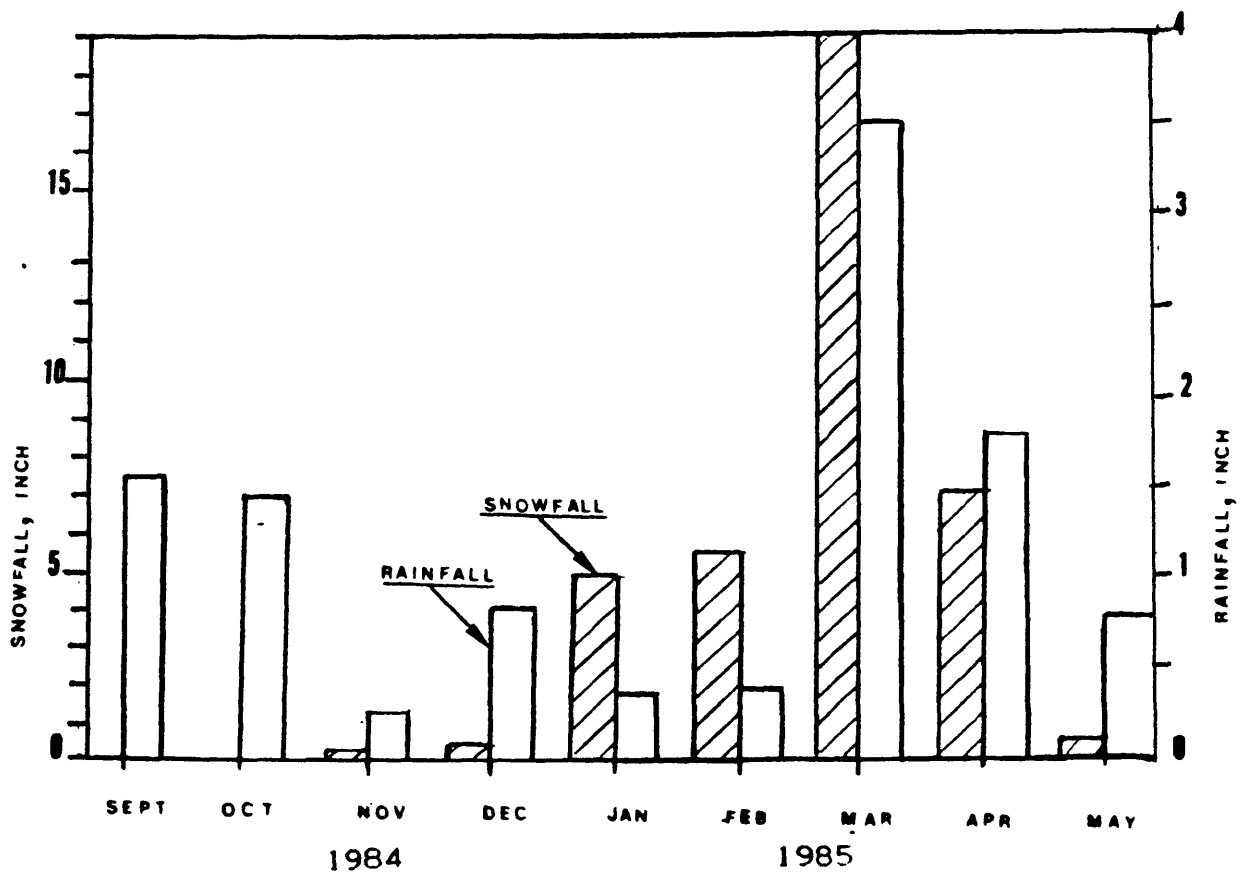
Figure 8 : Precipitation Data, Year 1984-1985.

Table 2 shows the rainfall and snowfall data from September 1984 to May 1985 obtained from NOAA climatological records. These data are for the town of Eagle, the closest available station to the study area. A plot of this data is shown in Figure 8. The increase in precipitation during the months of April and May, 1985, correlated with the increase in the piezometric water levels at that time, suggesting that rainfall and snowmelt contributed to the recharge in the slide. This is probably due to the heavily fractured and broken character of the siltstone forming the surface of the slide. This probably facilitates water percolation into the slide material rather than allowing it to flow across the surface and via local drainages directly into Eagle River.

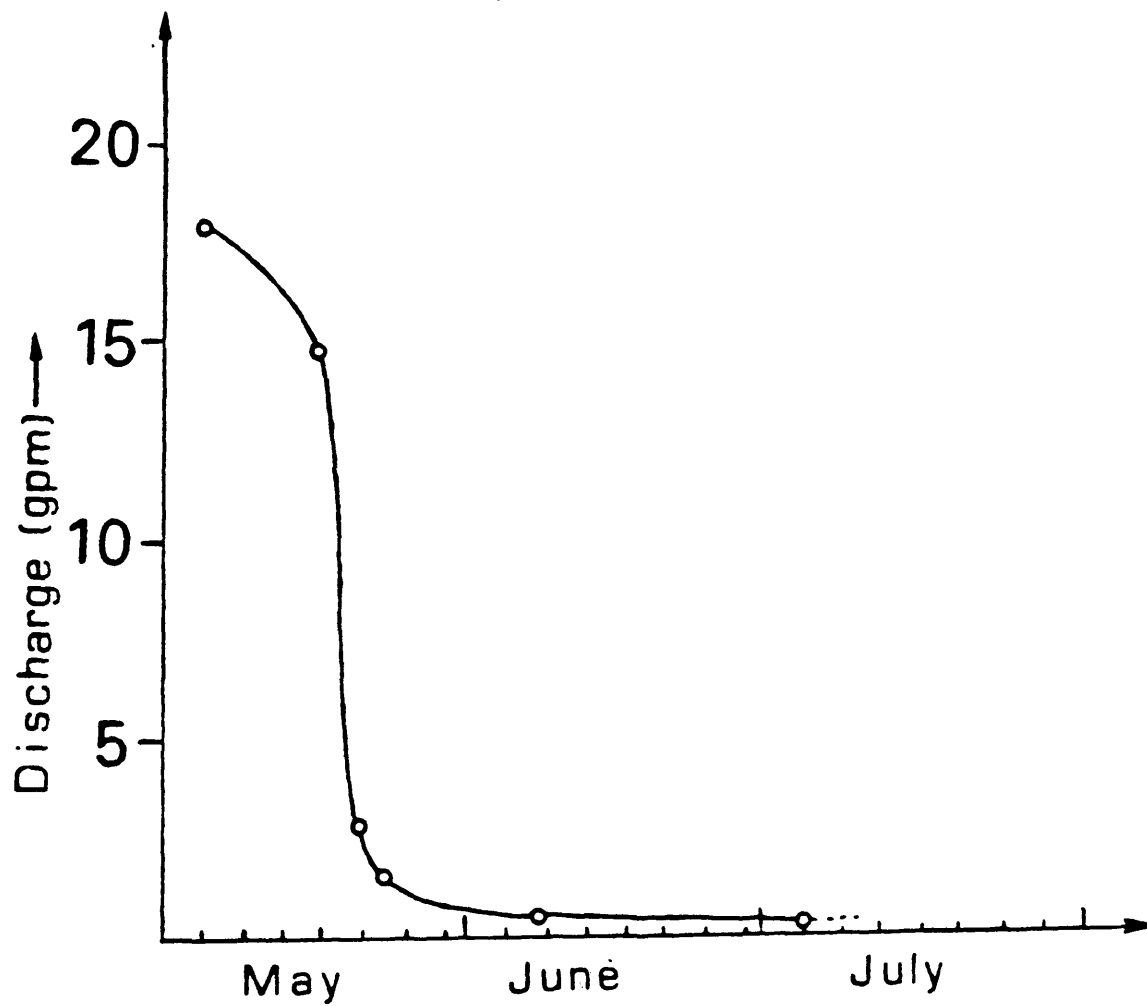
Figure 9 : Flow Rates versus Time near Inclinator CSMW4.

Seepage was observed at several locations early in May. The largest seepage was observed near CSMW4 adjacent to the eastern scarp of the landslide. Other seepages were observed on the scarp face above the Eagle River meander at the toe of the landslide. The discharge at the seep near CSMW4 was measured by averaging the times required to fill a known volume of a container. These flow rates at different dates are shown in Table 3 and Figure 9. The flow rate decreased dramatically by the middle of May as most of the snow had melted from the hillside. Flow completely ceased by the beginning of August.

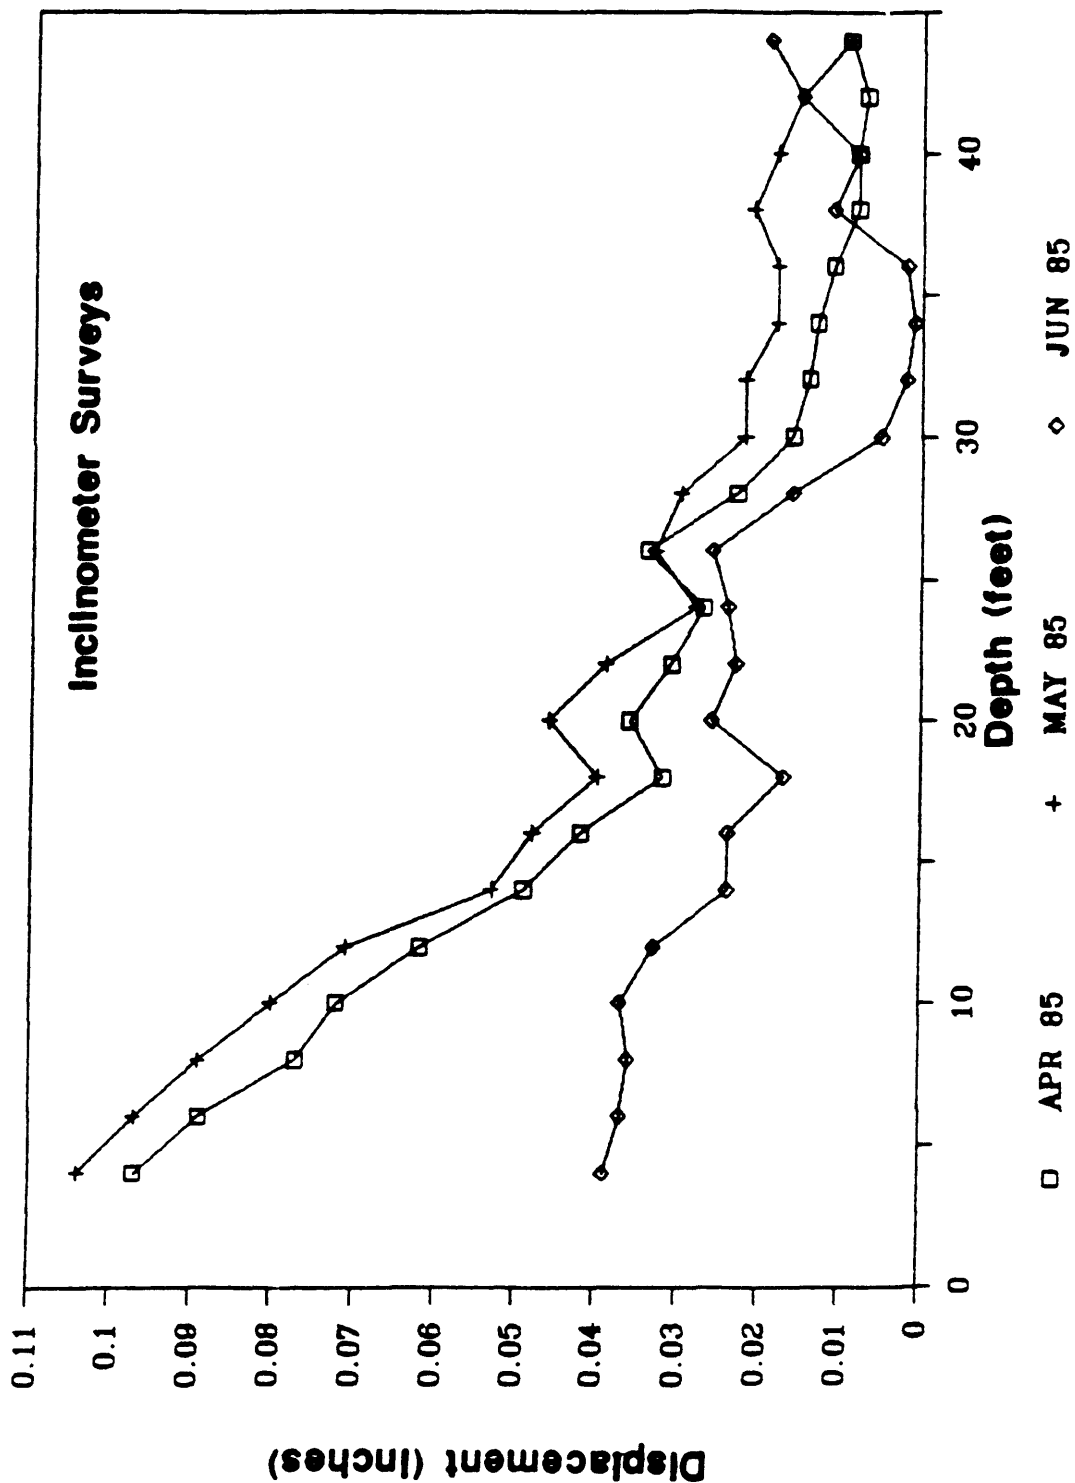
Figure 11 : Inclinometer CSMW2 Data.

Inclinometer CSMW4 sheared off just below the ground surface on May 24, 1985. The probe could not get below 10 feet into inclinometer CSMW9 on May 24, 1985. Complete data were taken from inclinometer CSMW2 from April to June 1985. A plot of these data is shown in Figure 11. However, inclinometer CSMW2 gave no useful data because it is located outside the slide mass.

The inclinometer data only suggested that the sliding occurs along a shallow failure surface. However, an accurate location of the failure surface using these data was impossible. Additional data on the location of the failure surface were taken from the observation wells although they were not designed as inclinometers. These wells would bend or break at shearing zones. Accordingly, a "Dead-man", shown in Figure 12, was lowered down these holes to locate such bends. The results obtained are summarized in Table 4, and were used to locate the shallower failure surface. The deeper failure surface was identified in the field at nearby bedrocks outcrops, and by observation of the subsurface cores.

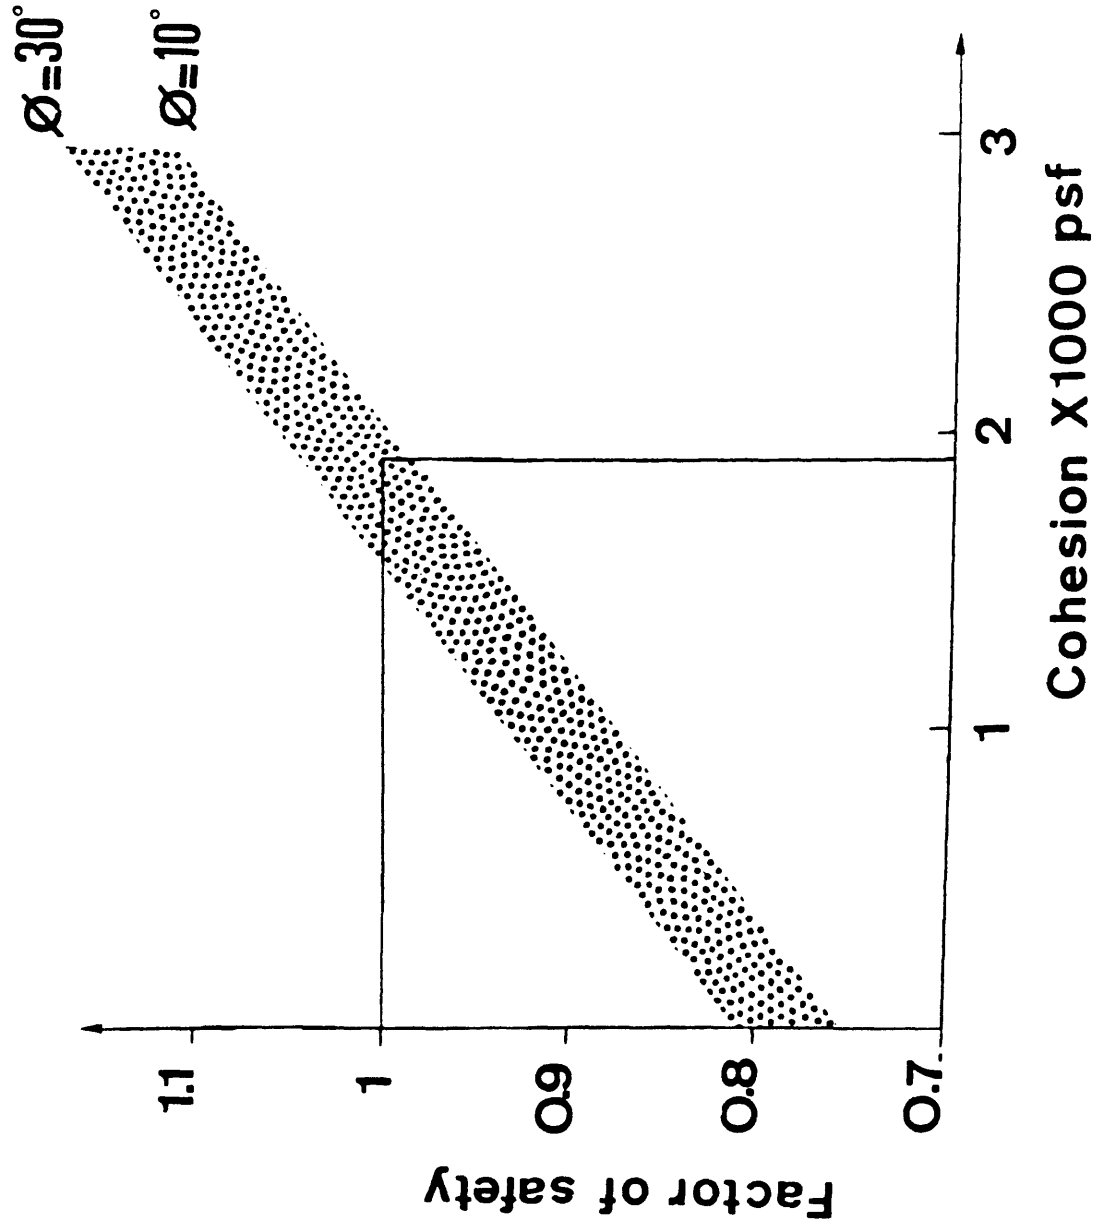
Figure 21 : Sensitivity Analysis.

Figure 21 shows the relationship between the cohesion and the factor of safety for various angles of internal friction. The limits of the shaded area cover all likely subsurface conditions. By examination of Figure 21, it is apparent that the cohesion affects the factor of safety much more than the angle of internal friction. As the angle of friction varies from 10 to 30 degrees, the factor of safety changes only about 5 to 7 %, while a change in cohesion from zero to 3000 psf causes the factor of safety to increase by about 25 %.

Based on the sensitivity analysis a value of 14 degrees for the angle of internal friction and a cohesion of 1900 psf were selected for the landslide material. However two marked failure surfaces were observed and believed to contain bentonite. Accordingly, values of 200 psf and 6 degrees were selected for these layers. These values were chosen from published data on a bentonite zone involved in a landslide in Minneapolis (Wilson, 1974).

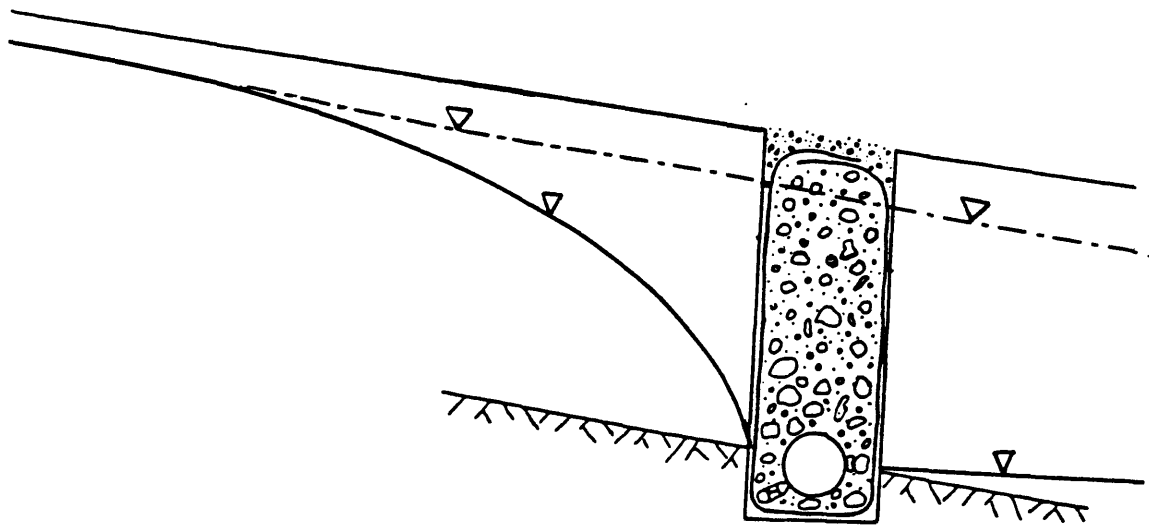
Figure 22 : Effect of Drain Installation on the Groundwater Table.

Interceptor drains are frequently used to drain groundwater in landslide zones. They are installed perpendicular to the groundwater flow direction, and create a continuous zone where groundwater flows towards the drain with a resulted lowering of the water table. Figure 22 shows the effect of an interceptor drain in altering the configuration of the groundwater table.
